M. E. Williams and Associates, Inc.

Case Study: Steam Coil Return Bend Failure

Merlin E. Williams, P.E.

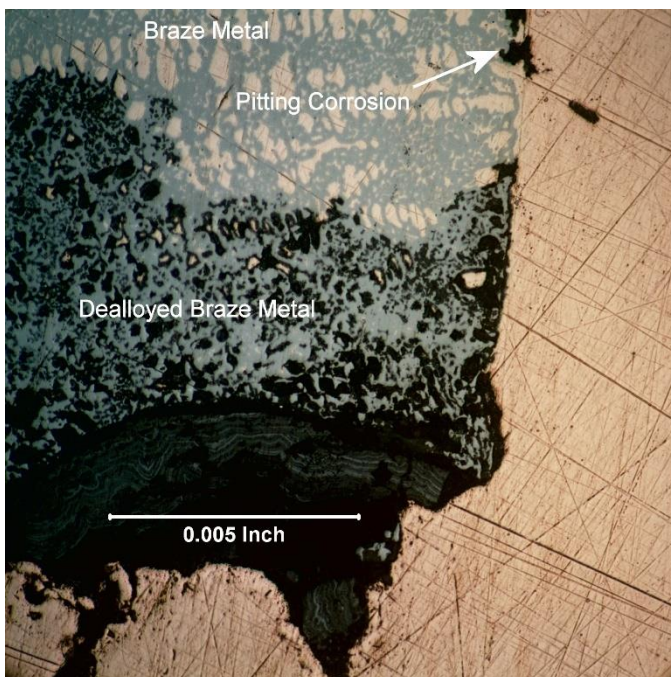
Figure 1 – 400X - Corrosion and De-Alloying of Braze Metal

Figure 1 shows corrosion in the braze joint of the bend. There was penetration of the corrosion into the braze joint. Dealloying of the braze metal was along the copper tube - braze metal interface, Figure 2.

The element that caused the de-alloying and corrosion of the braze metal and copper tubing used for the return bend was sulfur. Moist sulfur compounds will cause de-alloying of copper-phosphorous braze alloys. The sulfur came from the external environment and not from the steam boiler. There was nothing found on the inside diameter of the return bend but copper oxide.

There are two things that needed to be done to prevent future occurrences of leakage similar to what was found on this steam coil: (1) use a braze alloy that is free from phosphorous, such as Bag-7 and Bag-34, which contain copper, silver, zinc, and tin. These braze alloys work well in moist sulfur environments. (2) The return bends need to be enclosed to prevent buildup of debris around them. Pictures provided showed debris accumulation over the return bends. The debris was likely the source of the sulfur.

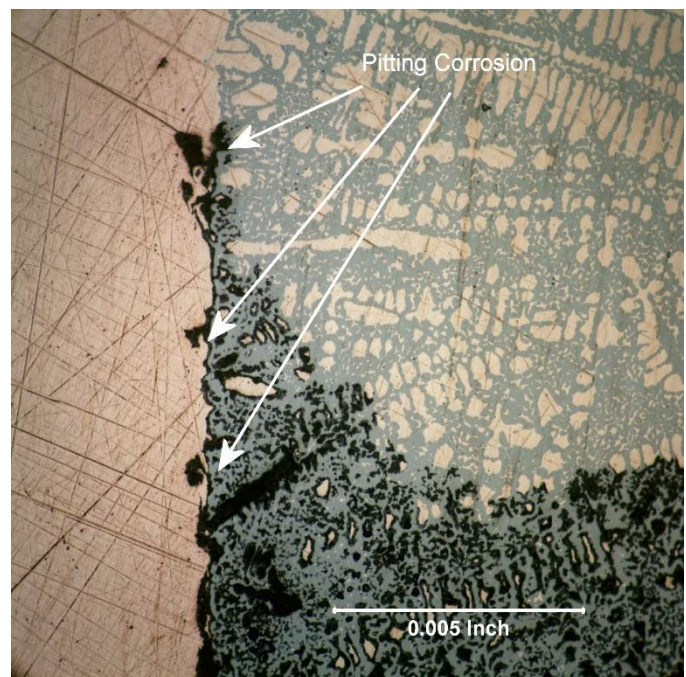
Figure 2 – 400X - Corrosion and De-Alloying of Braze Metal

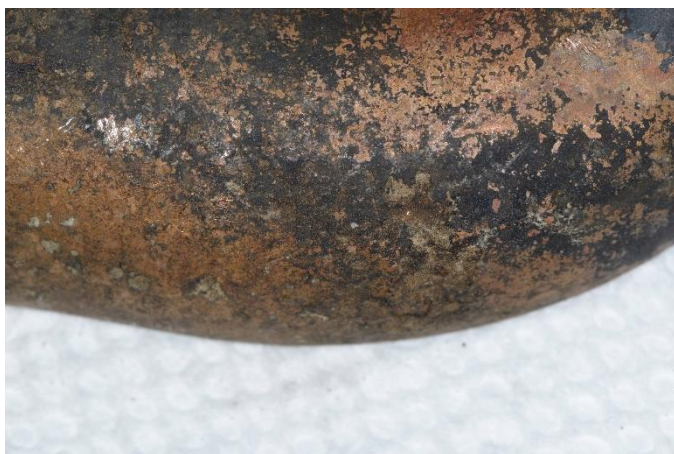
Figure 3 – Scale on OD of Return Bend

Figure 3 shows black scale on the outside diameter of the return bend. The black deposit appeared to be a buildup on the surface. Figure 4 shows the brown-to-black scale on the inside diameter of the return bend.

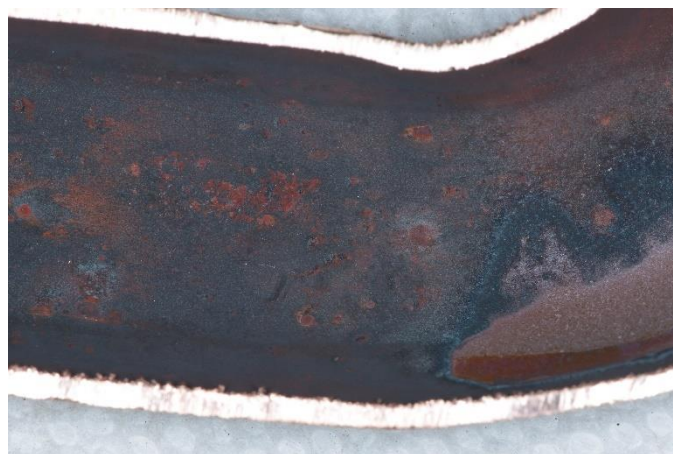
Figure 4 – Scale on ID of Return Bend

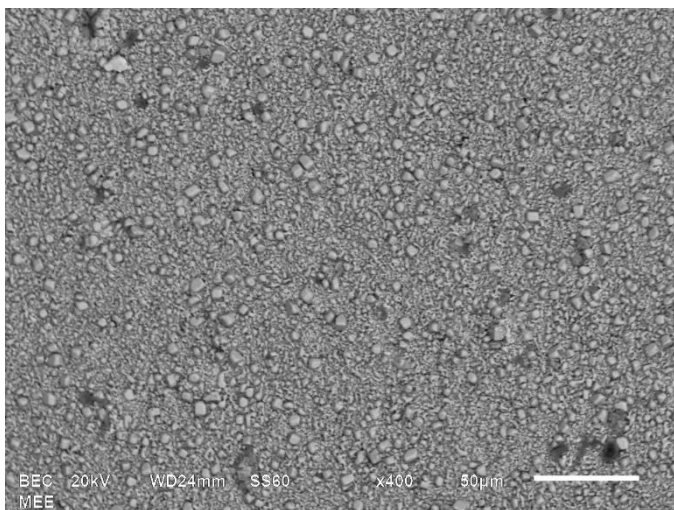
Figure 5 – 400X - Scale ID of Return Bend

Figure 5 shows the scale on the inside diameter of the return bend. The EDS analysis was done over the entire area shown. Figure 6 shows the scale on the outside diameter of the return bend. The Energy Dispersive X-ray, EDS, analysis was done on the entire area shown in Figure 6. Figure 7 shows a braze fillet on the return bend. EDS analysis was done on the two areas shown. The results of all the analyses are given in the table that follows.

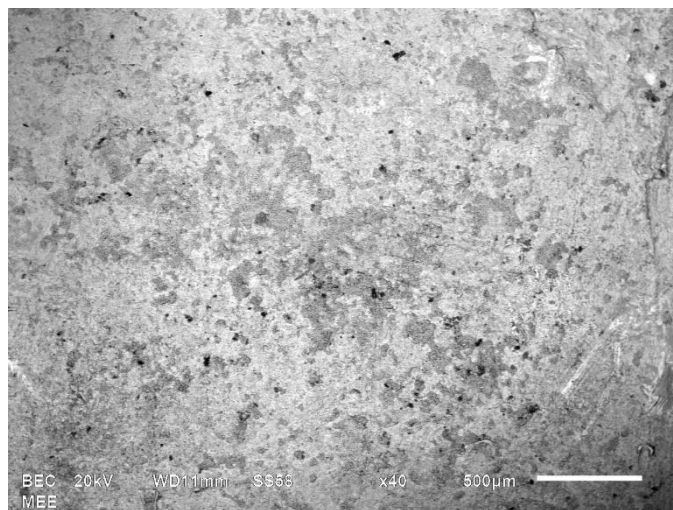
Figure 6 – 40X - Scale OD of Return Bend

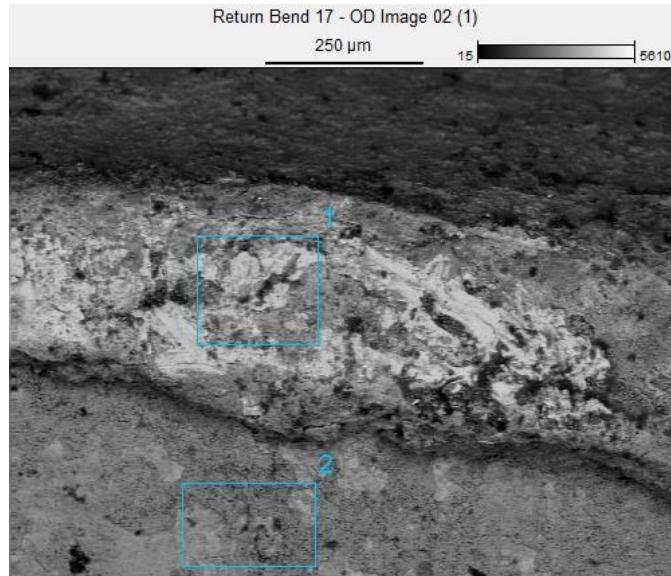
Figure 7 – 120X - Braze Fillet

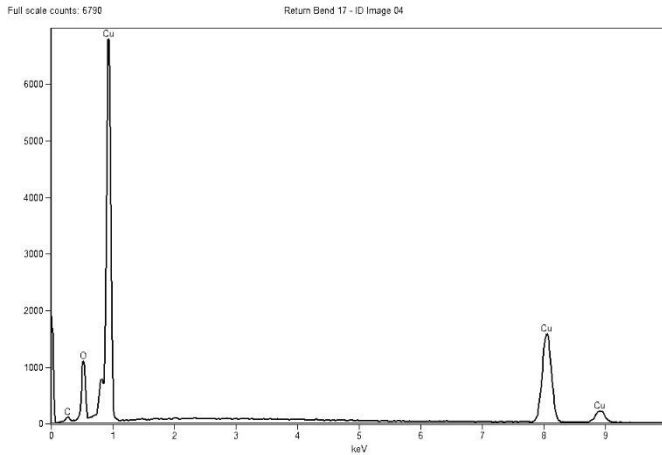
Figure 8 – Spectrum of Scale ID, Return Bend

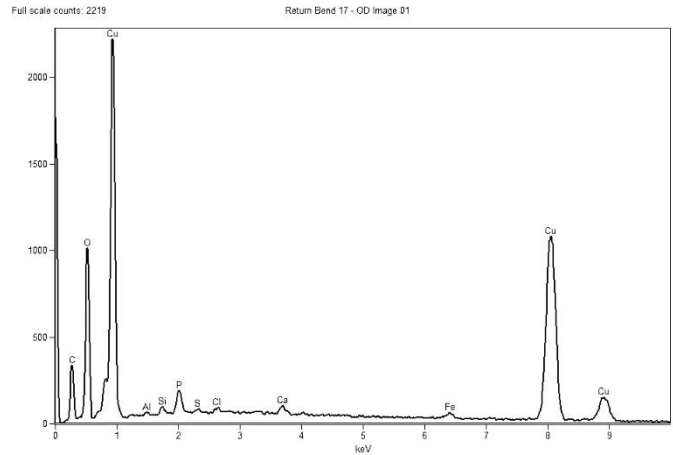
Figure 9 – Spectrum of Scale OD, Return Bend

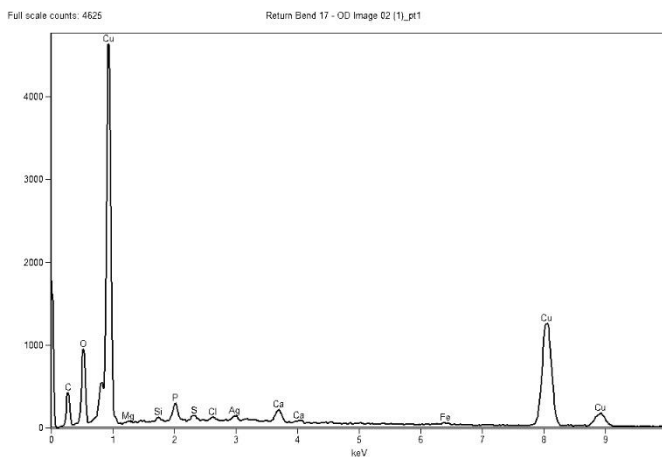
Figure 10 – Spectrum of Braze Fillet, Return Bend

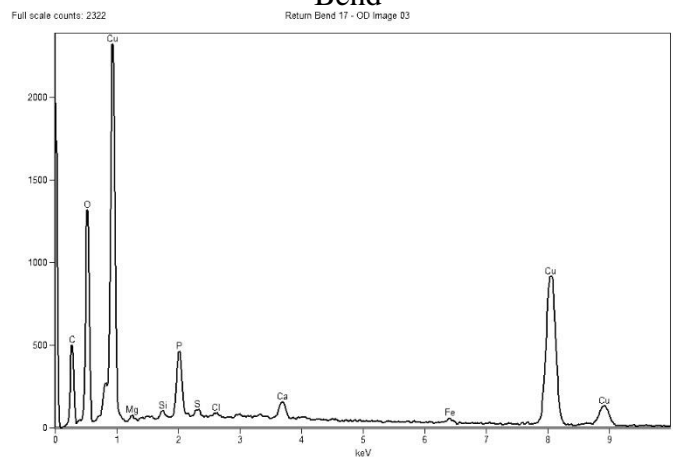
Figure 11 – Spectrum of Tube Next to Braze Fillet, Return Bend
