Case Study: Intergranular Failure

Failure analysis of a three-inch diameter drive shaft to determine the cause of failure, and to recommend reworking to prevent additional failures. The shaft was examined using chemical analysis, hardness testing, and metallographic examination.

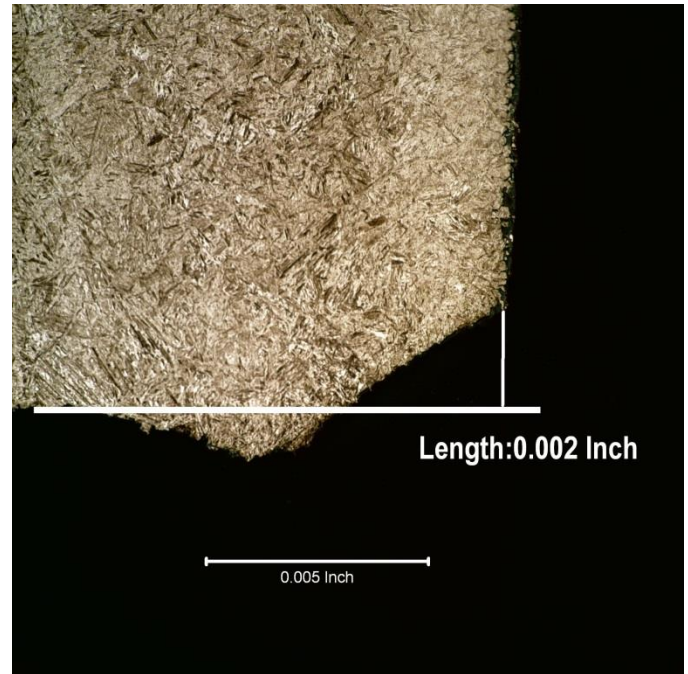
Figure 2 – 400X Shear Lip, Sample 1

Figure 1 shows the tempered martensite microstructure and shear lip associated with Sample 1. The martensitic microstructure was very fine grained, indicating that the shaft was austenitized at the correct temperature. The shear lip, Figure 2, was approximately 0.002 inch. The size of the shear lip was used to estimate the Charpy Impact Strength at this location, which was estimated to be 4 foot-pounds. Charpy Impact Strengths of steel at room temperature of less than 20 foot-pounds is considered brittle.

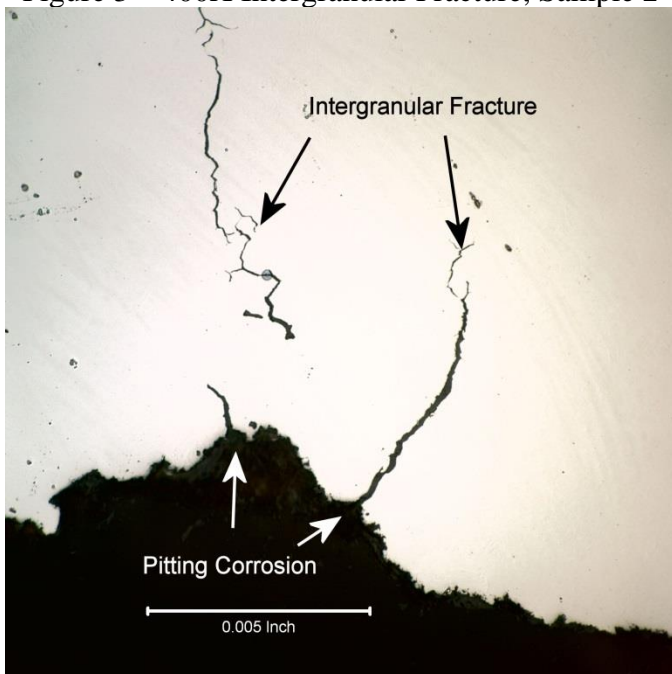
Figure 5 – 400X Pitting Corrosion and Intergranular Fracture, Sample 3

Sample 3 was taken near the fracture origin in the shaft. Figure 5 shows pitting corrosion and intergranular fracture. The pitting corrosion occurred after the shaft had been broken. The surface with the pitting corrosion was the original fracture surface. The intergranular fractures, indicated in Figures 5 and 6, were secondary cracks.
