M. E. Williams and Associates, Inc.

Case Study: Steam Coil Failure

Subject

Examination of ½ inch schedule 160 steel tubing removed from a steam coil to determine the cause of leaking. The tubing was examination by visual examination, hardness testing, and metallographic examination. I had been informed that standing water was found in the tubing. This is a very good example of how basic metallurgical testing can determine the cause of failure.

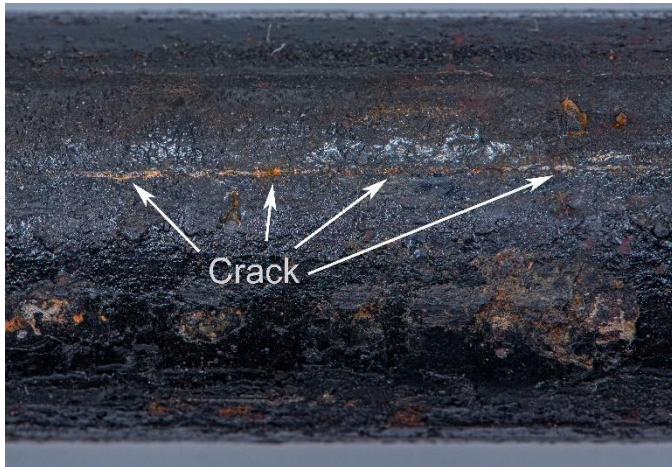
Figure 1 – Crack on Outside Diameter of Tube

Figure 1 shows the barely visible crack on the tube surface. Figure 2 shows the fracture surface after the tube had been opened up. There was a small amount of rust on the fracture surface. The fracture surface was flat with no shear lips, and there were shiny specks on the surface. These two characteristics are associated with cleavage fracture, which is a brittle fracture mode typically associated with high strain rate or fracturing below the ductile brittle transition temperature.

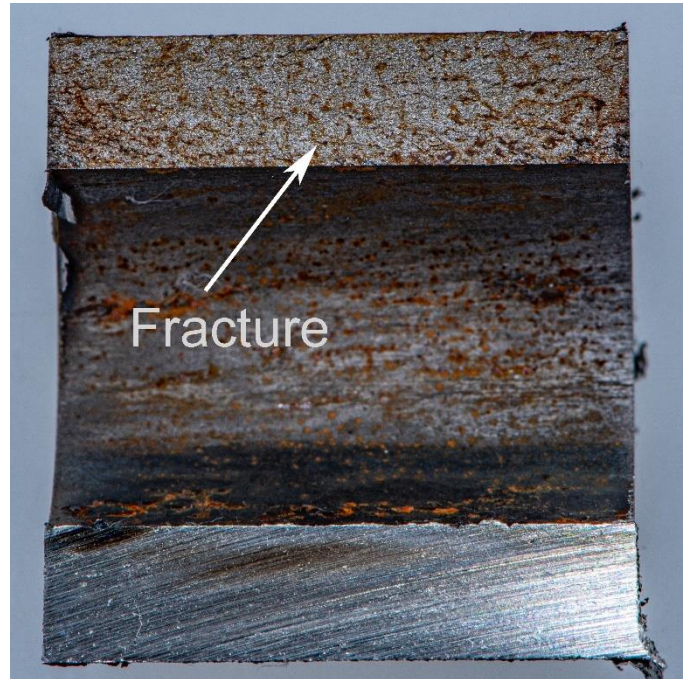
Figure 2 – Flat Fracture Surface

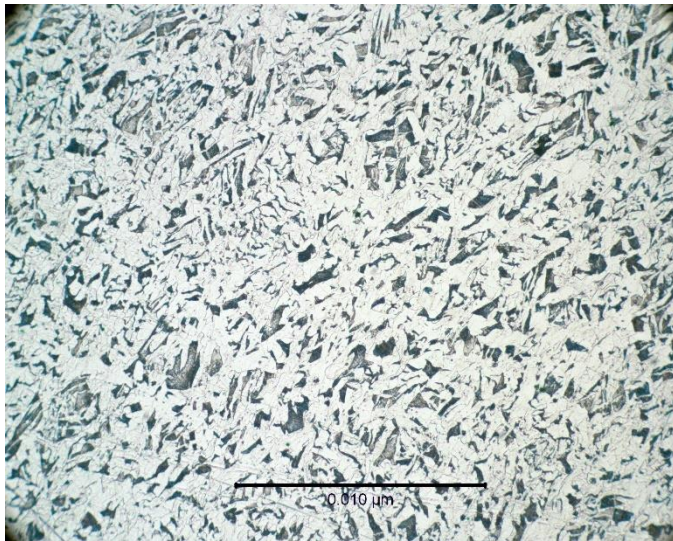
Figure 3 – 200X General Microstructure

The general microstructure of the tube steel is shown in Figure 3. The white areas are ferrite and the dark areas are pearlite. The microstructure is 30% pearlite and pearlite is 0.627% carbon. The steel contains approximately 19% carbon, which corresponds with the composition of the steel indicated in the mill certification. The microstructure is typical of a hot finished, cold worked steel. Hot finished, cold worked steels are more susceptible to cleavage fracture than cold finished annealed steels.

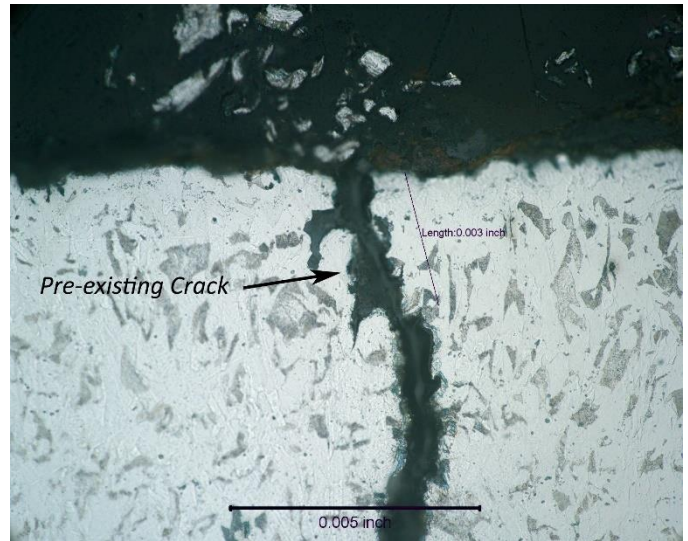
Figure 4 – 400X Fracture Origin

The fracture origin was on the inside diameter of the tubing, shown in Figure 4. There was a seam approximately 0.003 inch deep at the location shown. There were several other locations on the inside diameter of the tubing where the failure could have begun. These location are shown in Figures 5, 6, and 7.

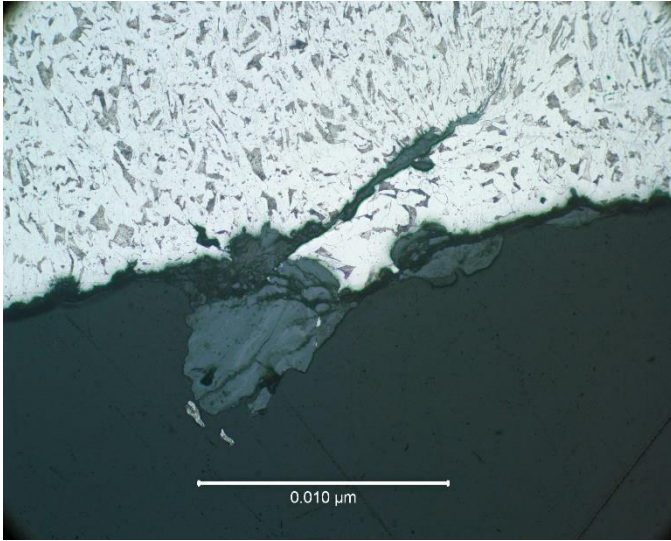
Figure 5 – 200X Seam, Tube I.D.

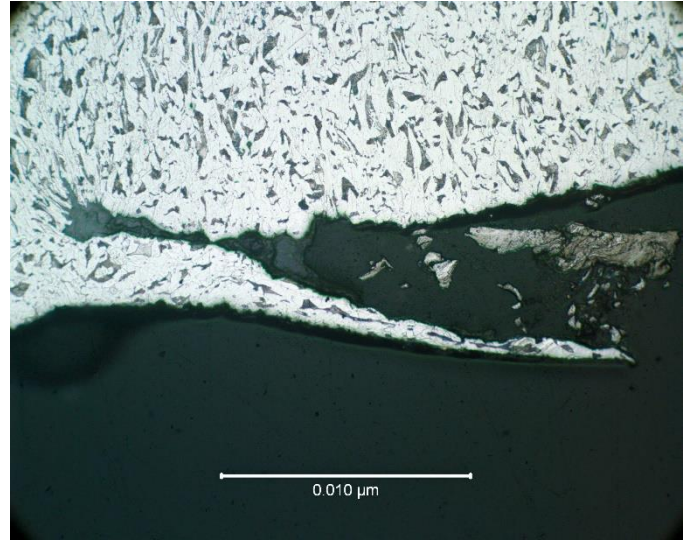
Figure 6 – 200X Seam, Tube I. D.

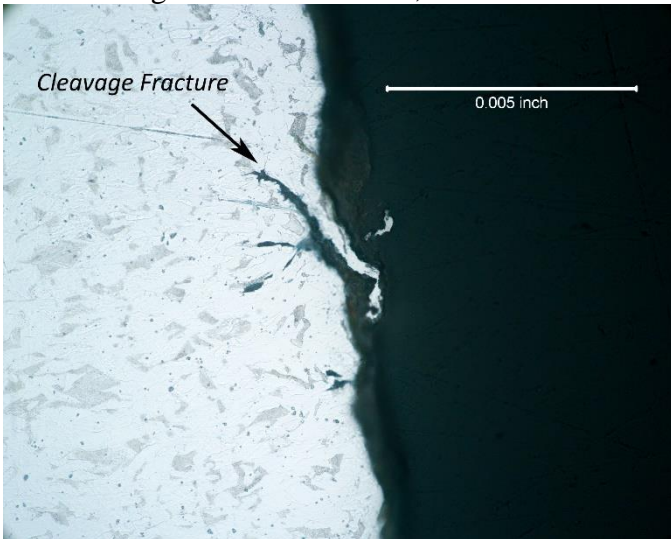
Figure 7 – 400X Seam, Tube I.D. with Cleavage Fracture

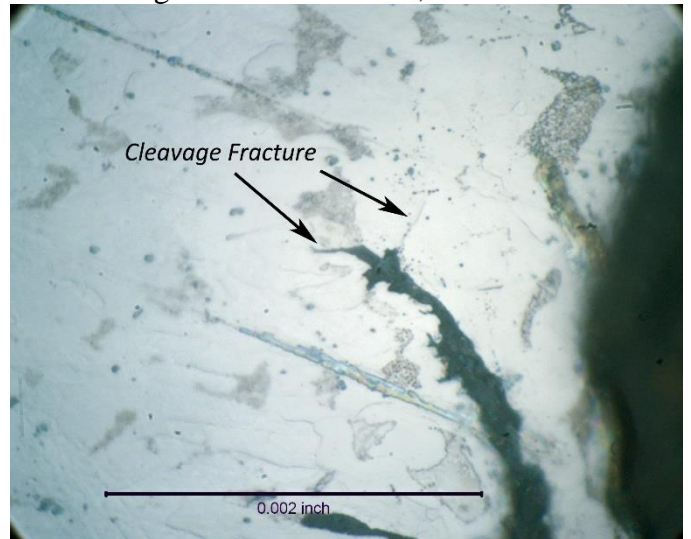
Figure 8 – 1500X Initiation of Cleavage Fracture in Seam, Tube I.D.

Figure 8 shows the seam shown in Figure 7, at higher magnification. The presence of transgranular cleavage is shown at the end of the seam. Transgranular cleavage is caused by high strain rate loading when the temperatures are below the ductile brittle transition temperature. The ductile brittle temperature in plain carbon steels is controlled by the manganese content. For this steel, manganese content was 0.758%. The ductile brittle transition temperature was approximately 32° F or 0° C. Freezing water would have caused cleavage fracturing of this tube. Transgranular cleavage fracture occurs at 50% of the yield strength of the steel, and shows no evidence of dimensional changes in the surrounding material. Figure 9 shows transgranular cleavage along the fracture.

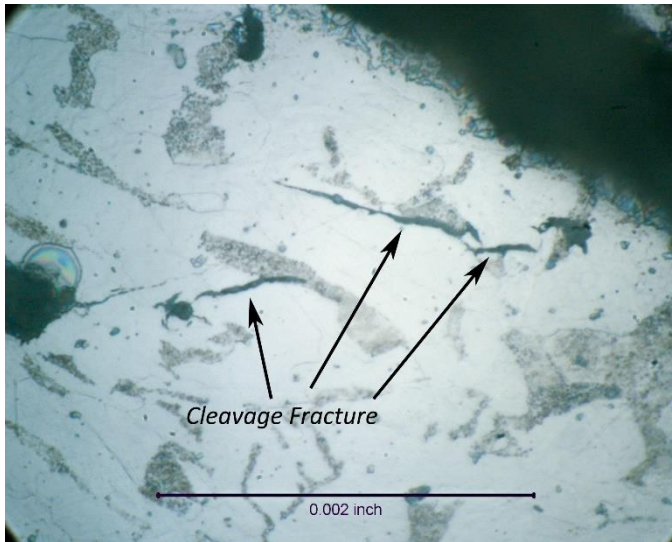
Figure 9 – 1500X Transgranular Cleavage along Fracture

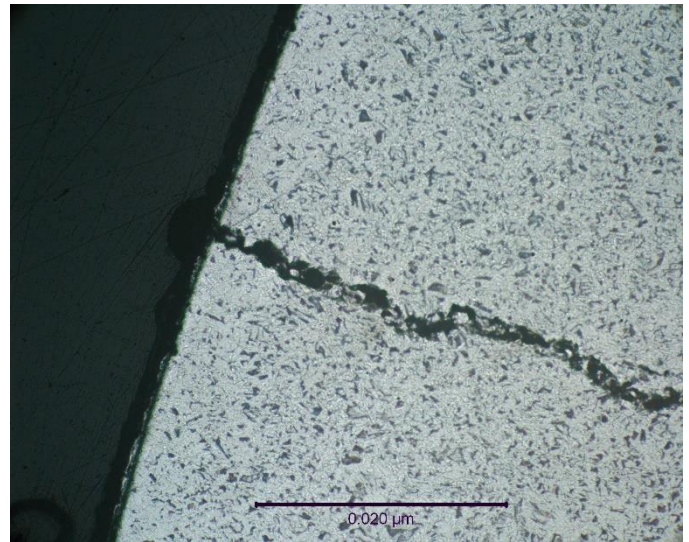
Figure 10 – 100X Fracture at Tube O.D.

Figure 10 shows where the crack in the tubing is exiting on the outside diameter of the tubing. There is no evidence of a shear lip present. The more ductile the steel, the greater the size of the shear lip. This steel had no ductility at the time of fracture.
