## Case Study: Prototype Evaluation

Evaluation of surface defects on a Prototype Parker-Compatible, hydraulic hose crimp fitting to determine if the defects would affect the life of the fitting. The fitting was machined from free machining steel, AISI/SAE 1215, and was examined by visual examination, hardness testing, and metallographic examination to determine the cause of the visual defects, and if they would affect the life of the fitting.

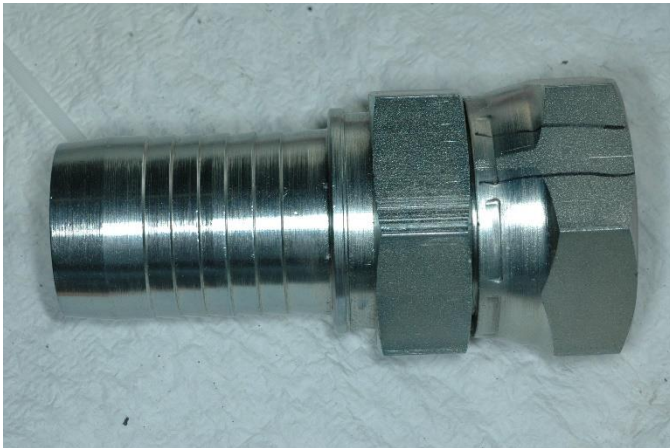
Figure 1 – Fitting Body

Figure 1 shows the body of the fitting. There were several defects on the right end of the body, as shown in Figure 1. Figure 2 shows several grooves that were on the surface of the body. These grooves appeared to be tool marks caused by the screw machining process used in forming the body from the specified steel bar, or by the device used during the crimping assembly of the Body and Sleeve.

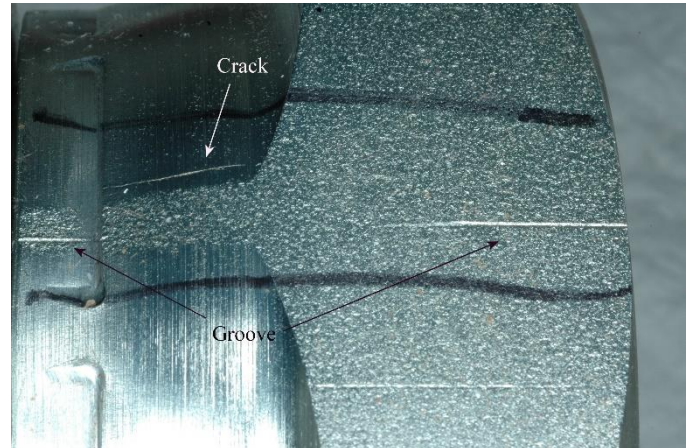
Figure 2 – Crack and Grooves, Body

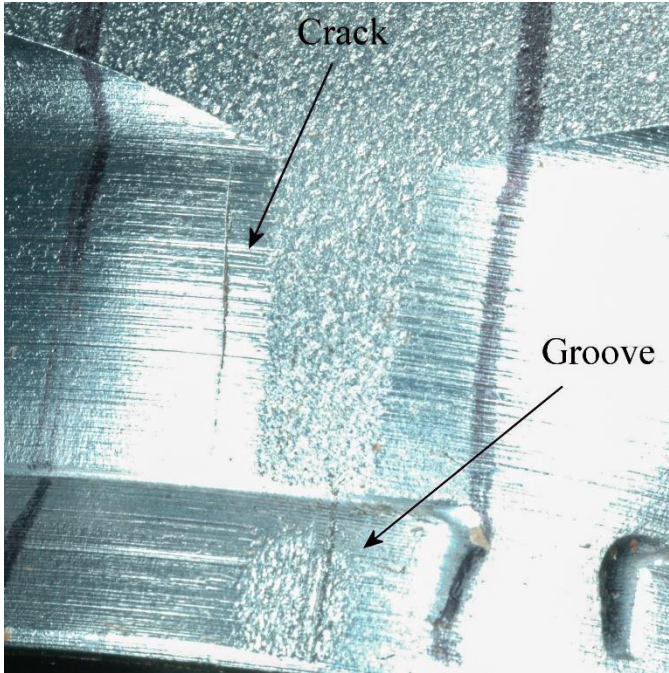
A crack, which was not a surface defect, is shown in Figure 3. The crack appeared to have been initiated by a nonmetallic inclusion, not still present, but typical of those found on or near the surface of free machining steels. The crack opened up during crimping.

Figure 3 – Crack and Groove in Body

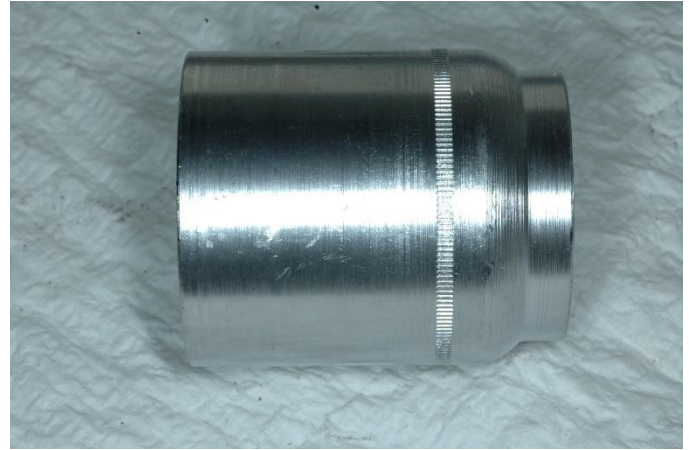
Figure 4 – Sleeve

The Sleeve was annealed, as indicated by a hardness of 68.06 RB. The low hardness was necessary to ensure proper crimping of the sleeve without cracking.

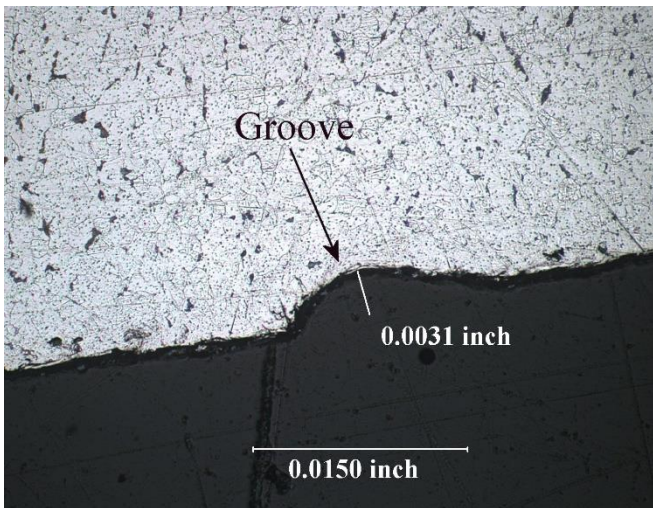
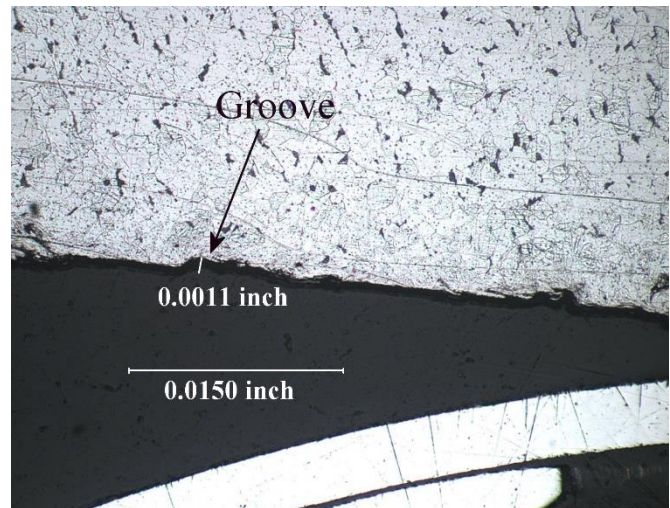
Figure 5 – 100X Body, Groove on Hex Flat

Figure 6 – 100X Body, Groove Crimp Area

Figures 5 and 6 show the groove in two locations in the Body: the hex flat, and the crimp area. The depth of the groove in the hex flat was approximately 0.003 of an inch. In the crimp area, the depth was 0.001 of an inch. Grooves of this type, without sharp edges to act as stress risers, would not be a problem for the coupling's function.

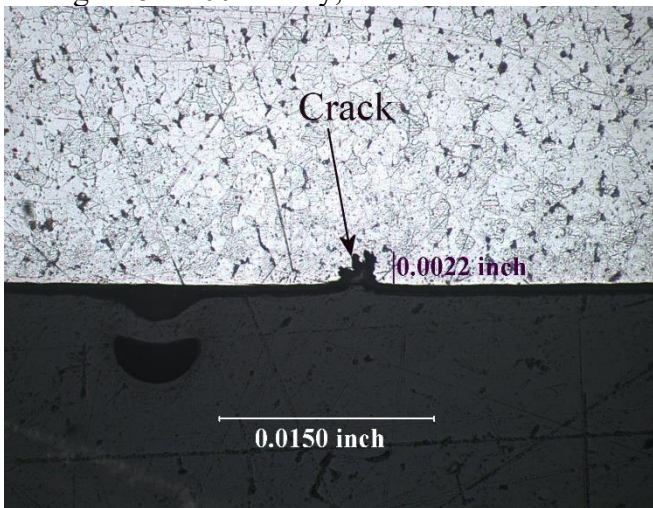
Figure 7 – 100X Body, Crack on Crimp Area

Figure 7 shows the 0.002 of an inch deep crack in the crimp area of the Body. The crack was likely caused by an inclusion in the surface of the steel, and had opened up during crimping. Cracks of this nature were not acceptable and would affect the fittings function.

very poor, short, transverse fracture toughness, meaning that small surface cracks, like the one shown in Figure 7, would likely cause failure.

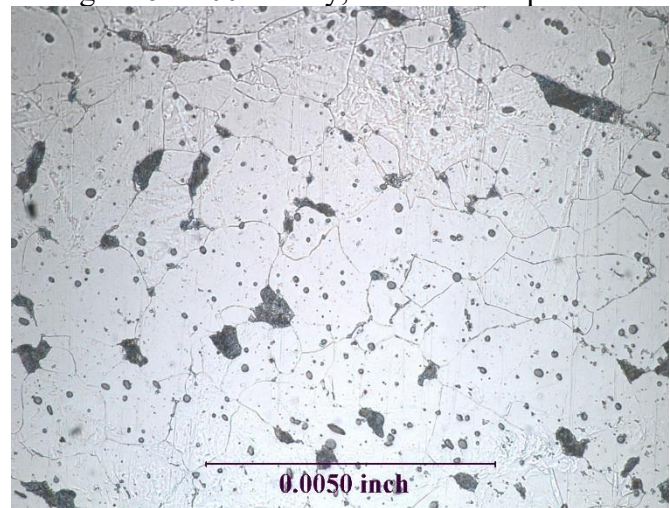
Figure 8 – 400X Sleeve Microstructure

Figure 8 shows the microstructure of the Sleeve. The grain size was 22 microns, which is equivalent to ASTM 8.0. This grain size, and the hardness of 68 Rockwell B, indicated that the sleeve was properly annealed. The microstructure of the sleeve was a mixture of ferrite at 94%, the white phase, pearlite, the larger dark phase at 6%, and inclusions, the very small dark phase. The microstructure indicated that the steel used for the Sleeve was AISI/SAE 1215. This grade, like other grades of free machining steel, has
