M. E. Williams and Associates, Inc.

Case Study: Leak in Inner Groove Tubing

Merlin E. Williams, P.E.

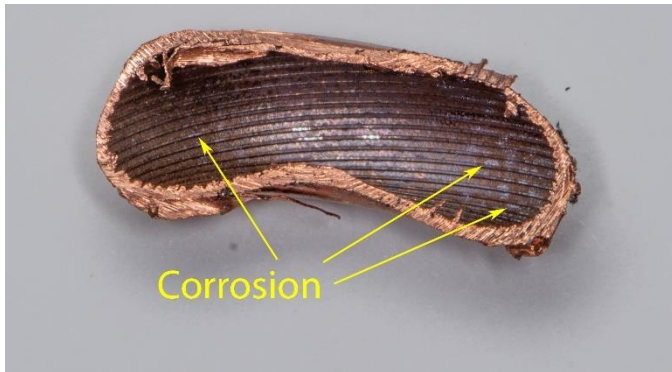
Figure 1 – Corrosion on the Inside of Hairpin

Figure 1 shows a section sliced from a leaking hairpin. There were purple colored deposits, indicated by arrows, on the inside of the tube, which are characteristic of corrosion products formed by breakdown of a POE oil.

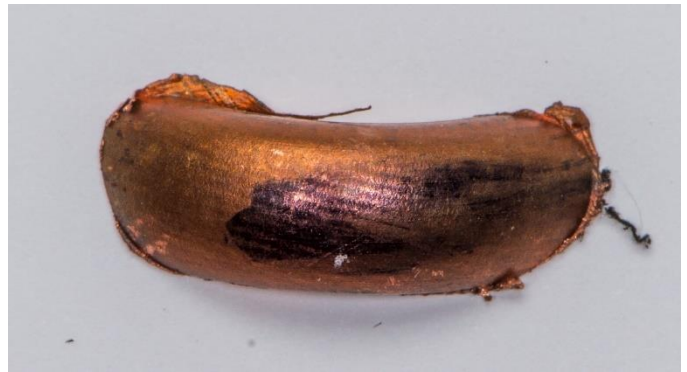
Figure 2 – Leak Indications on Outside of Hairpin

Figure 2 shows the outside of the hairpin. The black marking indicates where leaking was found.

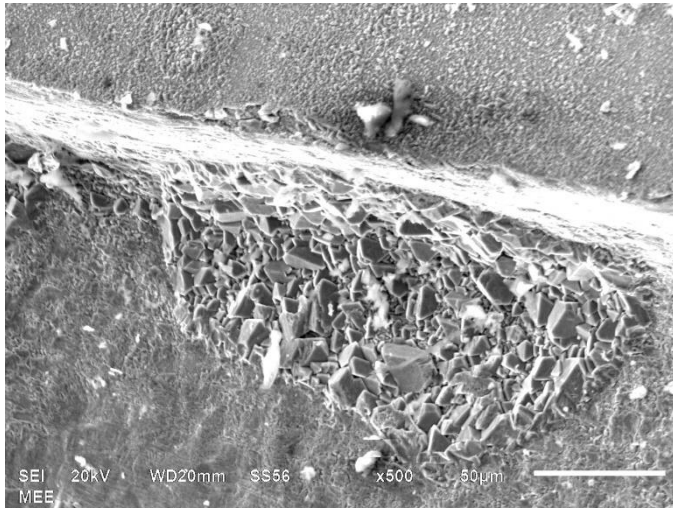
Figure 3 shows corrosion on the inside diameter of the hairpin. The crystalline deposits are typical of copper oxide crystals formed by corrosion in the presence of an acid and water. The EDS spectrum of this location, Figure 4, shows the presence of carbon, oxygen, fluorine, copper, and aluminum. The presence of fluorine indicates that municipal water was trapped at this location. Fluorides are not corrosive because of their very low solubility. The EDS analysis did not indicate the nature of the corrosive agent. This fact

indicates that the corrosive agent may have been an organic acid. The source of the aluminum detected was likely stray x-rays from the aluminum carrier the tube sample was on.

Figure 3 – 500X Corrosion on ID of Hairpin

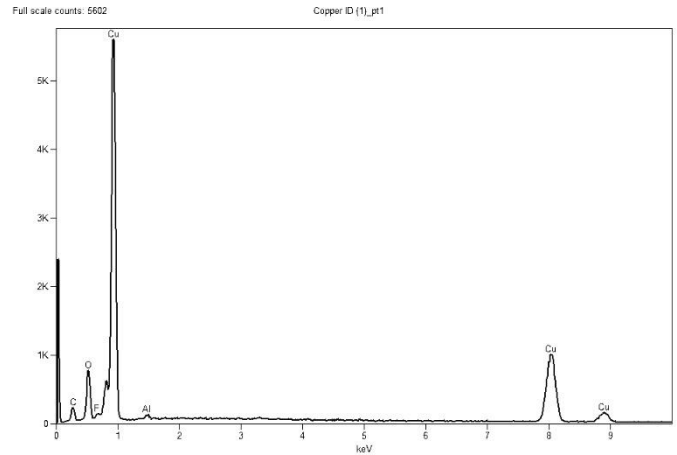
Figure 4 – Spectrum of Corrosion on ID of Hairpin

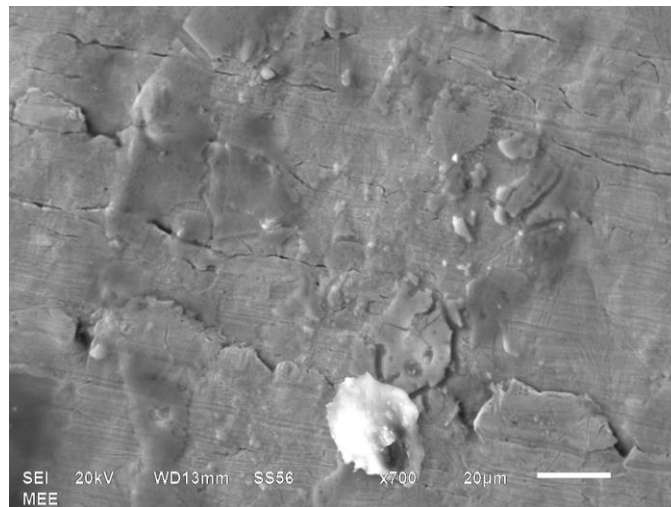
Forming of hairpins usually results in microscopic surface cracking. Figure 5 shows that condition in the tubing. The amount of surface cracking appears to be somewhat more than normal, but the condition could be the result of the drawing of the tubing at the mill, and did not appear to have been a contributing factor to the leaks in the hairpin.

Figure 5 – 700X Surface Cracks on OD of Hairpin

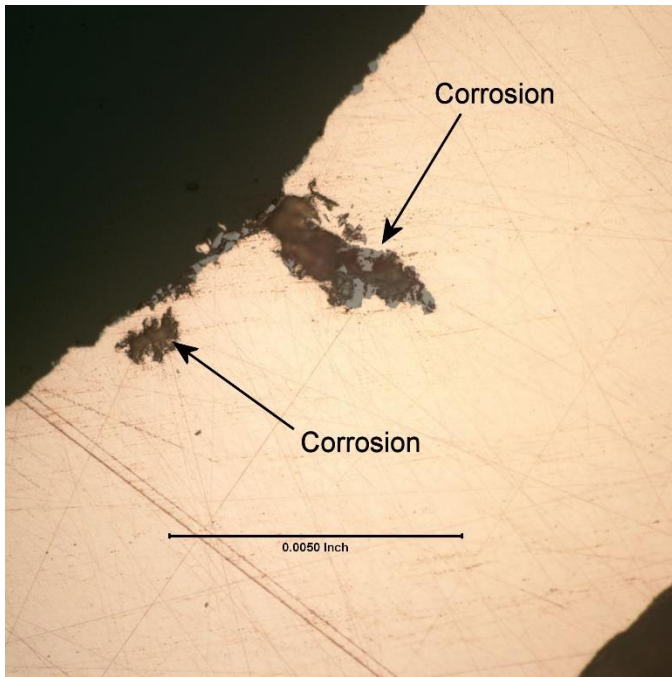
Figure 6 – 400X Corrosion on ID of Hairpin

Figures 6 and 7 show corrosion originating on the inside diameter of the hairpin. The corrosion has the visual characteristics of corrosion that resulted from the presence of water and POE oil. The corrosion pattern shown in Figure 7 has many of the characteristics of formicary corrosion.

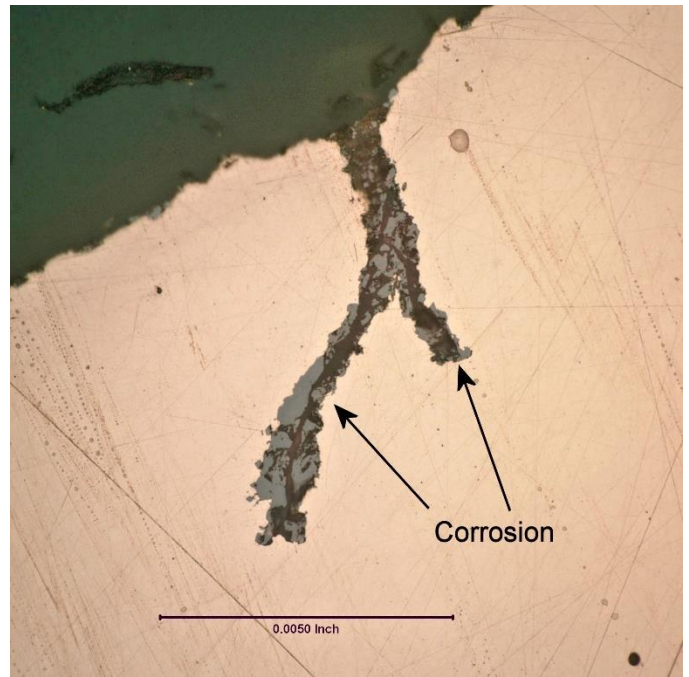
Figure 7 – 400X Corrosion on ID of Hairpin

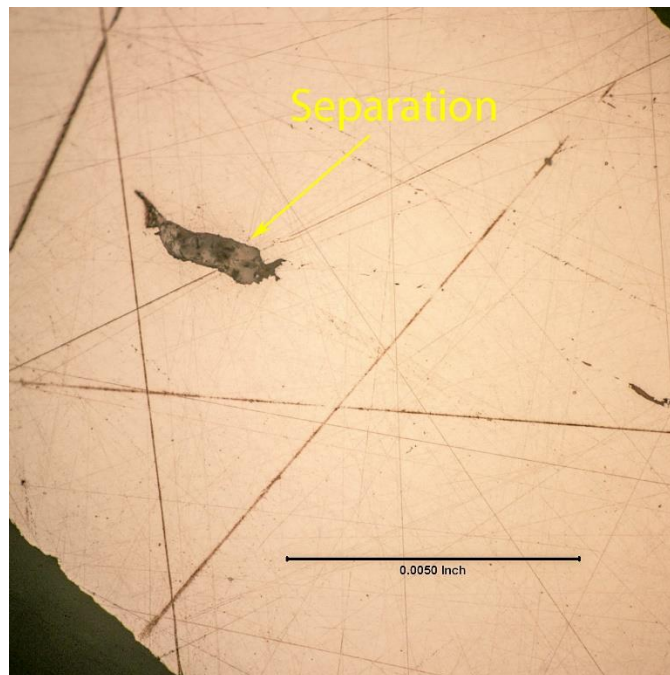
Figure 8 – 400X Separation in Tubing

Figure 8 shows a separation in the copper tubing. The separation was caused by incomplete bonding of the copper during the initial drawing of the tubing. There were no cases found where separations were connected with the corrosion in the inside diameter of the tubing.
