## Case Study: Chromate Conversion Coating

Merlin E. Williams, P.E.

Evaluation of trivalent chromate conversion coating on zinc plating to determine possible cause of discoloration of the coating upon storage of the parts. At the time of this case study, the discoloration of trivalent chromate conversion coatings was an industry wide problem that was assumed to be corrosion. It was apparent that the discoloration only happened when parts were chromated by tumbling in barrel plating drums. This study determined the nature of the problem, that the soundness of the material was not affected, but only the surface appearance. Possible causes of the problem were also determined.

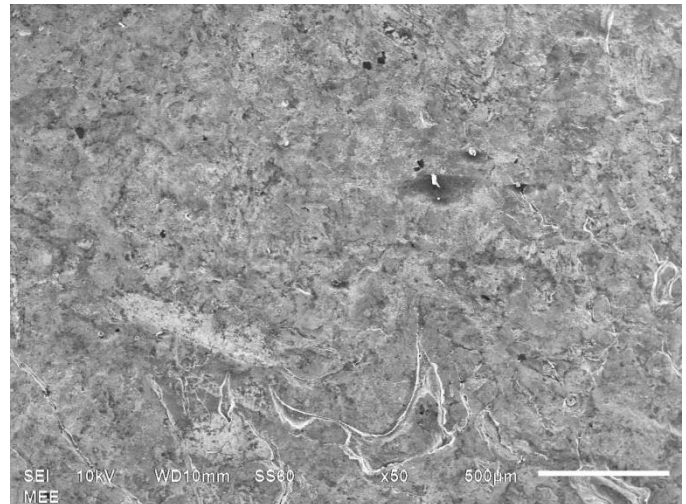
Figure 2 – 50X Analysis Area of Zinc Die Casting

A zinc die cast part, treated with trivalent conversion coating six months prior to the analysis of the surface, was examined. Figure 2 shows the area of analysis on the Zinc Die Casting. The semi-quantitative analysis results are given in Table 1, and the spectrum is shown in Figure 3.

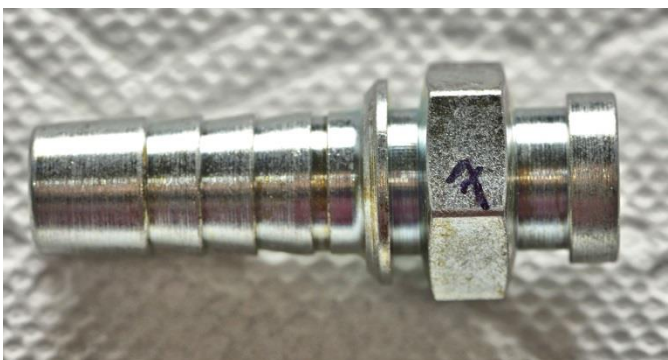
Figure 1 – Zinc Plated Steel after Five Months in Storage

Zinc plated steel, Figure 1, was fabricated from 12L14 steel and plated five months prior to the evaluation with alkaline non-cyanide zinc, then given a clear trivalent chromium passivate coating. The part was stored in a Ziplock bag. Analysis Area 1 was located on the hex. The surface for Area 1 is shown in Figure 2. There was mechanical damage to the surface. The analysis locations are shown in Figure 3, and the semi-quantitative analysis results are given in Table 1.

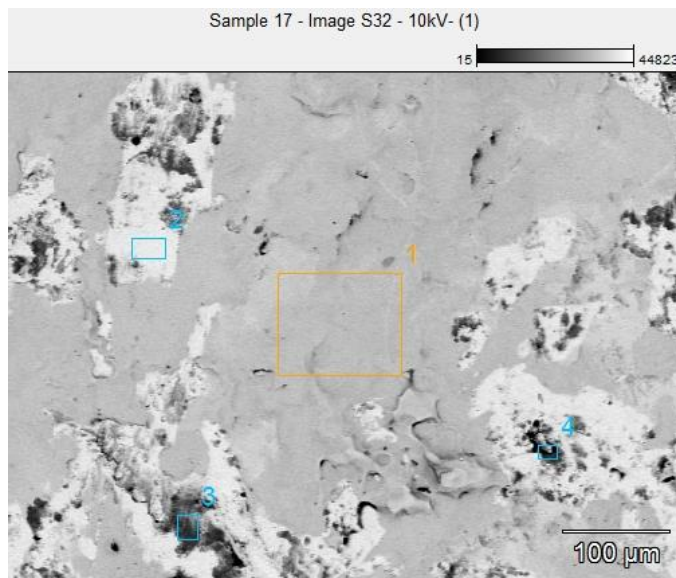
Figure 3 – 200X Zinc Plated Steel, Area 1, Analysis Locations

There was no fluorine or silicon present at Location 1, but chromium was found. Location 2 was free of the conversion coating. The dark material, Figure 3, Locations 3 and 4, showed the presence of fluorine

and chromium. Location 4 also had silicon. In Locations 3 and 4, the coating was thicker, allowing for better analysis.

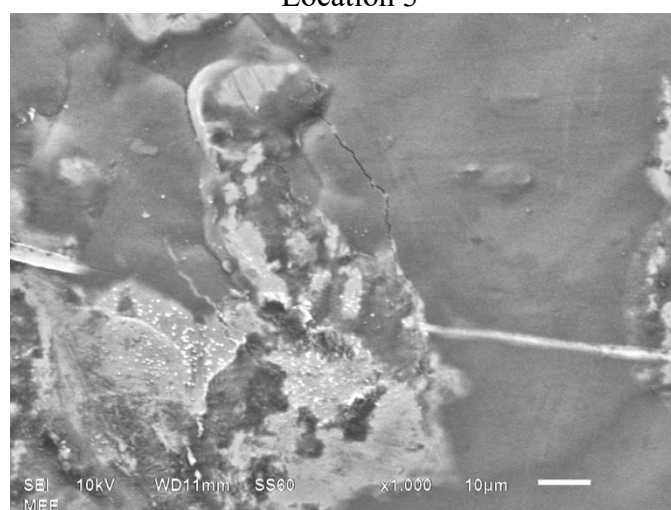
Figure 8 – 1000X Zinc Plated Steel, Area 2

Zinc Plated Steel, Area 2, is shown in Figure 8. There were several cracks in the zinc plating at this location. There were very small white spheres present in a portion of the location shown. The analysis locations are shown in Figure 9. The semi-quantitative analysis result for each location is given in Table 2.

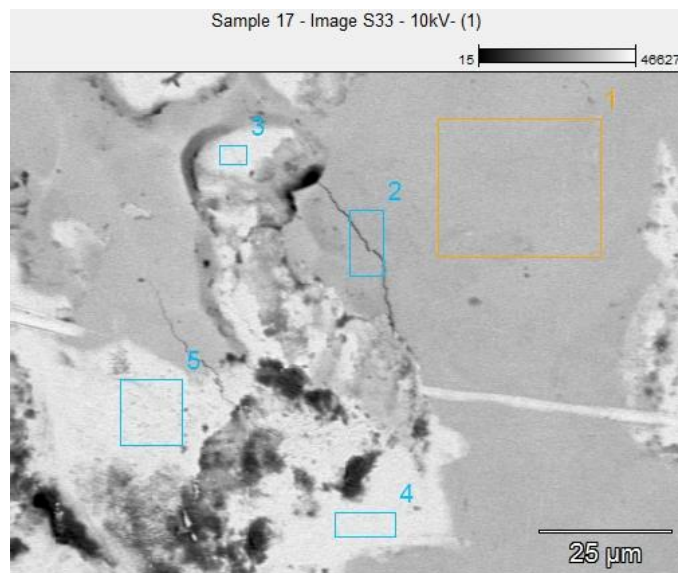
Figure 9 – 1000X Zinc Plated Steel, Area 2,  
Analysis Locations

Locations 1 and 2 had the conversion coating, but the supplemental coating was not detected. Locations 3, 4, and 5 were free of any detectible coating.

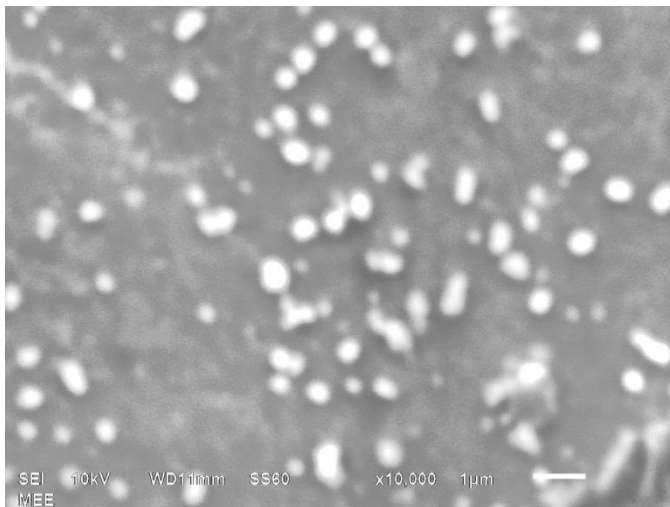
Figure 15 – 10,000X Sample 7, Area 3

Sample 7, Area 3, consisted of submicron sized particles that were seen on the surface in Area 2. Analysis was done to determine what the particles were. Table 3 gives the semi-quantitative analysis results for the four particles that were analyzed.

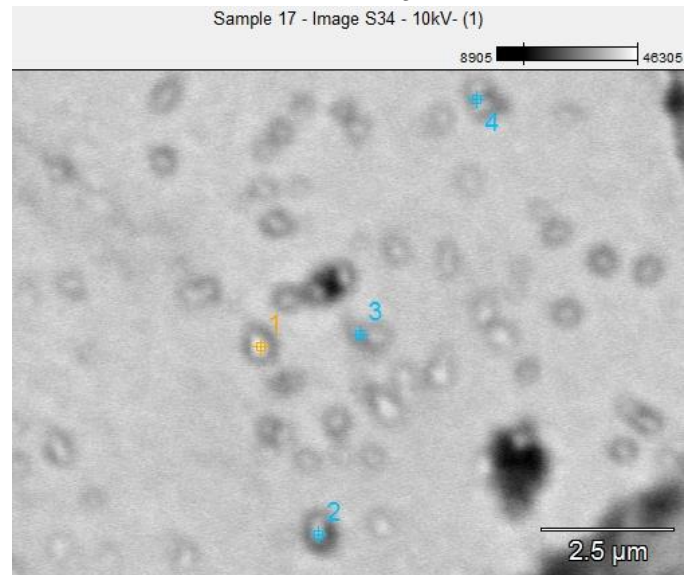
Figure 16 – 10,000X Sample 7, Area 3, Analysis Locations

The analysis of the particles showed that they were submicron-sized zinc particles.

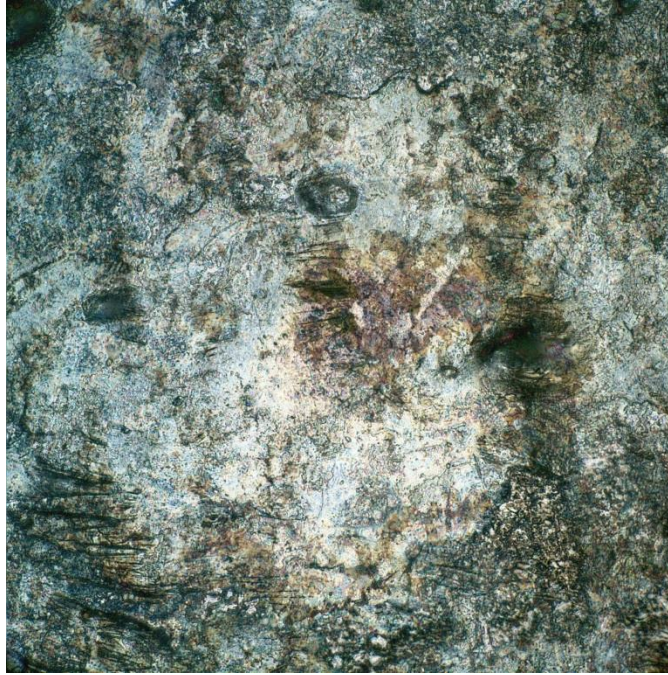
interfering with the wetting of the zinc plating by the conversion coating bath. Incomplete coverage of the zinc plating with the conversion coating will set up differences in oxygen potential on the surface. It could not be determined if this potential would be high enough to convert trivalent chromium to hexavalent chromium, but this appeared to be happening. Upon re-examination, the zinc die cast showed red-brown discoloration starting to form, see photo below.

400X Surface of Treated Zinc Die Casting
