M. E. Williams and Associates, Inc.

Welding Nightmares – Case Study

Heavy Section Weldment of Medium Carbon Steel

Re-Bar and Support Bracket Failure

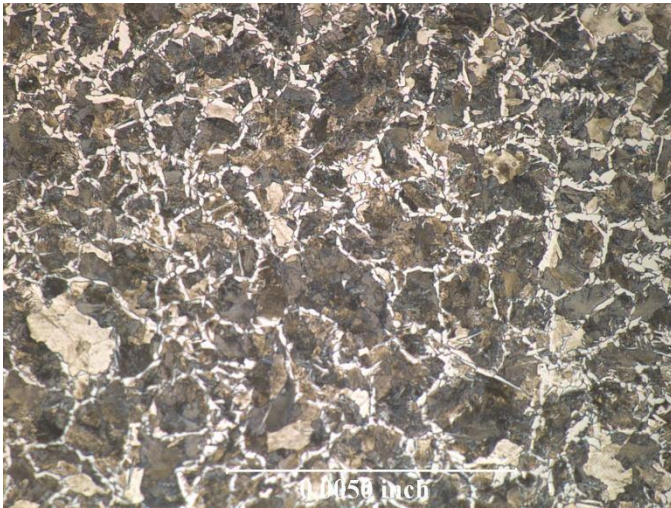
Figure 1 – 400X Microstructure of 1045/1050 Steel

In Figures 1 and 2, the material that was welded was a 4 inches by 4 inch heavy section channel, about 40 pounds/foot, of 1045 carbon steel. The microstructure of the channel steel consists of pearlite and grain boundary ferrite, typical of 1045 steel. This section was used as a wear bar and was welded to a steel plate with a 3/8 inch fillet weld. The welds holding the wear bar to the steel plate were failing long before the bars were wearing out.

Figure 1 shows the normal heat affected zone of 1045 steel. The microstructure consists of tempered martensite islands surrounded by ferrite. Figure 2 shows coarse grained Widmanstatten, which is formed by very rapid cooling from temperatures just below the melting point in ferrous alloys. This microstructure was first noticed in iron meteorites in the early 1800's and is found in titanium alloys.

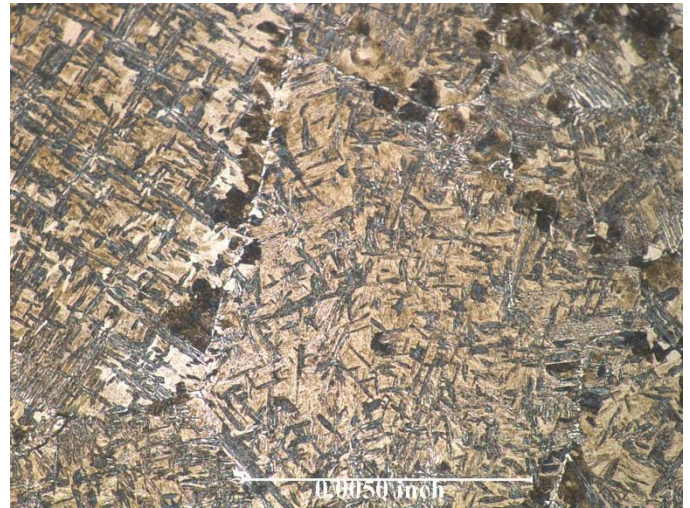
Figure 2 – 400X Coarse Grain Widmanstätten

Widmanstatten is a very brittle microstructure in ferrous alloys, and usually results in premature weld failures, as in this case.

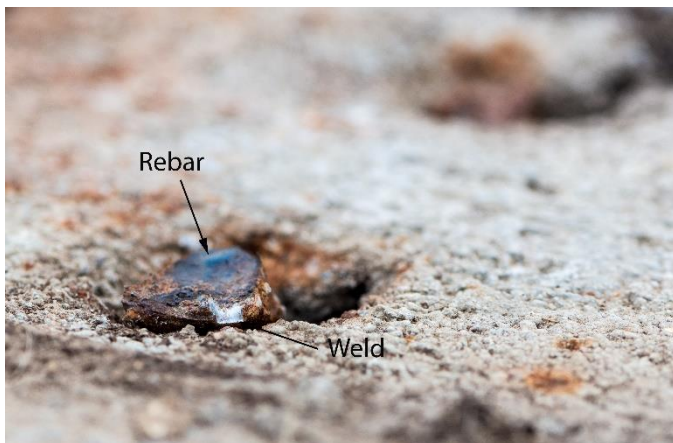
Figure 3 – Typical Weld Failure

Figure 3 shows a typical remaining weld on a reinforcing bar embedded in concrete. Most of the weld joints had failed prior to the windstorm, and some had failed by the time it was imbedded in the concrete.

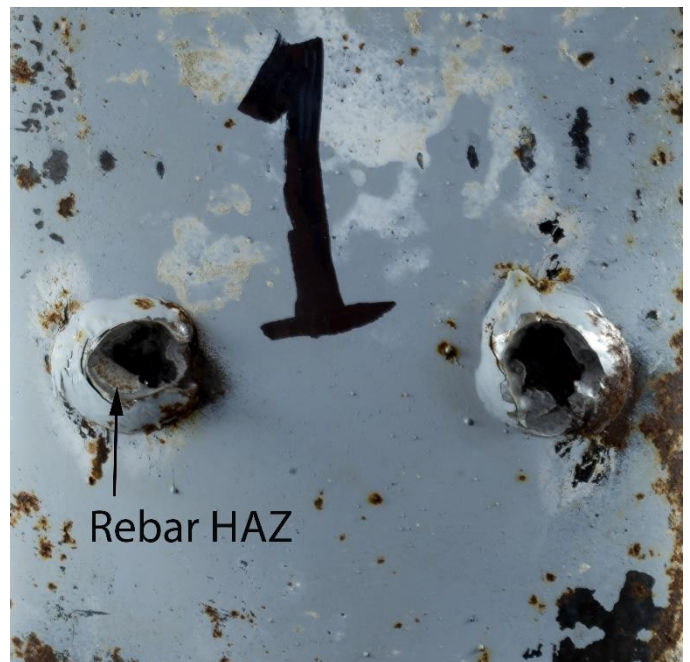
Figure 4 – Failed Weld Joint on Bracket

Figure 4 shows broken weld joints on the bracket. These two weld joints failed in the reinforcing bar heat affected zone.

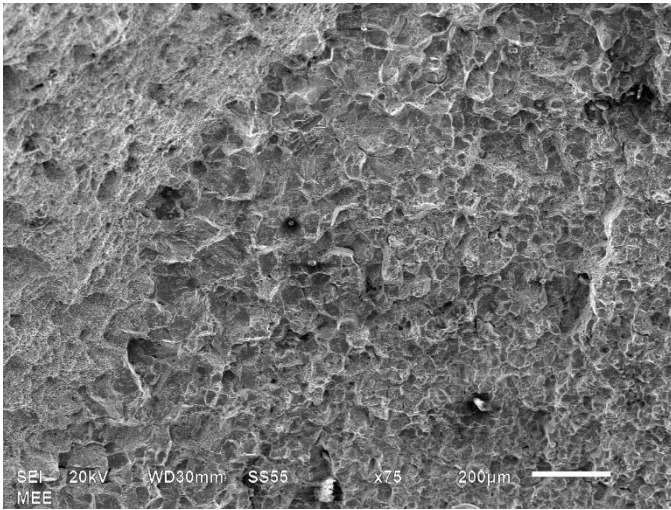
Figure 5 – 75X Brittle Fracture Rebar HAZ

The reinforcing bar was a Grade 80, and the material used was a medium carbon, nickel-chromium steel with a carbon equivalent of 0.55%. This steel required preheating prior to welding and post-heating after welding. Figure 5 shows that the fracture mode for the weld was intergranular brittle fracture, and Figure 6 shows that the cause of the intergranular brittle fracture was Widmanstatten. The bracket material was ASTM A36 steel.
