## Case Study: Residential Heat Exchanger Failure

Merlin E. Williams, P.E.

### **Subject**

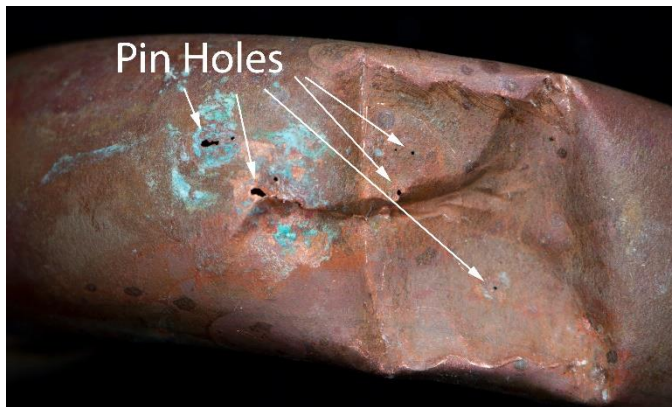
Figure 1 – Pin Holes in Return Bend

Figure 1 shows the outer surface of a return bend. There were five pin holes present, and the wall thickness of the copper tubing had been thinned sufficiently to make it easily deformed, as shown in the photo.

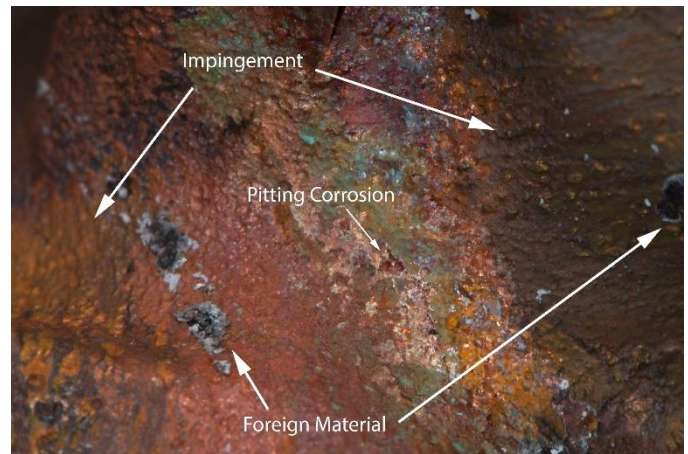
Figure 2 – Inside Diameter of Return Bend

Figure 2 shows the inside of a return bend that had been cut open. There were gray-black deposits of an unknown foreign material present. There was clear evidence of impingement, which is caused by a mixture of a fluid and a solid or gas when there is turbulent flow present. There was pitting corrosion present, which was likely the result of the high sulfate concentration and the acidic water conditions.

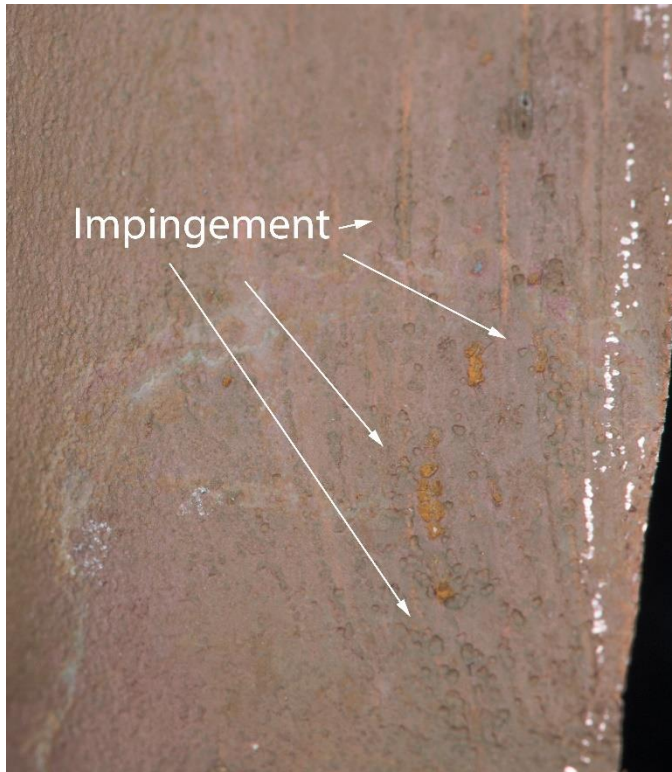
Figure 3 – Impingement on Return Bend I.D.

Figure 3 shows impingement and a flow pattern in the inside diameter of another return bend.

1. The water used in the heat exchanger was corrosive to copper and copper alloys because of the high levels of nitrates, sulfates, chloride, and the acid pH. The water also contained
2. particulate matter, as shown in Figure 3, which contributed to impingement, or erosion corrosion. If no other factors were involved, the water problems were sufficient to cause premature failure of the heat exchanger.
3. The visual examination showed the presence of impingement (erosion corrosion), foreign material, pitting corrosion, and biological activity, most likely in the form of sulfur reducing bacteria. The impingement was the result of particulate matter in the water, combined with turbulent flow. The turbulence was the result of excessive velocity of the water in the heat exchanger. The blue-green mounds formed during periods of low flow rates and stagnant conditions.

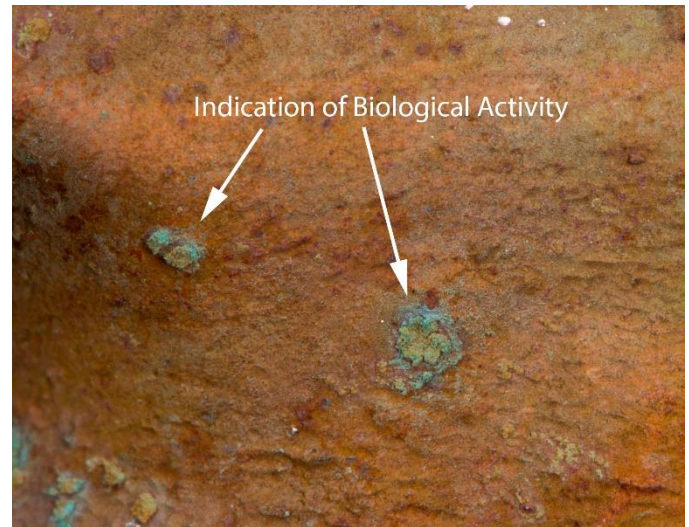
The mounds of blue-green material, Figure 4, are typical of the mounds formed by sulfur reducing bacteria on copper tubing in an environment of cold water containing sulfates and chlorides. The mounds formed during periods of time when there was low flow or the water was stagnant in the heat exchanger.

Figure 4 – Indication of Biological Activity on I.D. of Return Bend

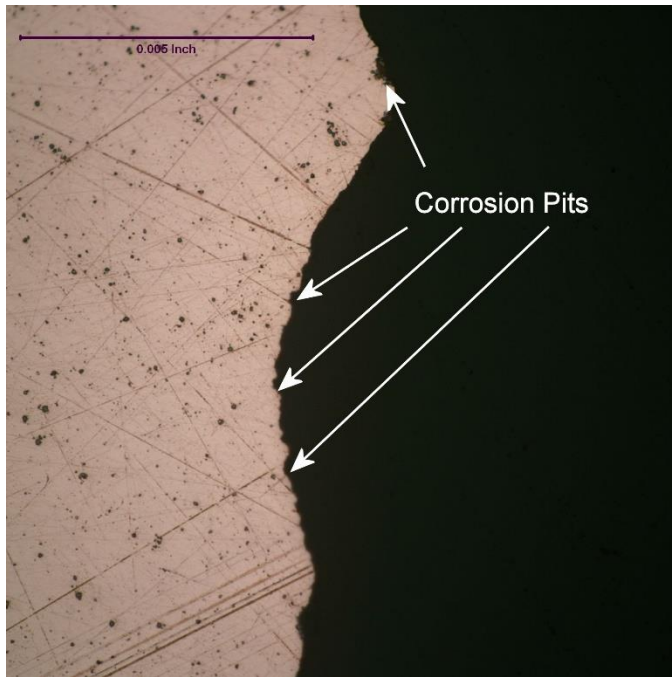
Figure 5 – 400X Erosion Pit with Pitting Corrosion

Figure 5 shows an erosion pit on the inside diameter of a return bend. The shape of the pit indicates that the direction of water flow was from the top to the bottom of the photo. Besides erosion, there was pitting corrosion occurring on the eroded surface. Figure 8 shows the development of the pitting corrosion at a higher magnification.

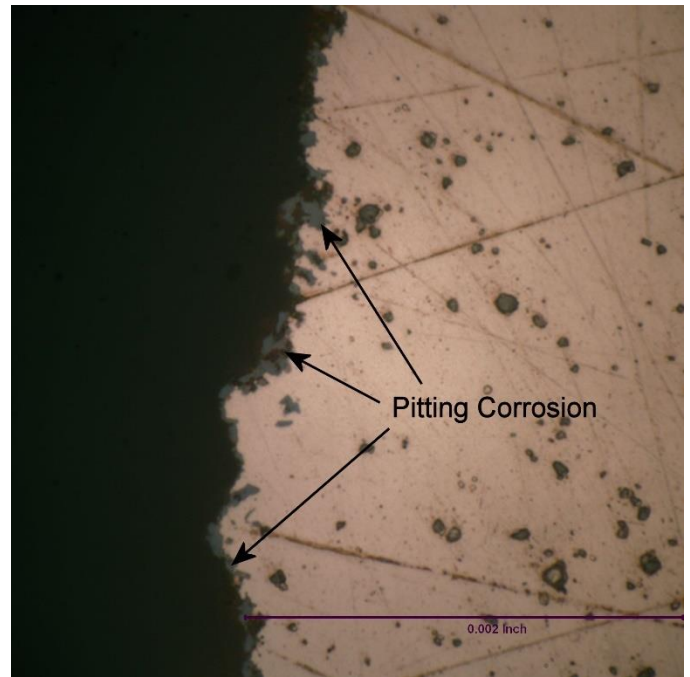
Figure 6 – 1500X Pitting Corrosion, Return Bend I.D.

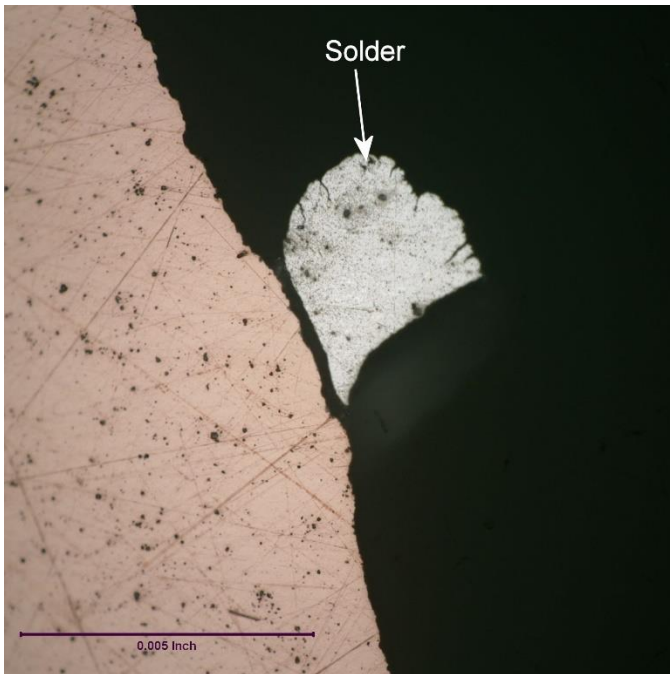
Figure 7 – 400X Solder on I.D. of Return Bend

The piece of solder, shown in Figure 8, should not have been there. Foreign materials such as solder can initiate corrosion, and are an indication of poor quality workmanship, either in the heat exchanger or elsewhere in the plumbing system.

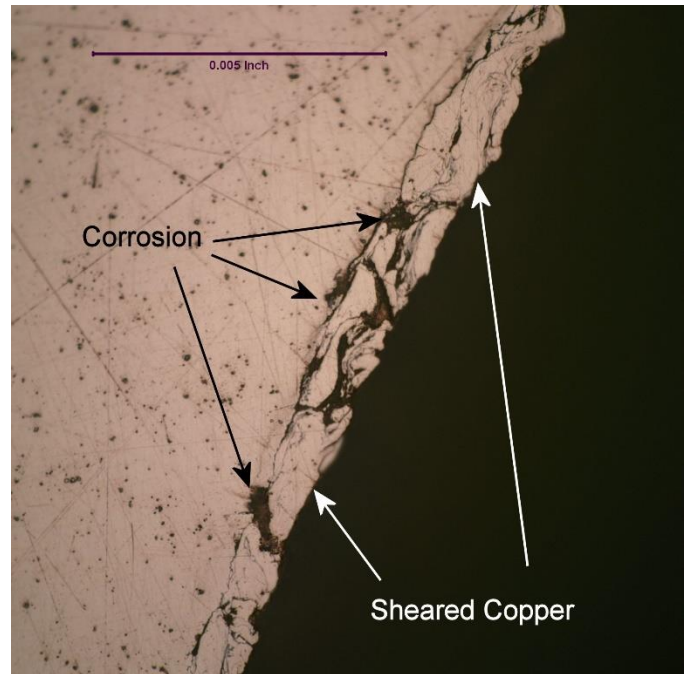
Figure 8 – 400X Sheared Copper on O.D. of Return Bend

The shear material shown on the outside diameter of the return bend tubing and the inside diameter of the return bend indicated poor quality workmanship in the forming of the return bend. The shear material trapped contaminants, and resulted in corrosion starting on the outside diameter of the return bend tubing.

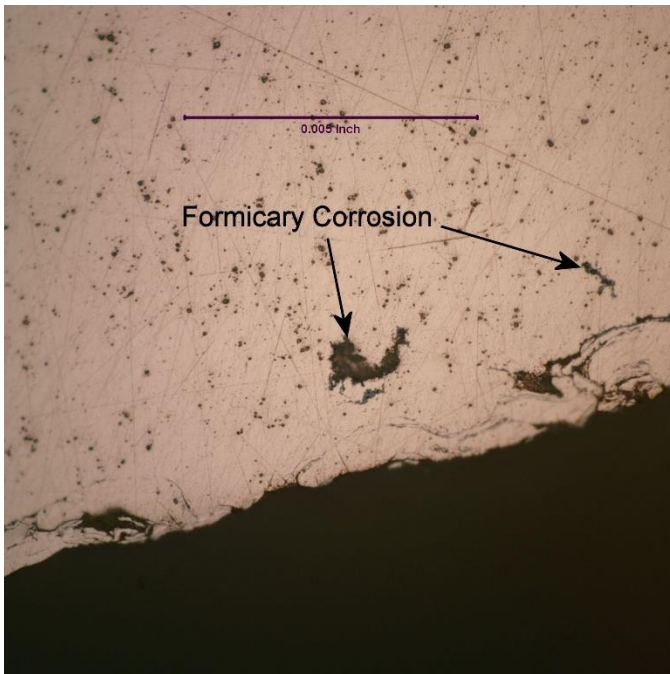
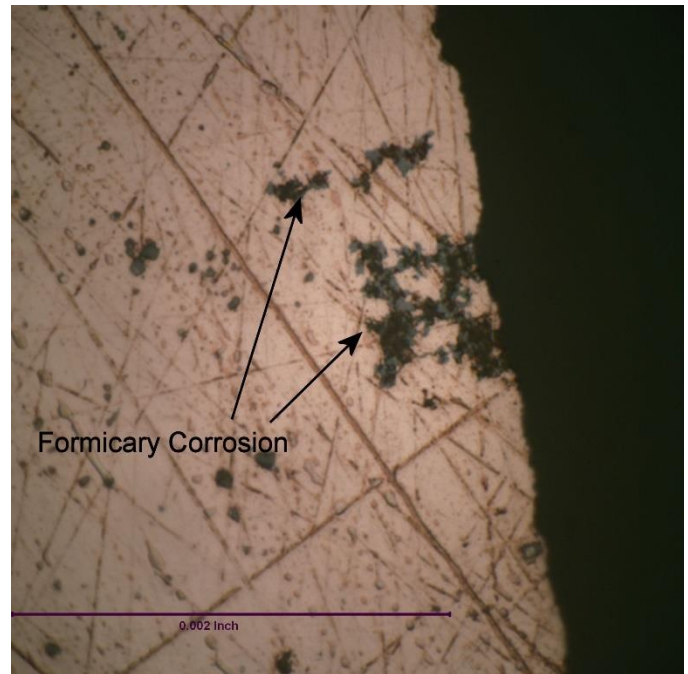
Figure 9 – 400X Formicary Corrosion Return Bend Tube O.D.

Figure 10 – 1500X Formicary Corrosion Return Bend Tube O.D.

There were clear indications of formicary corrosion on the outside diameter of the return bend tubing. Figures 9 and 10 show the beginning of formicary corrosion on the outside diameter of the return bend. There was a significant number of locations where formicary corrosion was observed, indicating some of the leaks in the heat exchanger were the result of formicary corrosion. The most likely cause of the formicary corrosion was the decomposition products of a POE oil used in the forming process of the return bends. This heat exchanger was defective at the time of manufacture.
