M. E. Williams and Associates, Inc.

Formicary Corrosion in Copper Hairpin

Merlin E. Williams, P.E.

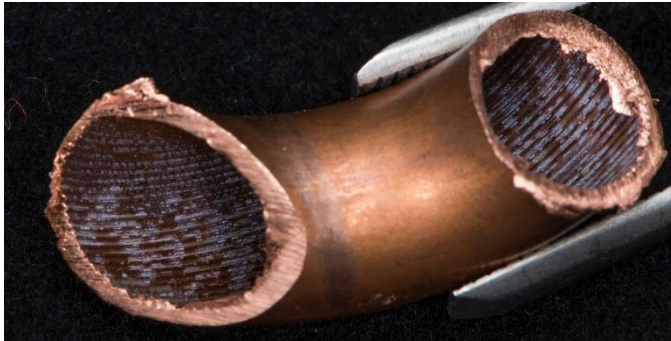
Figure 1 – Hairpin Sample

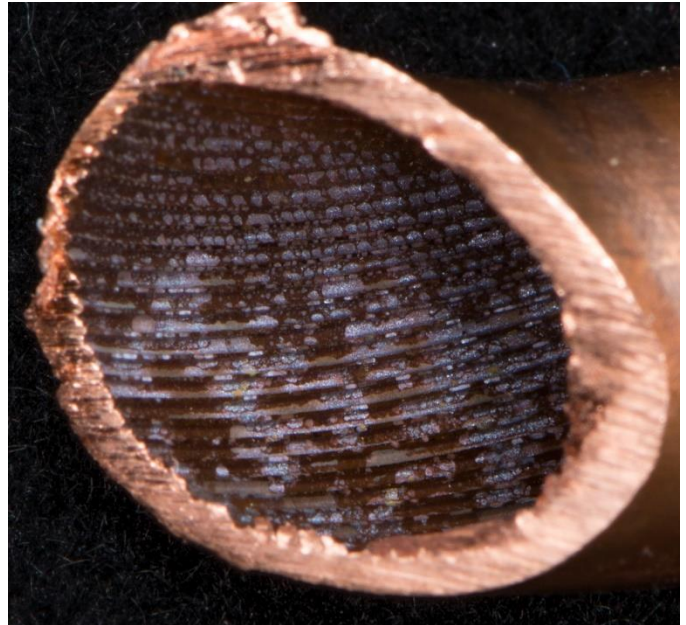
Figure 2 – Corrosion on I.D. of Hairpin

Figure 1 shows the hairpin as received. Figure 2 shows corrosion on the inside diameter of the hairpin. Figure 3 shows the only location found on the outside diameter of the hairpin that appeared to be a leak.

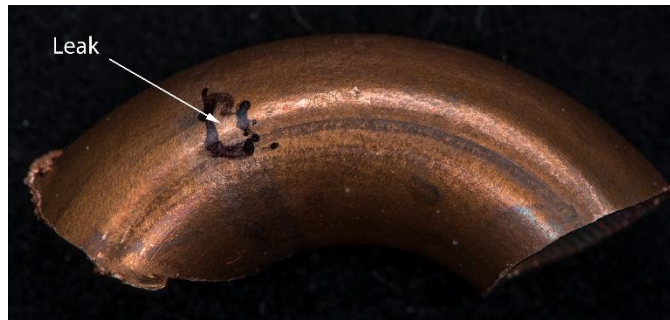
Figure 3 – Leak Location O.D. of Hairpin

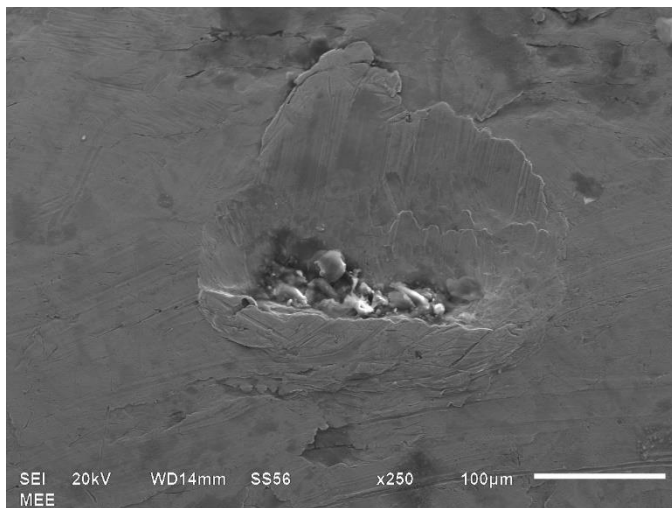
Figure 4 – 250X Leak Location O.D.

Figure 4 shows the only leak location on the outside diameter of the hairpin.

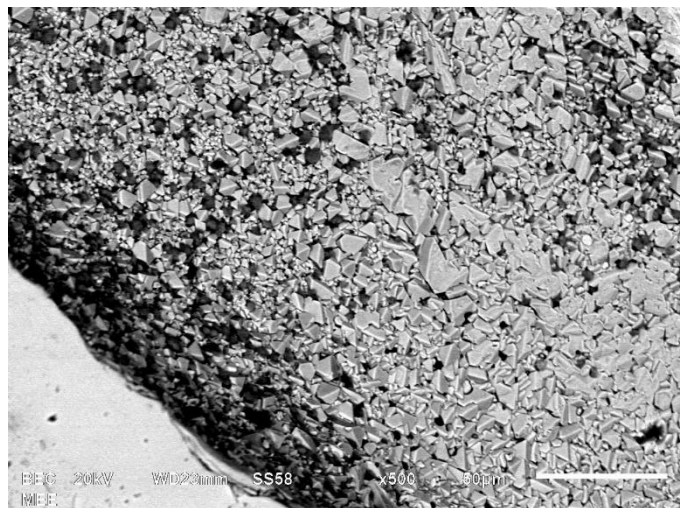
Figure 5 – 500X Corrosion Products on Hairpin I.D.

Figure 5 shows corrosion products on the inside diameter of the hairpin. The angular deposits are of copper oxide. The dark deposits are organic material.

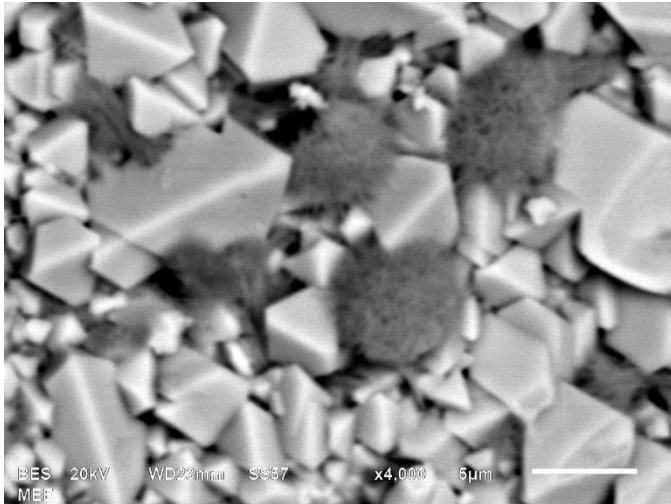
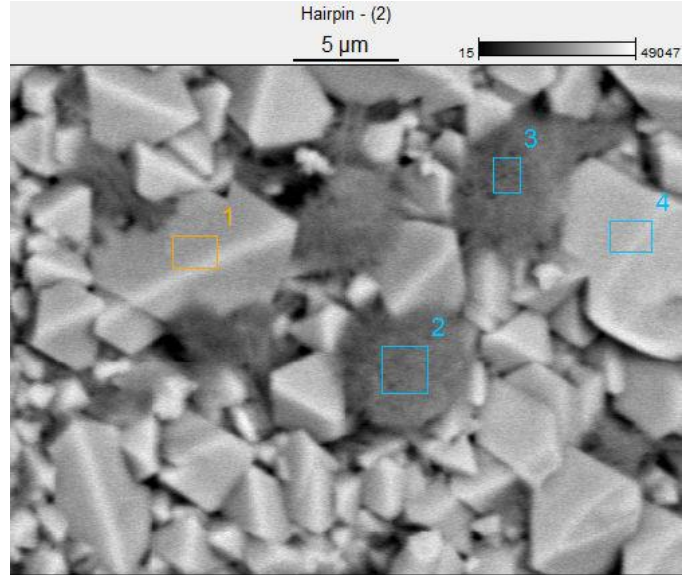
Figure 6 – 4000X Corrosion and Organic Material

Figure 7 – 4000X Spectra Locations for Materials

Figures 6 and 7 are identical. They show the corrosion at a much higher magnification than Figure 5. The darker organic material has the characteristics of mold spores. Three conditions are needed for mold to grow: water, or humidity equal to 70%, organic material for food, and a temperature greater than 32 degrees F. The likely source of water was pressure testing of the heat exchanger. The water may have been introduced at some other time. The source of the organic material is unknown, but likely sources are lubricants use to draw the inner groove tubing or to form the hairpins. Molds can produce organic acids which cause formicary corrosion in copper tubing. The semi-quantitative analysis for the three locations shown in Figure 8 is given in Table 1 that follows, and the spectra are shown in Figures 8, 9, and 10.

The carbon and oxygen levels for Locations 2 and 3 are somewhat high, indicating the material is organic. Because of the nature of the x-ray analysis, the levels of copper indicated are the result of the underlying copper oxide. The crystal at Location 1 is copper oxide.

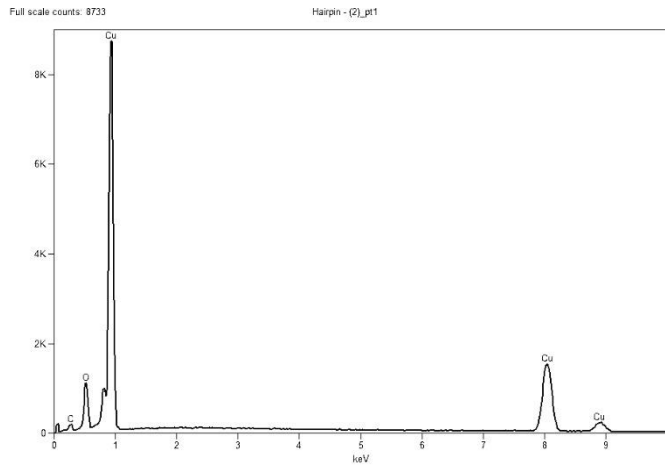
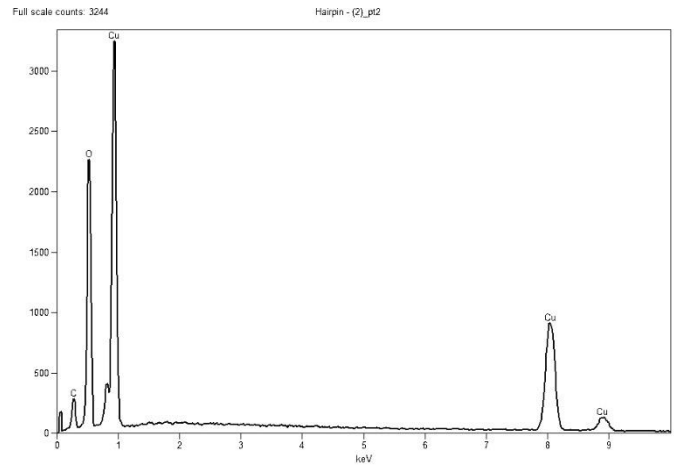
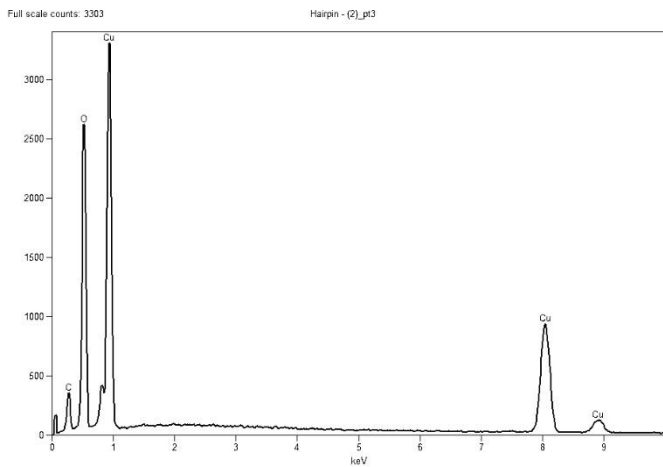
Table 1 Corrosion Hairpin I.D. (Percent by Weight)			
Element/Location	Location 1	Location 2	Location 3
Carbon	1.15	3.67	4.59
Oxygen	12.42	31.14	33.40
Copper	86.43	65.19	62.00
Total	100.00	100.00	100.00

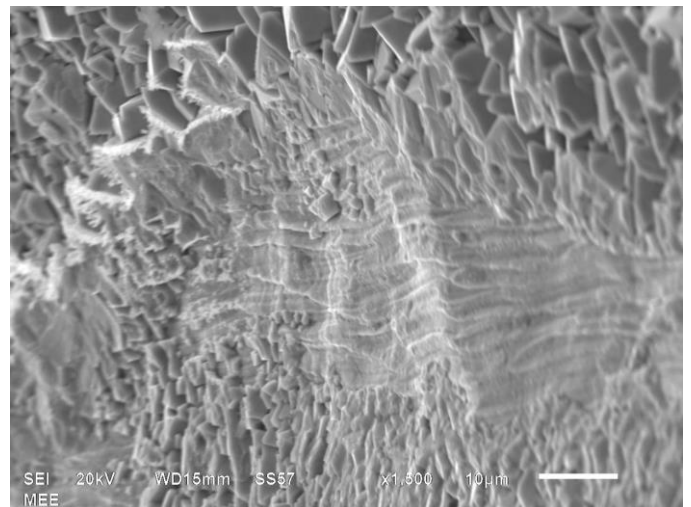
Figure 11 – 1500X Etched Copper in Tube I.D.

The inside diameter of the hairpin showed clear evidence of having been etched, Figure 11. The etching is a definite indication of the presence of acid and water.

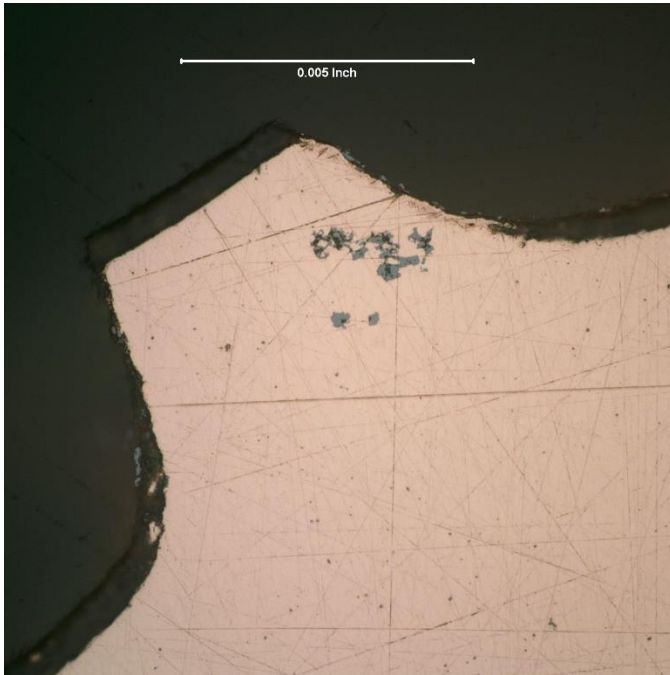
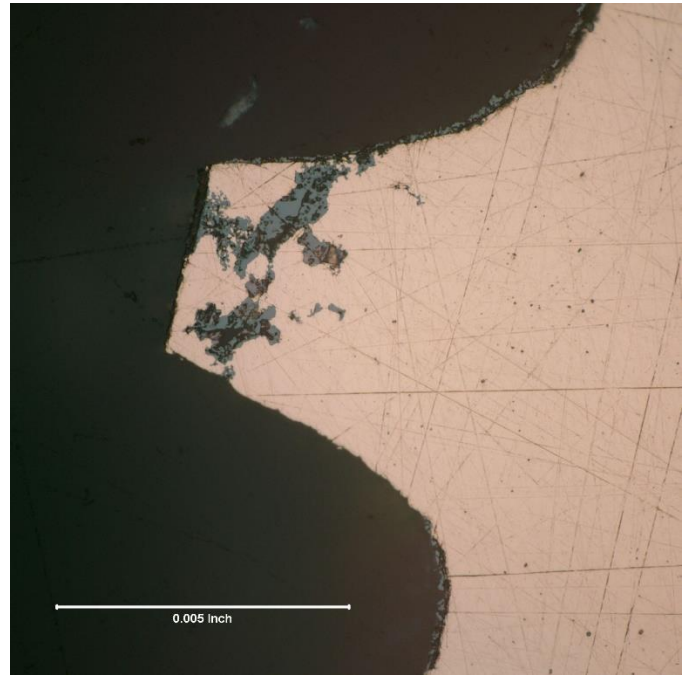
Figure 12 – 400X Indication of Formicary Corrosion in Tube I.D.

Figure 13 – 400X Indication of Formicary Corrosion in Tube I.D.

Figures 12 and 13 show a characteristic formicary corrosion pattern in two different fins on the inside diameter of the inner groove tubing. Formicary corrosion is caused by organic acids. Another characteristic of formicary corrosion is apparently disconnected corrosion deposits in the tube wall.
