# ***M. E. Williams and Associates, Inc.***

## Case Study: Locking Clamp Failure

Examination of three Locking Clamps to determine the cause of failure. The clamps were machined from 12L14 steel. The failed clamps were examined by visual examination, hardness testing, metallographic examination, and fracture mechanics.

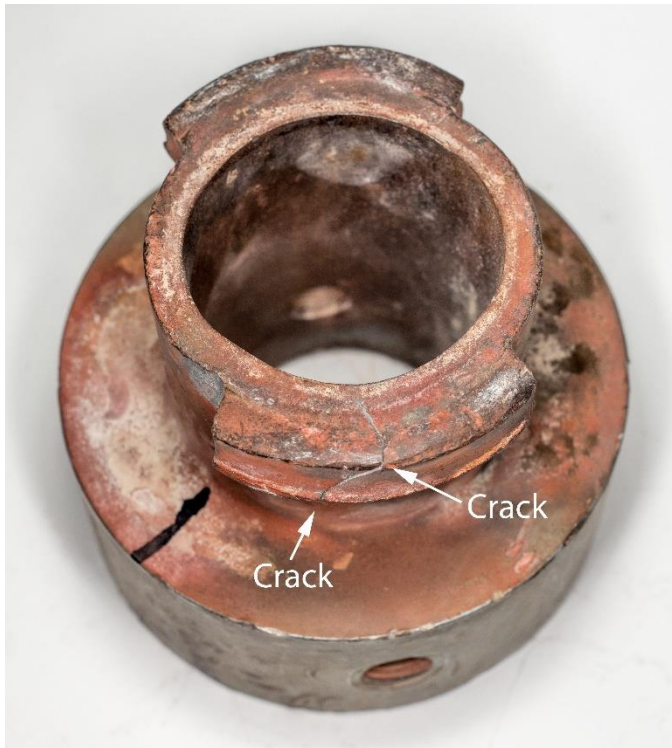
Figure 1 – Crack in Lug, Locking Clamp 1

Figures 1 and 2, show Locking Clamp 1 and the fracture of one of the lugs, which was clearly brittle fracture, as can be seen in Figure 2.

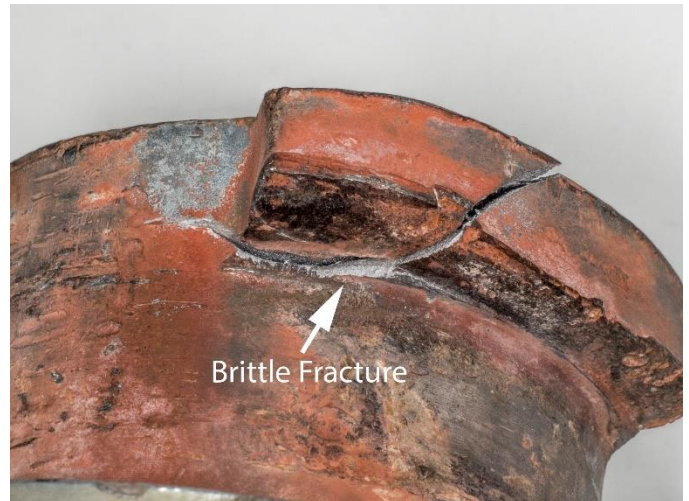
Figure 2 – Visual Indication of Brittle Fracture in Locking Clamp 1

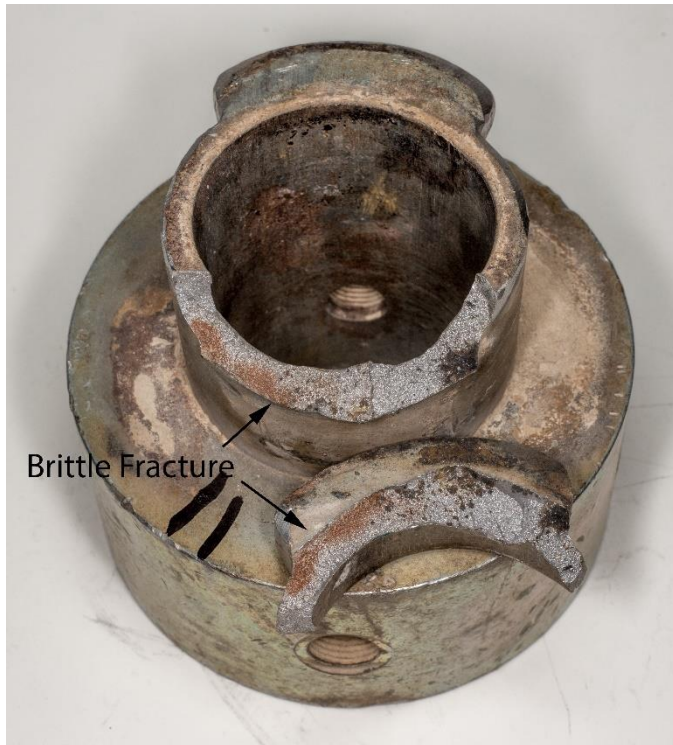
Figure 3 –Locking Clamp 2

Figure 3 shows Locking Clamp 2. The fracture mode of this clamp was also brittle fracture. The metallographic cross section of this clamp was made through the intact lug.

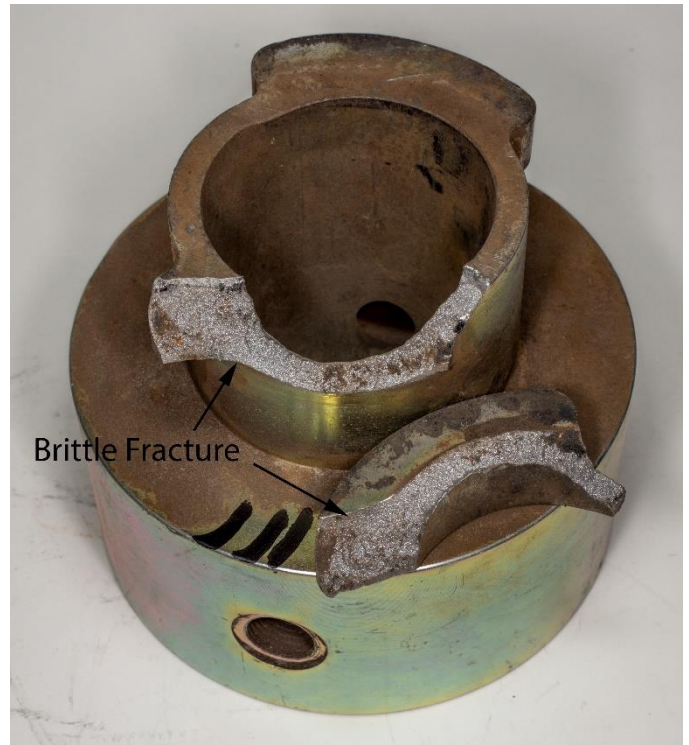
Figure 4 –Locking Clamp 3

Locking Clamp 3 is shown in Figure 4. The fracture mode of this clamp was also clearly brittle fracture. The metallographic cross section of the clamp was made through the intact lug. The condition of the plating on the surface indicates that the Locking Clamps had not been used more than a few times.

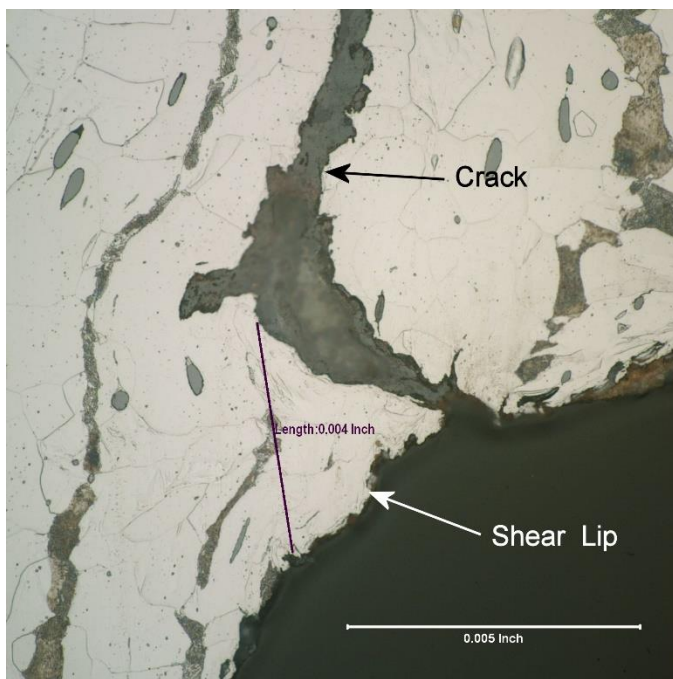
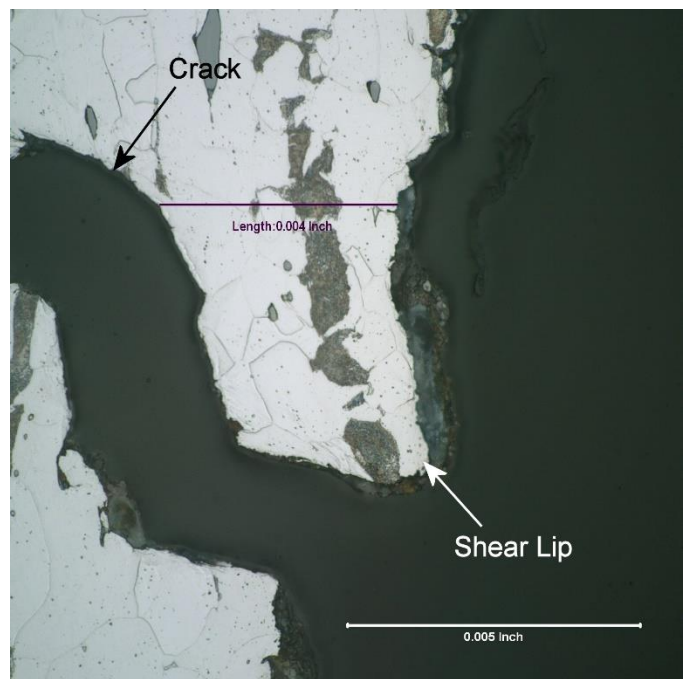
Figure 5 – 400X Fracture Origin 1 for Locking Clamp 1

Figure 6 – 400X Fracture Origin 2 for Locking Clamp 1

Figures 5 and 6 show shear lips associated with two of the cracks found in the cross section of Locking Clamp 1. The presence of small shear lips, 0.004 inch in size, was one of the indicators that the material was very brittle. This is a characteristic of 12L14, which is a resulfurized, rephosphorized, and leaded grade of steel. The sulfur, phosphorous, and lead are added to the steel to promote chip breakage which facilitates machining. This reduces the fracture toughness of the steel parallel to the rolling direction to almost zero.

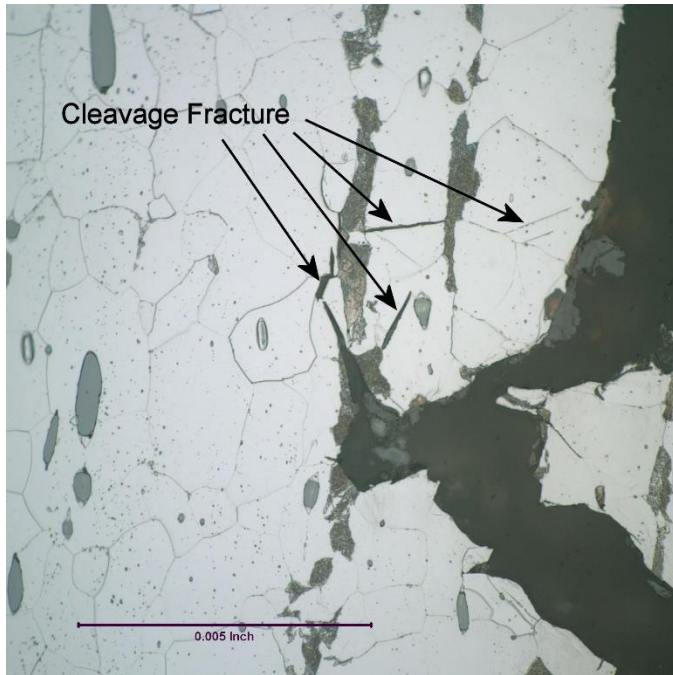
Figure 7 shows the presence of cleavage fracture associated with a surface crack in Locking Clamp 1. Cleavage fracture occurs below the ductile brittle transition temperature of a steel at stress levels below 50% of the steel yield strength. It usually occurs during impact loading. The ductile brittle transition

temperature for a resulfurized, rephosphorized, leaded steel can be well above room temperature. The magnitude of the impact load can be very low.

Figure 7 – 400X Cleavage Fracture, Locking Clamp 1

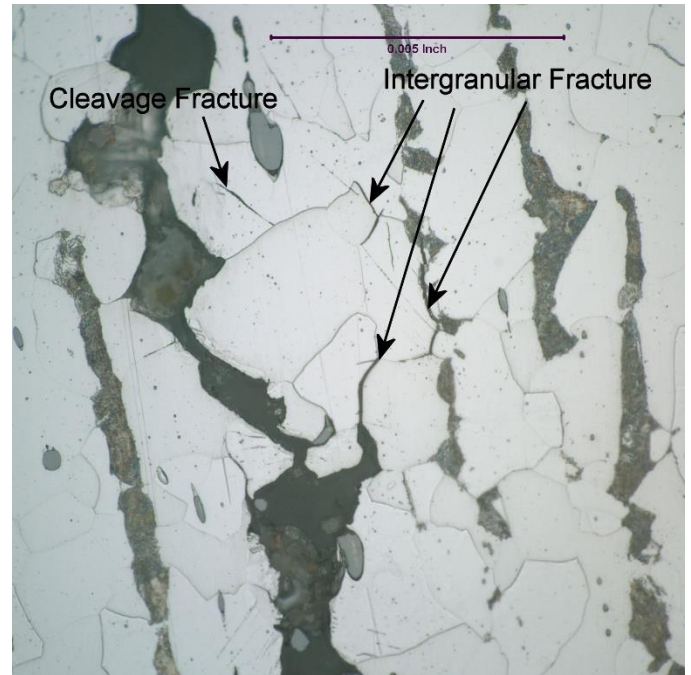
Figure 8 shows both cleavage and intergranular fracture. The intergranular fracture was likely the result of elevated phosphorous in the grain boundaries. Intergranular fracture can occur at very low stress levels, even at static loads, that are well below the materials yield strength.

Figure 8 – 400X Cleavage and Intergranular Fracture, Locking Clamp 1

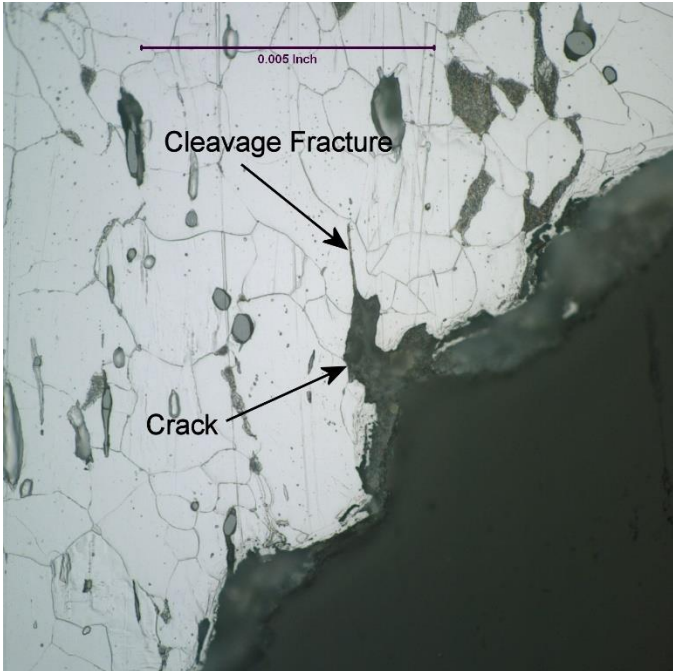
Figure 9 – 400X Crack Initiation Site in Locking Clamp 2

Figure 9 shows a crack initiation site on the lug surface of Locking Clamp 2. The crack initiation was cleavage fracture.

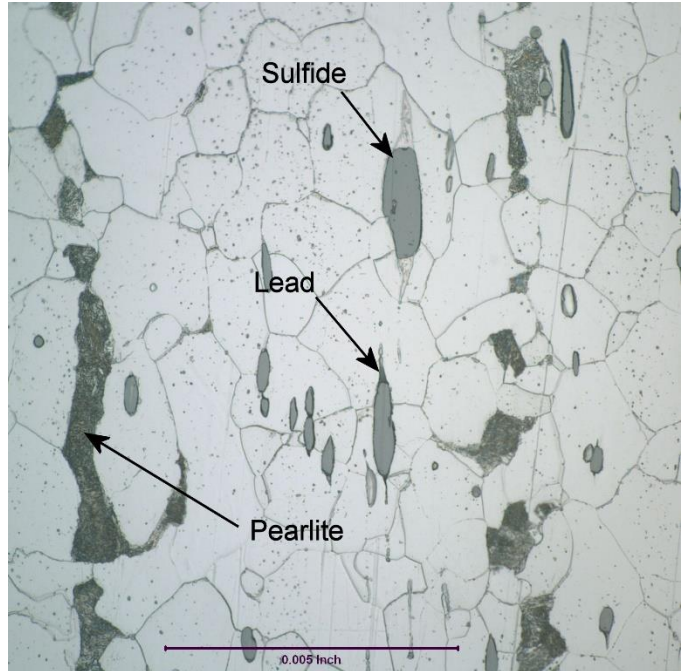
Figure 10 – 400X Alloy Phases of 12L14 in Locking Clamp 2

Figure 10 shows the four visible phases present: ferrite (the light colored, predominant phase), pearlite, gray sulfides, and the dark gray lead, which accumulates at the ends of the sulfide inclusions.

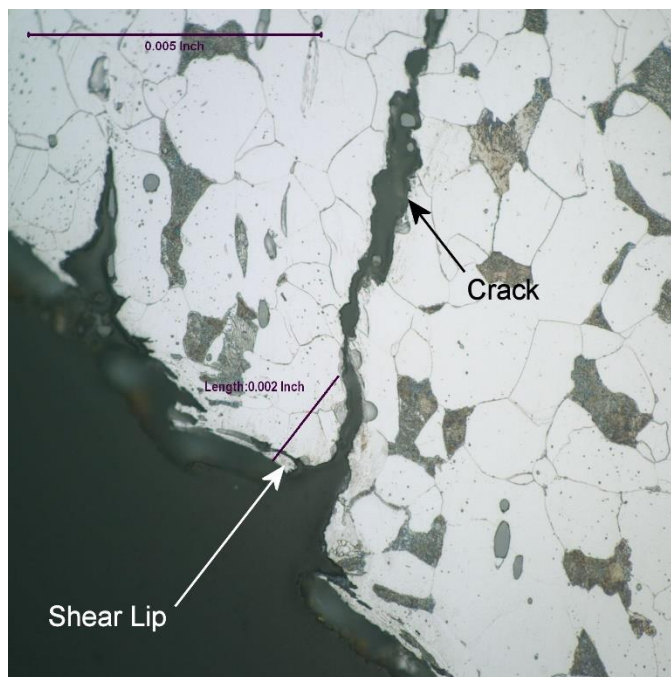
Figure 11 – 400X Shear Lip, Locking Clamp 3

Figure 11 shows the fracture on the lug surface of Locking Clamp 3. The shear lip associated with this crack was very small at 0.002 inch.
