M. E. Williams and Associates, Inc.

Case Study: Failure of a Repair Weld in Aluminum

Merlin E. Williams, P.E.

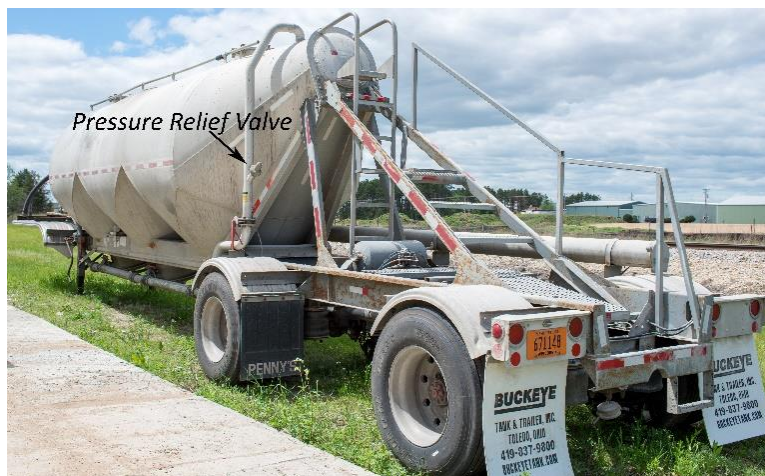
Figure 1 shows the trailer's left side. The valves for unloading the trailer are located on this side of the trailer. The pressure relief valve, that was set at 16 psi, is indicated.

Figure 1 – Trailer and Pressure Relief Valve

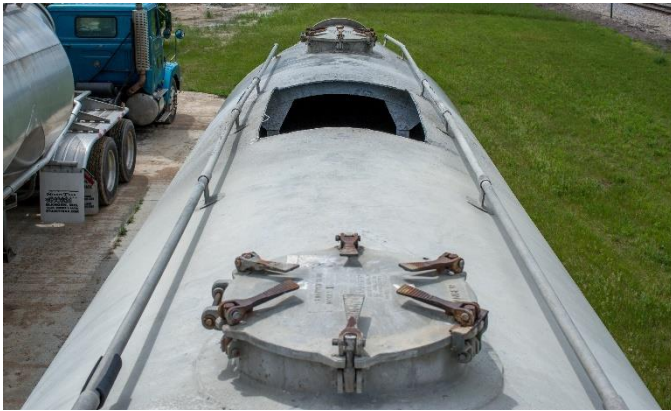
The damage on the top of the trailer is shown in Figure 2. The panel that was blown from the trailer is shown in Figure 3. This was apparently a replacement panel that was welded into the top center of the trailer. The locations of the three samples removed for further examination are indicated on the panel. The inside and outside of this panel was covered with hardened cement.

Figure 2 – Damage to Top of Trailer

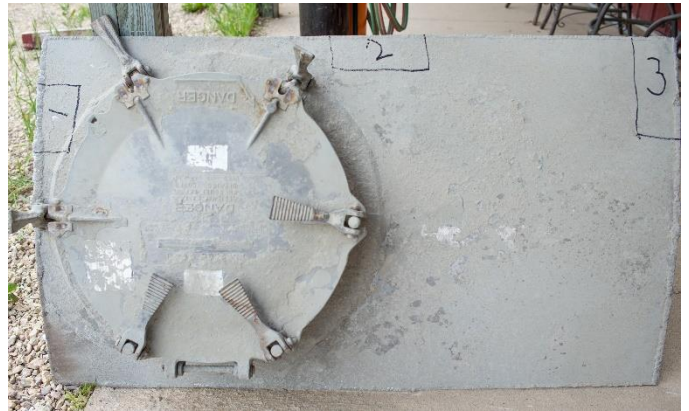
Figure 3 – Panel Blown from Top of Trailer

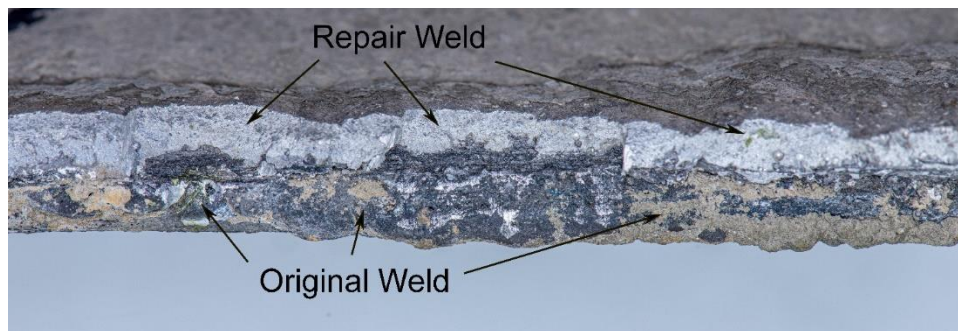
Sample 1, shown in Figure 4, had been welded twice. The original weld was a full penetration weld that appears to have broken. The tan and gray materials are cement. The metallographic cross section is shown in Figure 5. The two welds are evident, with the original weld being a full penetration butt weld. It had been repaired with a non-penetrating cover pass which was significantly weaker than the original weld.

Figure 4 – Sample 1 Welds

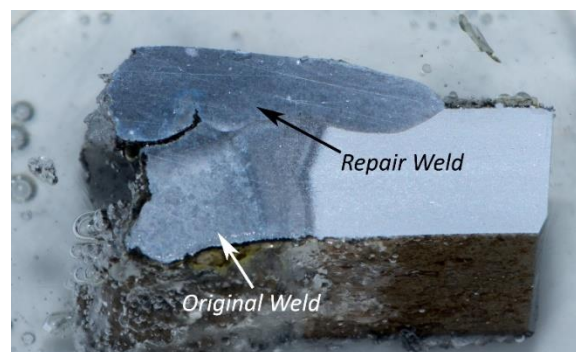
Figure 5 – Metallographic Cross Section of Sample 1

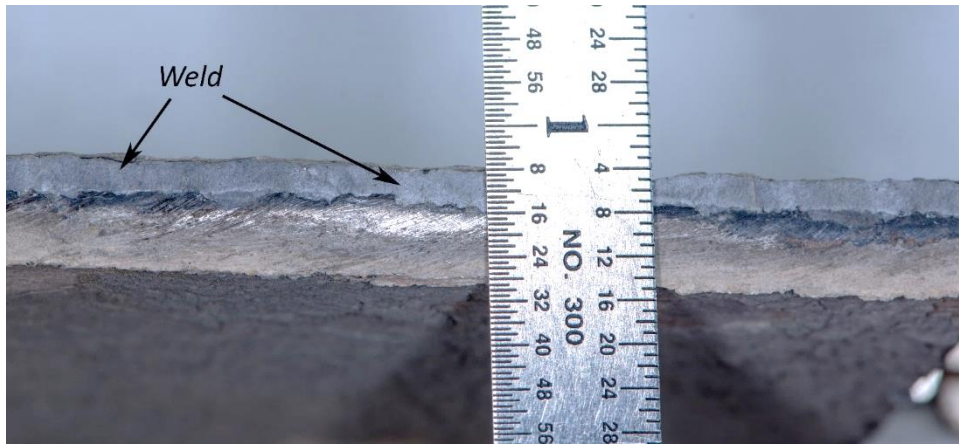
Figure 6 – Sample 2 Weld

The weld in Sample 2, Figure 6, was a partial penetration weld, with a throat depth of about 1/8 inch. This was a potential problem when the trailer tank was pressurized during unloading. The unwelded section in the plate thickness can act as a stress riser.

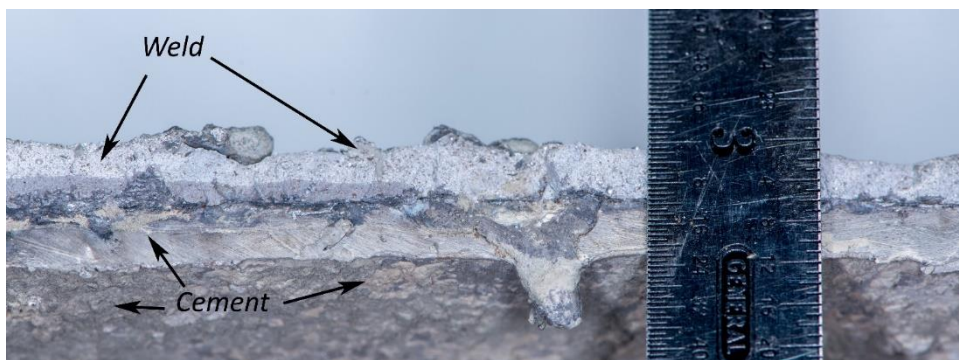
Figure 7 – Sample 3 Weld

The Sample 3 weld is shown in Figure 7. The weld thickness for this sample in the area shown was about 5/32 of an inch, somewhat better than Sample 2, but still not a full penetration weld. At the location of the two cross sections made through this sample, the welds were full penetration welds.

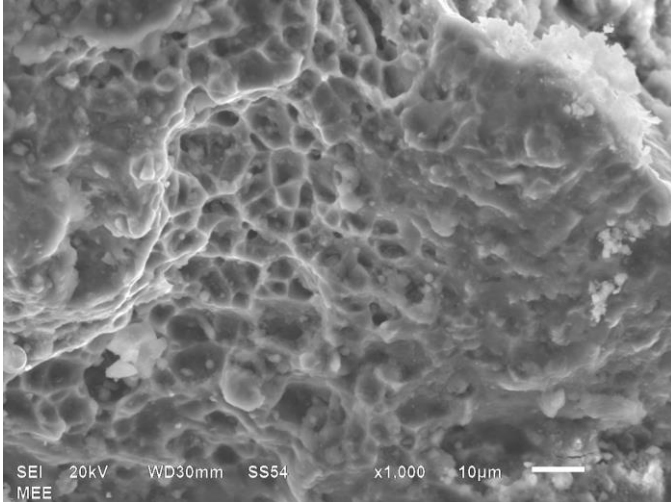
Figure 8 – 1000X Sample 1, Ductile Rupture and Corrosion near Outer Surface of Weld

Figure 8 shows the fracture surface of the weld just below its outer surface. The fracture mode was ductile rupture. The fracture was formed at the time of failure. There was also extensive corrosion present, indicating that corrosion had penetrated the thickness of the weld. The location of Figure 9 was near the root of the repair weld. This area was heavily corroded, but some evidence of ductile rupture remained. The presence of ductile rupture near the weld root, and corrosion near the surface, indicated that this weld was broken most of the way through prior to the trailer failure.

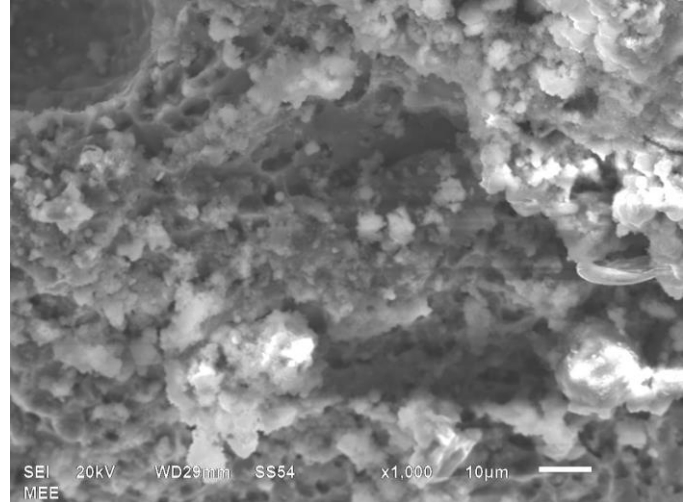
Figure 9 – 1000X Sample 1, Corrosion and Ductile Rupture near Weld Root

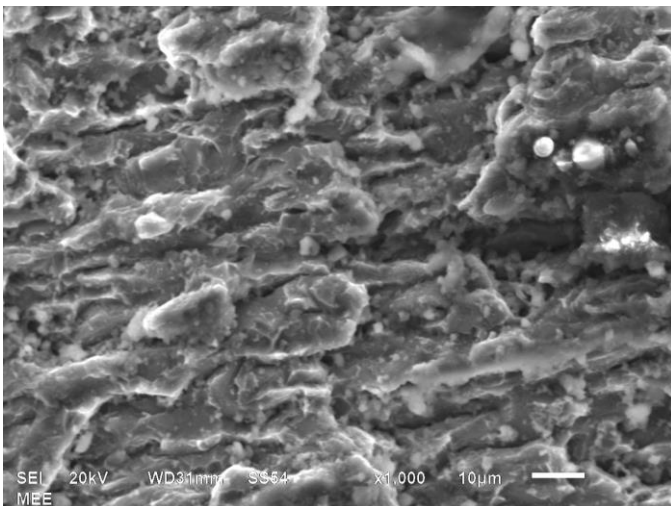
Figure 10, Sample 2, shows another location near the surface. The fracture mode at this location was very low cycle fatigue. The weld root showed evidence of intergranular corrosion, Figure 14. Intergranular corrosion is often found with fatigue in aluminum alloys when both fatigue and corrosion are present.

Figure 10 – 1000X Sample 2, Very Low Cycle Fatigue near Outer Surface

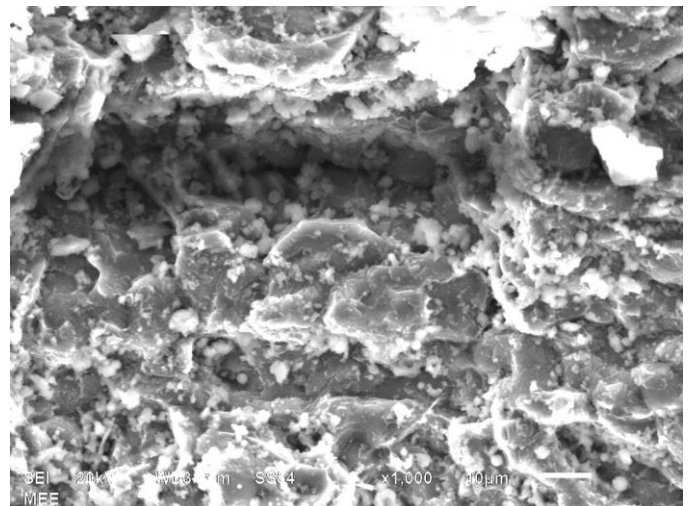
Figure 11 – 1000X Sample 2, Intergranular Corrosion in Weld

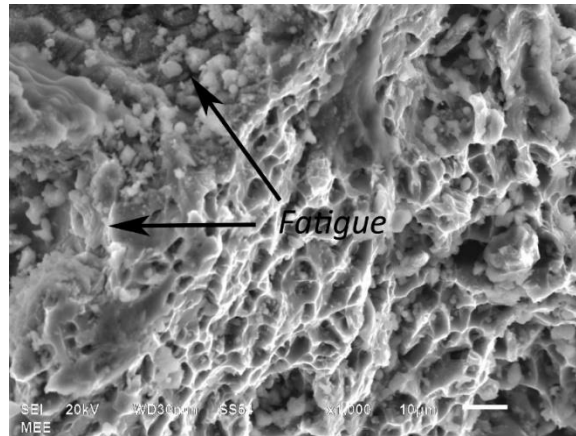
Figure 12 – 1000X Sample 3, Fatigue, Corrosion, and Ductile Rupture near Weld Root

The Sample 3 location, shown in Figure 12, shows ductile rupture fracture, high cycle fatigue. A small amount of corrosion indicated that this location had cracked prior to the accident.

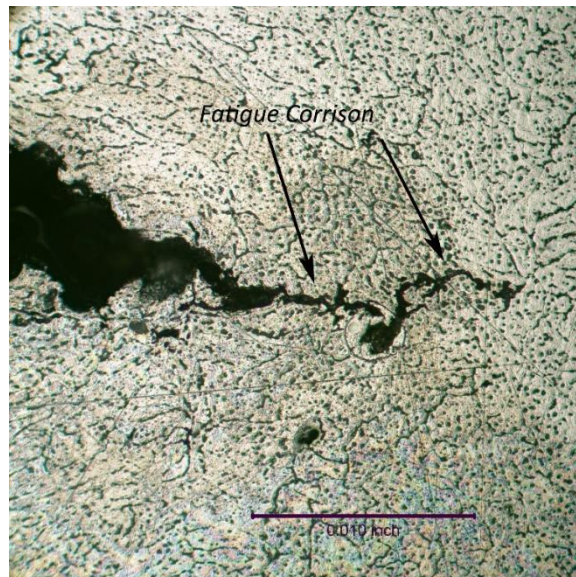
Figure 13 – 200X Sample 1, Fatigue Corrosion between Original and Repair Welds

There was a fatigue corrosion crack between the original weld and the repair weld, Figure 13, Sample 1. The proper procedure for doing a repair effectively is to grind or cut out the broken weld and then reweld.

Welding at the top of a broken weld provides a stress riser for continued crack propagation into the new weld.

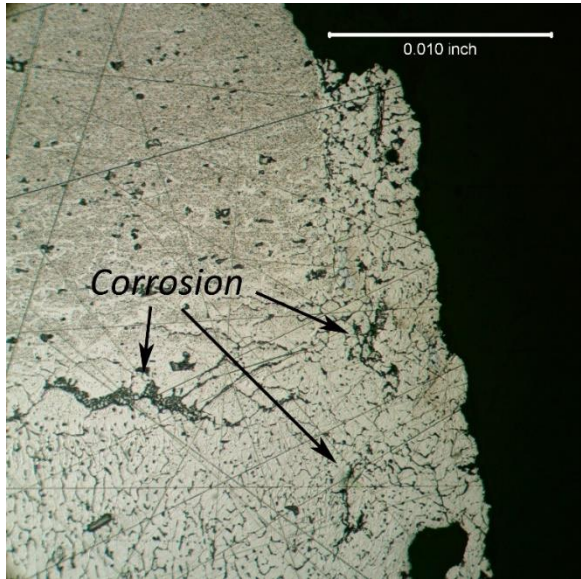
Figure 14 – 200X Sample 2, Corrosion in Weld Metal near Weld Root

Corrosion is normal for aluminum alloys in the presence of sodium and potassium hydroxides. Figure 14 shows interdendritic corrosion in the weld metal near the root of the Sample 2 weld. The surface on the right side of the photo is a profile of the fracture surface in the weld metal.

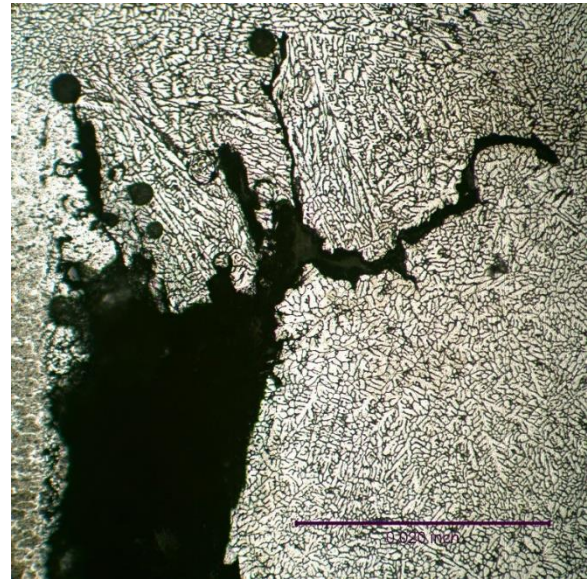
Figure 15 – 100X Sample 3, Fatigue Corrosion in Weld Root

Figure 15 shows the profile of the fracture surface near the outer surface of the weld. There was no deformation of the weld metal, indicating that the failure mode was very low cycle fatigue, shown in Figure 10.

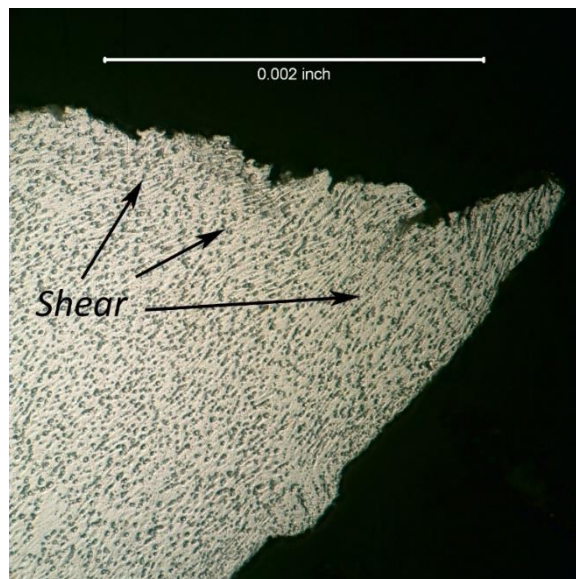
Figure 16 – 1500X Sample 3, Shear Fracture near Outer Surface of Weld

Figure 16, Sample 3, shows approximately 0.002 inch of weld material that failed by shear at the time of the trailer failure.
