Case Study: Aluminum Hoist Failure

Merlin E. Williams, P.E.

Subject

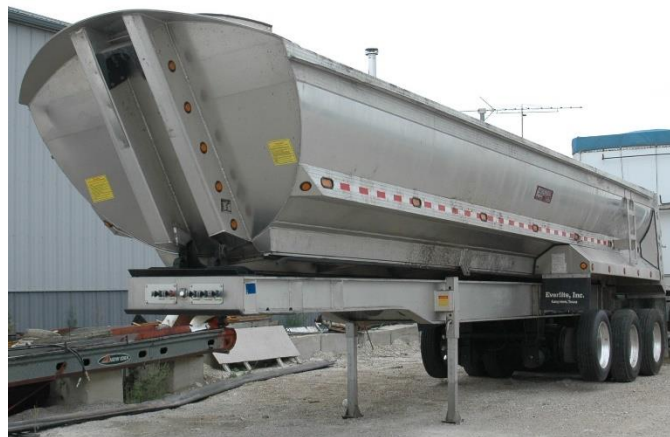
Figure 1 – Trailer, September 2, 2006

Figure 1 shows the condition of the trailer when it was examined on September 2, 2006. The failed hydraulic hoist was in the trailer bed. It had been removed after its failure.

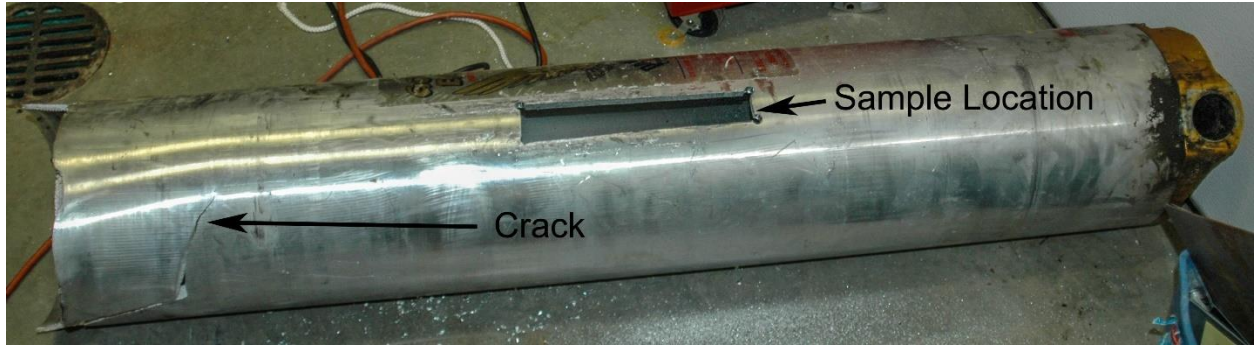
Figure 2 – Failed Aluminum Hoist Outer Cylinder after Test Sample Removal

Figure 2 shows the outer cylinder of the aluminum hoist after the removal of the test sample for chemical analysis and mechanical testing. The crack in the cylinder is also indicated.

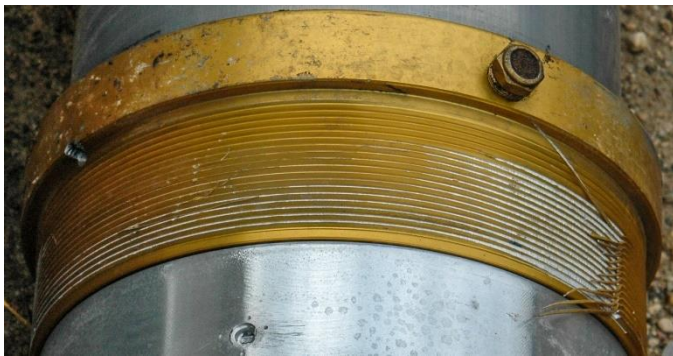
Figure 3 – Sheared Threads on Cylinder End Cap

Figure 3 shows the sheared threads on the end cap of the failed cylinder. The end cap was also the reducer for the next stage of the hoist assembly. The threads failed after the start of the failure of the cylinder.

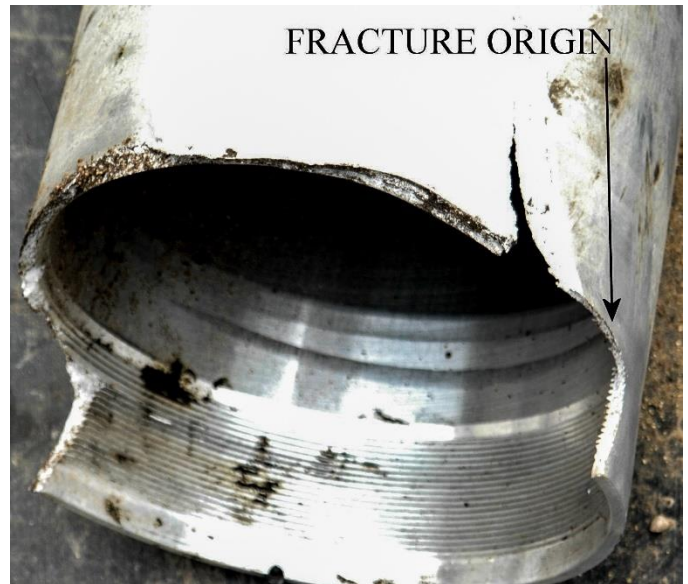
Figure 4 – Failed End of Cylinder

Figure 4 shows the failed end of the hydraulic cylinder. The approximate location of the fracture origin is indicated. The fracture origin was on the top end of the cylinder. It does not appear that side loading was a major factor in the cause of the cylinder failure.

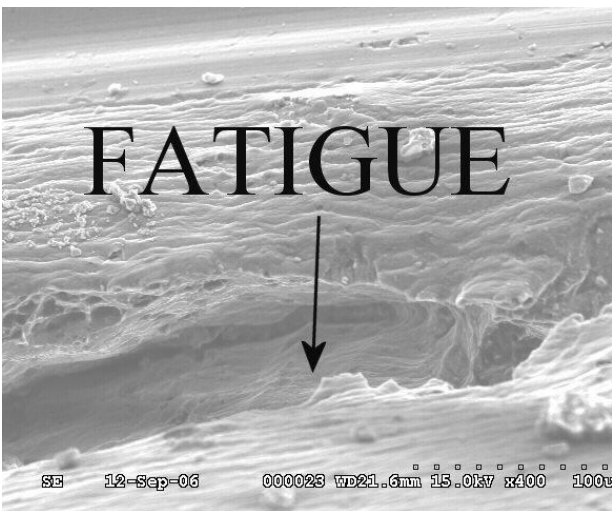
Figure 5 – 400X Fatigue Crack in Thread Root

Figure 5 shows clear evidence of a low cycle fatigue crack starting in a thread root.

The combined presence of fatigue and ductile rupture indicates that the fatigue was low cycle. The fatigue endurance limit for 6061-T6 aluminum is 14,000 psi at 500 million cycles. The fatigue life at 24,000 psi is approximately 20,000 cycles. The Dawson aluminum hydraulic hoist is rated at 35 tons, where most of the principle stresses in the area of the failure are at, or very close to 14,000 psi. This does not allow for any loading that may result from irregularities in the dumping

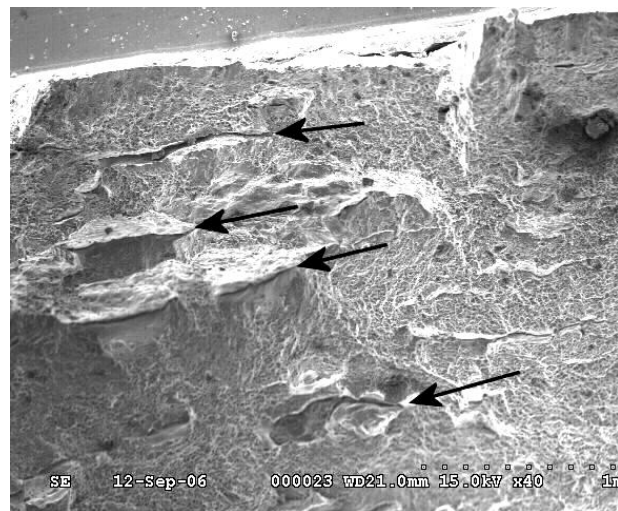
Figure 6 – 40X Fissile Fracture

The arrows in Figure 6 indicate fissile fractures perpendicular to the fracture surface. Cracks of this nature are the result of very high stress levels, that exceeded the tensile strength of the material. The primary fracture mode in the area is ductile rupture. The owner of the trailer indicated that the hoist bound-up at least once during dumping of a load. He further stated that he had contacted the manufacturer and had reported the situation.

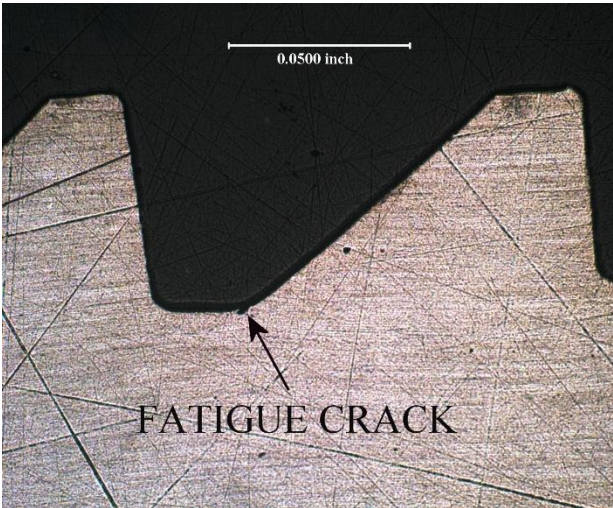
Figure 7 – 25X Fatigue Crack Thread Root

A fatigue crack was found in one of the thread roots, Figure 7. Figure 8 shows that there was a 0.0019 inch displacement in the crack opening, indicating that the material had been stressed beyond the yield point.
