## Case Study: Brittle Drive Shaft Failure

### **Subject**

Failure analysis of 3 inch Drive Shaft to determine the cause of failure, and if the shafts could be reworked to prevent additional failures. The shaft was examined by visual examination, chemical analysis, hardness testing, and metallographic examination.

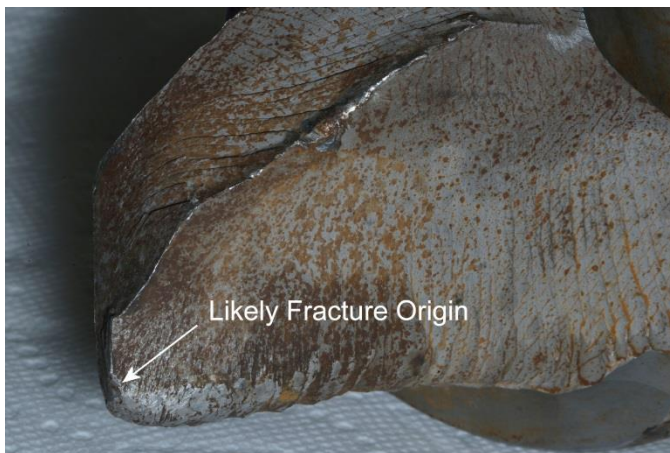
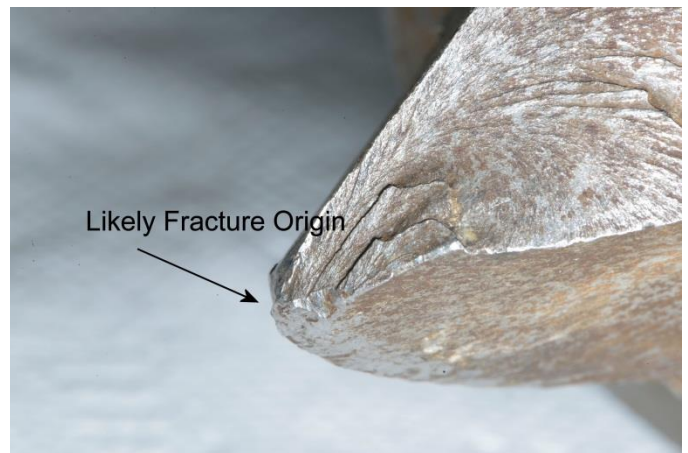
Figure 1 – Likely Fracture Origin

Figure 2 – Likely Fracture Origin

Figures 1 and 2 show the likely fracture origin. The shaft had been damaged by repeated impacts at this location, but the fracture pattern indicated that the fracture origin was likely at the tip.

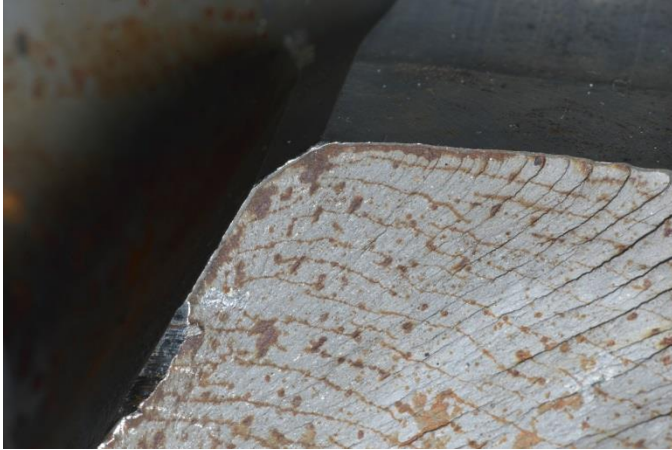
Figure 3 shows the fracture surface near the end of the fracture. There were conditions present – the flat fracture pattern, very small shear lip, and a fine crystalline texture - that indicated that the fracture was brittle.

Figure 3 – Flat Fracture and Very Small Shear Lip

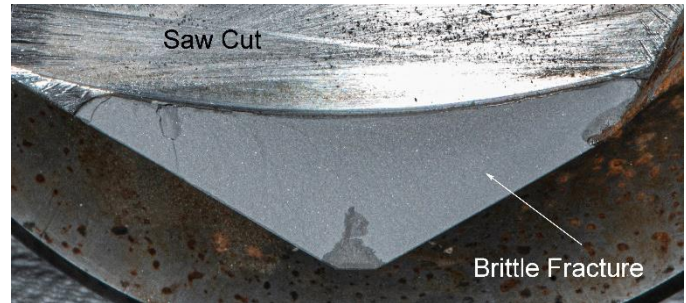
Figure 4 shows the initial saw cut through the shaft made to obtain samples for chemical analysis, hardness testing, and metallographic examination. The gray pattern at the bottom of the hex was brittle fracture. This was caused by hitting the shaft section with a small hammer as part of the examination, and indicated the very brittle condition of the shaft.

Figure 4 – Saw Cut and Brittle Fracture

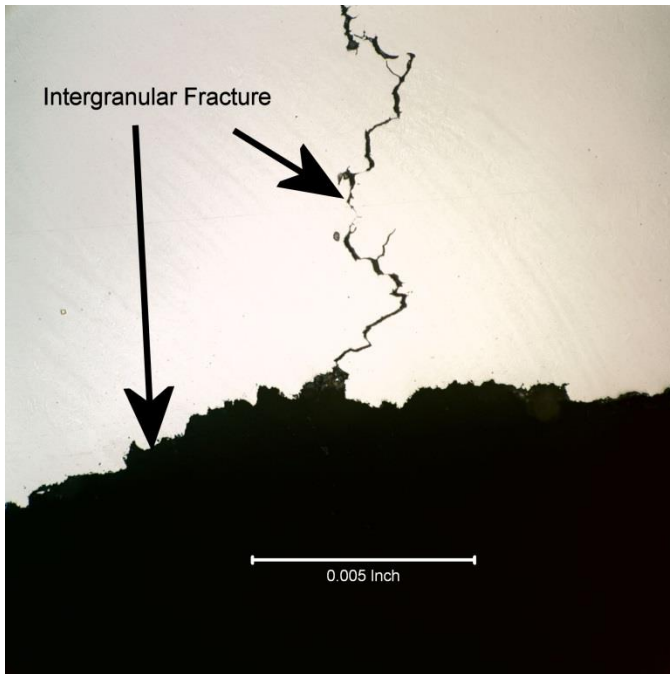
Sample 1 was taken from the fracture indicated in Figure 4. Figure 5 shows the presence of intergranular fracture on the fracture surface shown in Figure 4, and secondary intergranular fracture perpendicular to the primary fracture surface, indicating very brittle steel.

Figure 5 – 400X Intergranular Fracture Sample 1

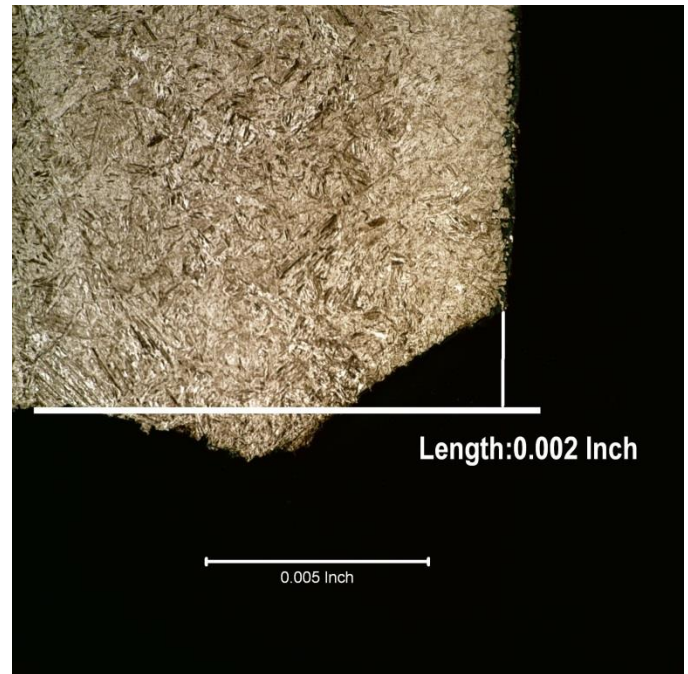
Figure 6 – 400X Shear Lip Sample 1

Figure 6 shows the tempered martensite microstructure and shear lip associated with Sample 1. The martensitic microstructure was very fine grained, indicating that the shaft was austenitized at the correct temperature. The shear lip was approximately 0.002 inch. The size of the shear lip was used to estimate the Charpy Impact Strength at this location, which was estimated to be 4 foot-pounds. Charpy Impact Strengths of steel at room temperature of less than 20 foot-pounds is considered brittle.

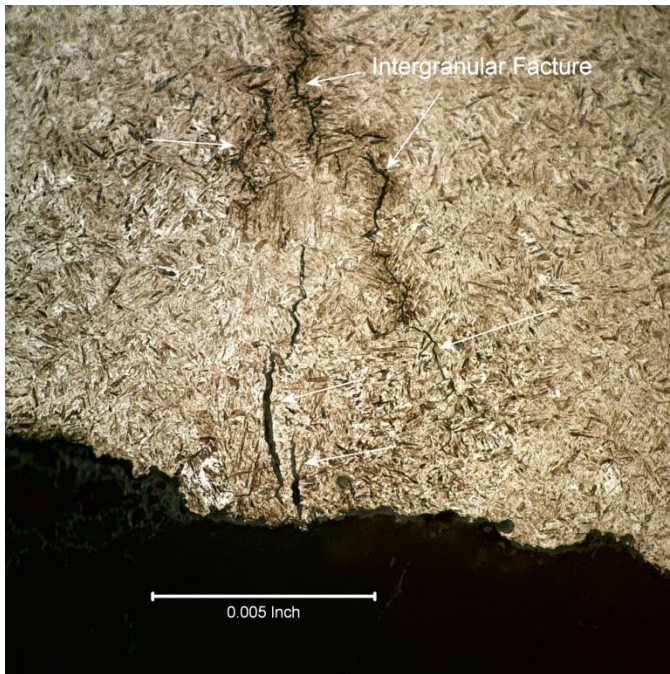
Sample 2 was cut from the flat fracture area shown in Figure 3. The presence of intergranular fracture, Figure 7, of the tempered martensite indicated very brittle steel. The presence of Bainite and pearlite, Figure 8, indicated that the quench rate was not high enough to produce a 100% martensitic microstructure, but, considering the overall size of the shaft, this was not unusual. The small area of Bainite and pearlite had little to no effect on the strength of the shaft.

Figure 7 – 400X Intergranular Fracture Sample 2

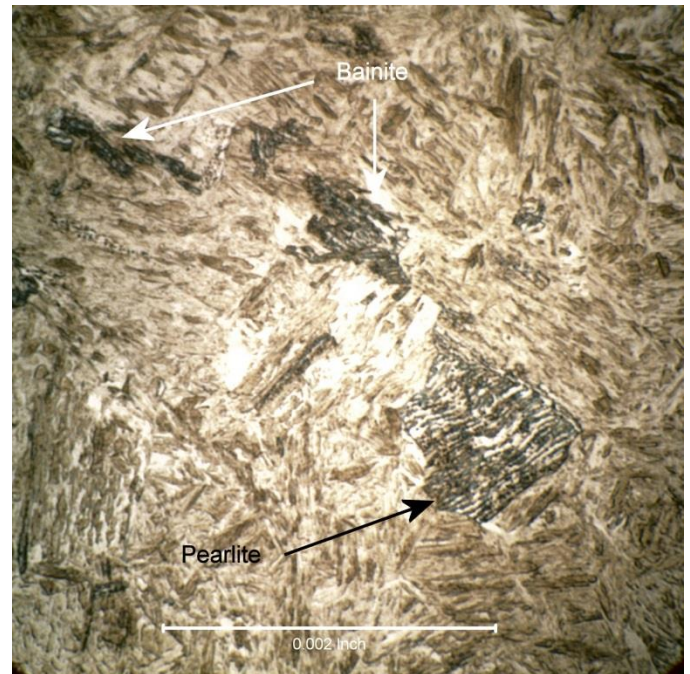
Figure 8 – 1500X Bainite and Pearlite Sample 2

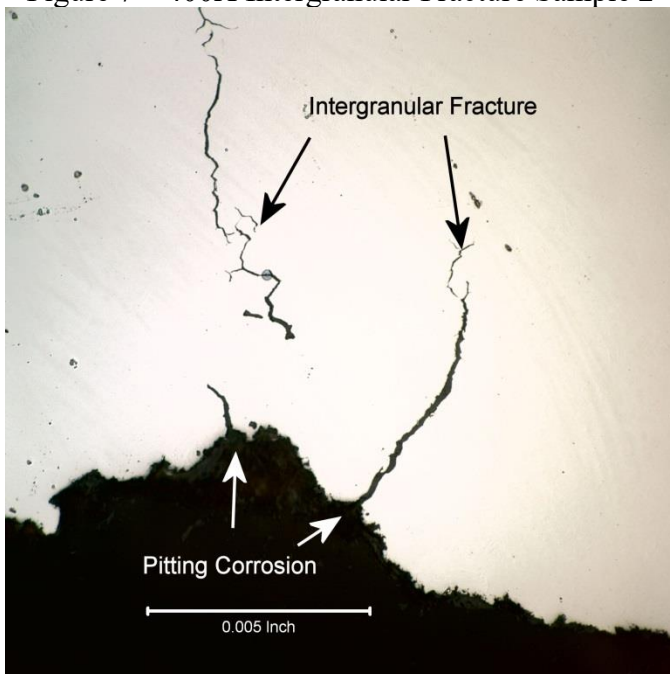
Figure 9 – 400X Pitting Corrosion and Intergranular Fracture Sample 3

Sample 3 was taken near the fracture origin shown in Figures 1 and 2. Figure 9 shows pitting corrosion and intergranular fracture. The pitting corrosion occurred after the shaft had been broken. The surface with the pitting corrosion was the original fracture surface. The intergranular fractures indicated in Figures 9 and 10 were secondary cracks.

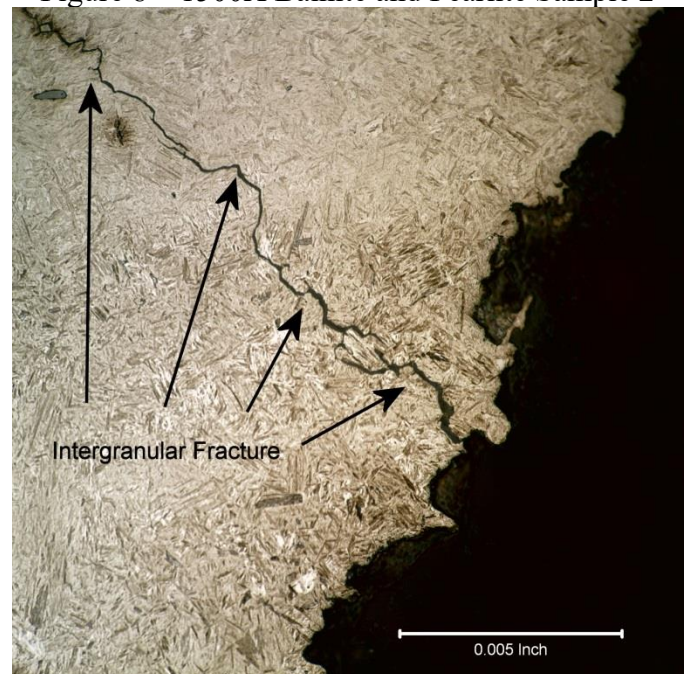
Figure 10 – 400X Intergranular Fracture Sample 3
