M. E. Williams and Associates, Inc.

Off Road Equipment Failure and Repair

Examination of Sweep 6 to determine cause of failure and repair procedure. A section of material removed from the support was examined by visual examination, chemical analysis, hardness testing, metallographic examination, and fracture mechanics to determine the cause of failure, and the best way to weld repair the tube. Replacement of the tube was not an option.

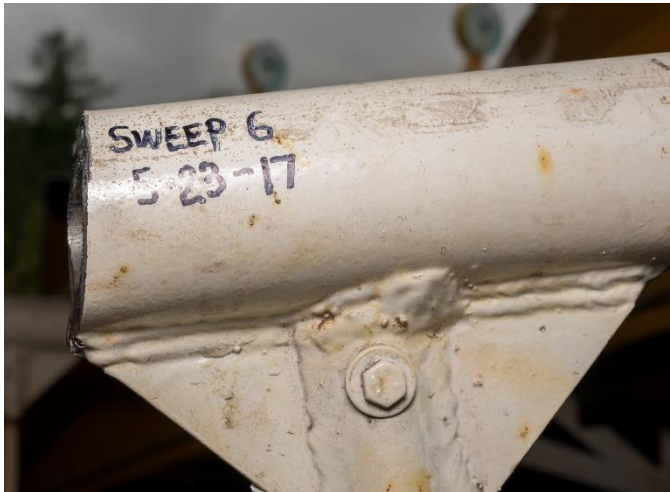
Figure 1 –Sweep 6 Failure Location

Figure 1 shows the location where Sweep 6 broke. The failure started at the gusset start/stop weld location as a fatigue crack, Figure 2. The weld on the left-hand side, indicated by an arrow, shows lack of fusion and was therefore defective. The fatigue crack had been present for some time, as indicated by the rust on the surface. The remainder of the fracture was brittle and appears to have been the result of two different

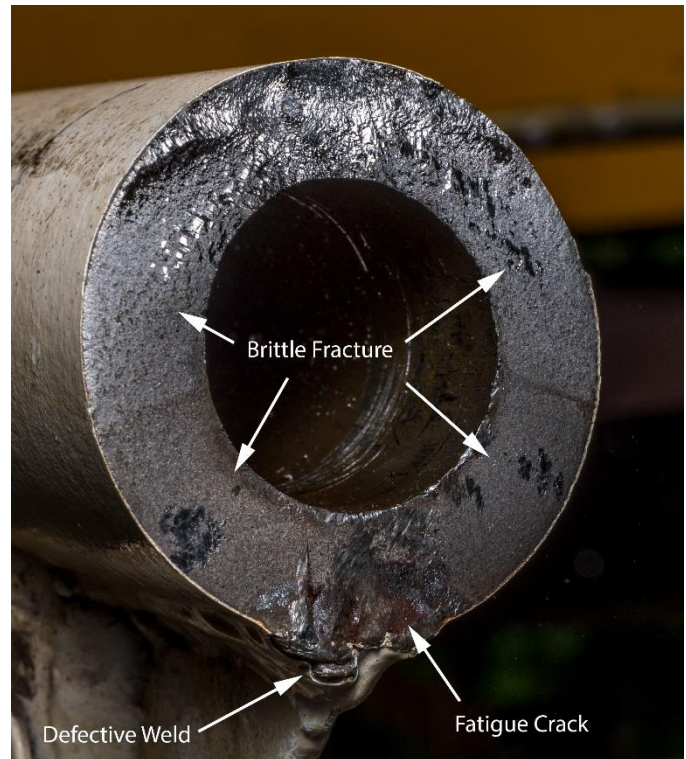
Figure 2 – Sweep 6 Fracture Surface

events, as indicated by differing coloration on the surface. The lower section in Figure 2 was one event, and the upper section was an additional event.

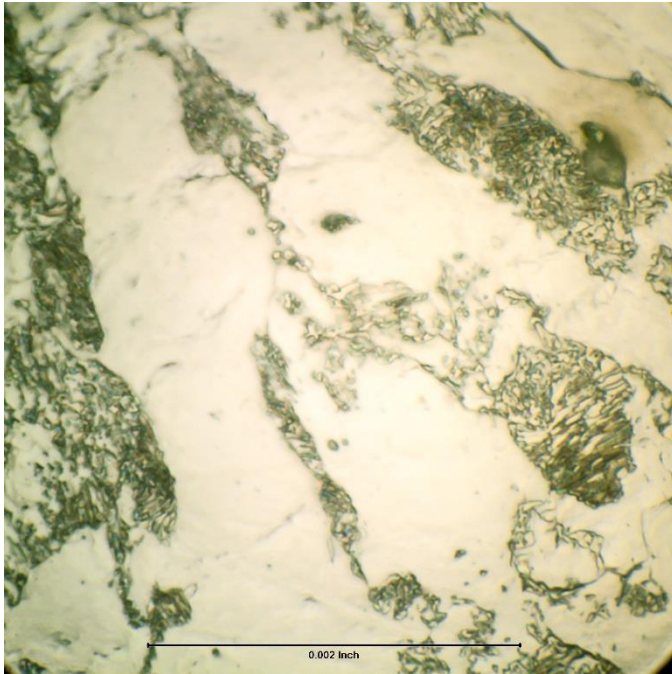
Figure 3 – 1500X Tube Steel Microstructure

Figure 3 shows the microstructure of the tube used for Sweep 6. The microstructure is fine grained and consists of coarse pearlite and carbides. The microstructure is similar to the microstructure produced by subcritical annealing. A 0.28% carbon steel having this microstructure would be expected to have a hardness in the 70 Rockwell B scale range. The hardness in the mid 90's Rockwell B scale range indicates that this tubing was highly cold worked after annealing. The condition of the steel in the sweep tube was a contributing factor in the failure of Sweep 6.

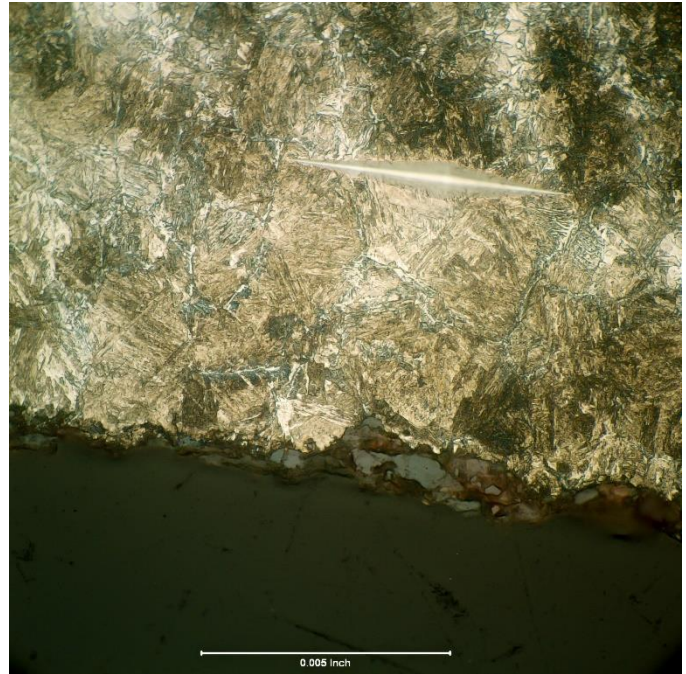
Figure 4 – 400X Weld HAZ

Figure 4 shows the martensitic heat affected zone near the origin of the fatigue crack. The Knoop indenter impression shown in the photo indicated a hardness of 40 on the Rockwell C scale. That is too hard for a heat affected zone in a carbon steel containing 0.28% carbon. There is also iron oxide scale on the surface, indicating the crack had been open for a long period of time.

- 1) Preheat to 150 degrees F. prior to welding.
- 2) Post heat to a minimum of 600 degrees F. following welding.
- 3) Preheat and post heat a minimum of 6 inches either side of the weld area.

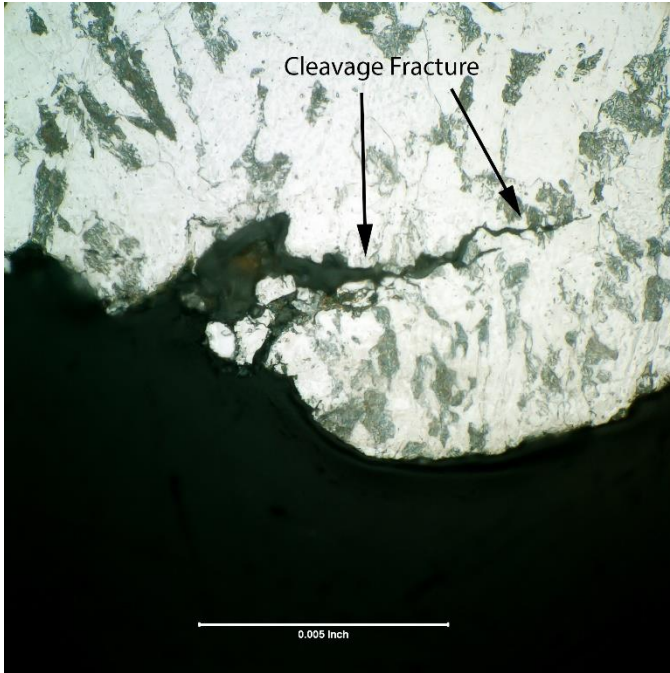
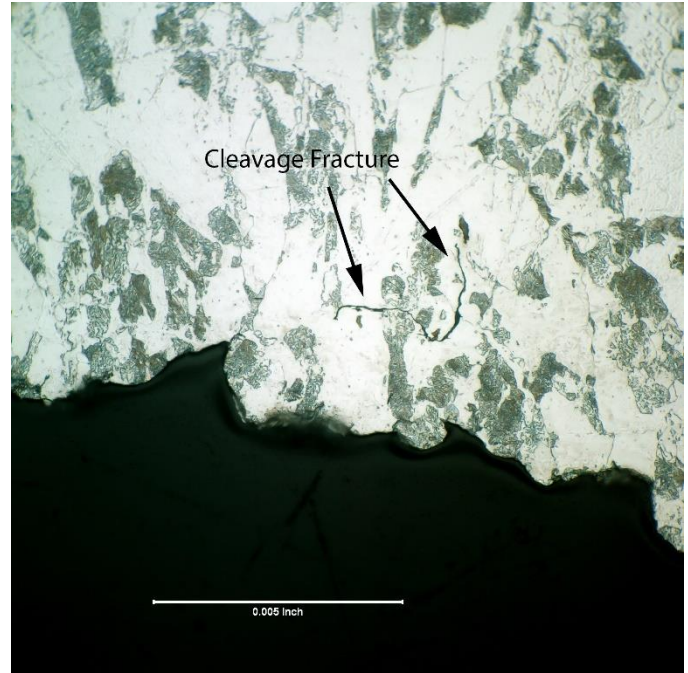
Figure 5 – 400X Cleavage Fracture

Figure 6 – 400X Cleavage Fracture

Figures 5 and 6 show examples of cleavage fracture. Cleavage fracture is a brittle fracture mode found usually in highly cold worked carbon steels. They are both temperature and strain rate (impact loading) dependent.

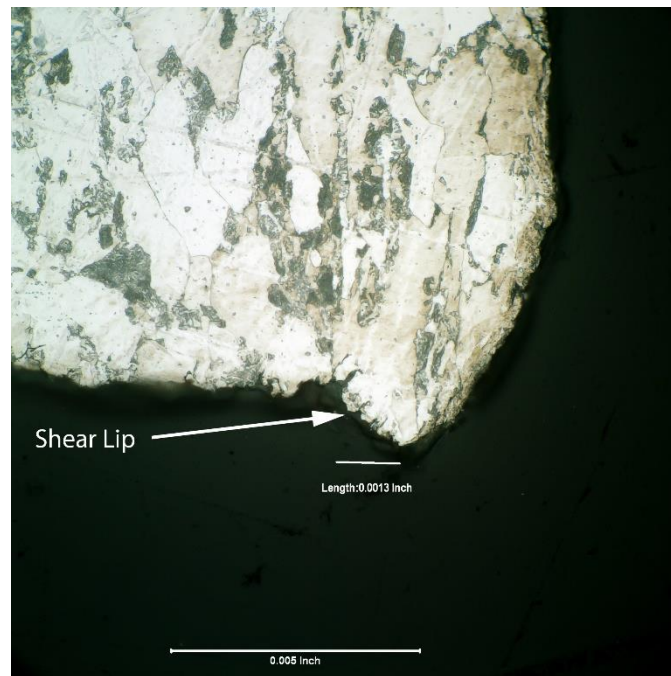
Figure 7 – 400X Shear Lip

Figure 7 shows a very small shear lip. The size of the shear lip is an indication of the load required for the failure to occur. Fracture mechanics can be used to estimate this load.

The estimated impact load that caused the failure was 4800 pounds. That is a very small load considering the length of the Sweep as a moment arm. Temperature was also a factor in the failure. The temperature was down to 44 degrees F. on the 23rd of May.
