# ***M. E. Williams and Associates, Inc.***

## Case Study: Locking Pawl and Gear Evaluation

Merlin E. Williams, P.E.

### **Subject**

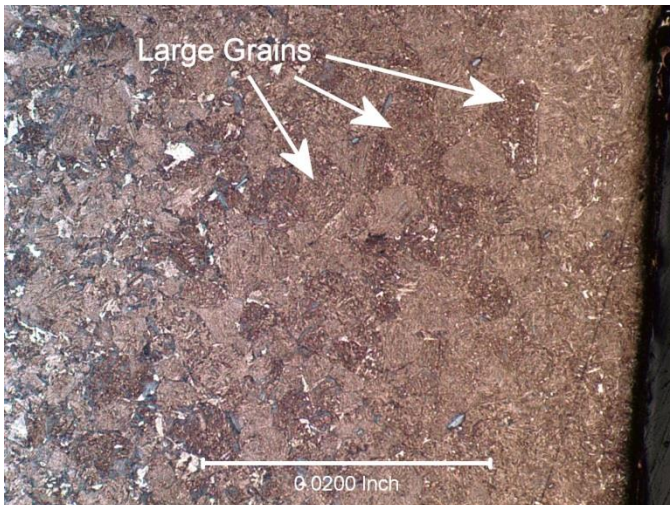
Figure 1 shows the carburized case of the pawl. The large grains in the case indicated that the carburizing process had been done at a very high temperature. Normally, the grains in a carburized case are not distinguishable at 400X, let alone 100X.

Figure 1 – 100X Carburized Case of Pawl

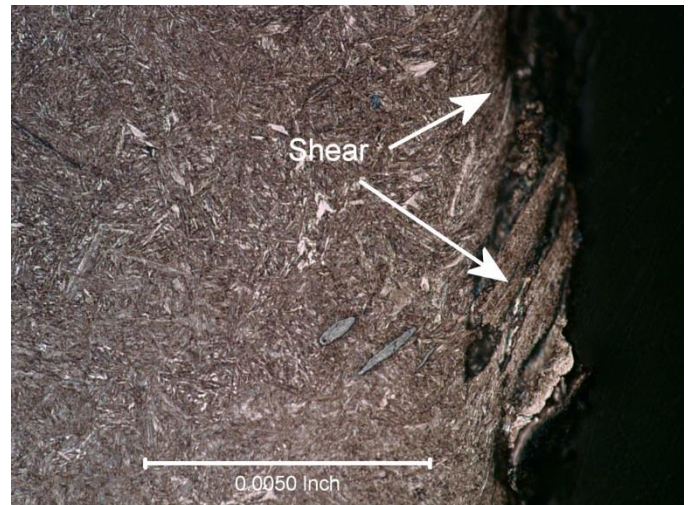
Figure 2 – 400X Shear in Pawl Wear Area

Figure 2 shows shearing of the carburized steel on the locking pawl wear face. The stress required to cause shearing of the carburized case is approximately 200,000 psi. The stress on the face of the pawl was equal to, or greater than, the yield strength of the heat treated 1018 steel of the locking pawl.

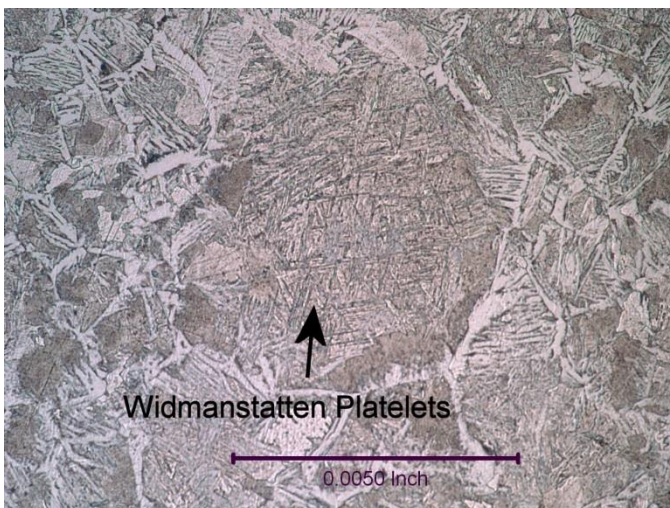
Figure 3 – 400X Widmanstatten Platelets - Core Microstructure of Pawl

Figure 3 shows a large grain in the core of the pawl which contained Widmanstatten platelets. Widmanstatten does not form in steel at temperatures lower than 2000° F., and typically forms at temperatures above 2200° F. Widmanstatten is a very brittle structure, and is not acceptable for any reason in a steel part. The maximum carburizing temperature for steels is 1900° F., and this is rarely done because excessive grain growth will weaken the carburized case. For that reason, the usual maximum carburizing temperature is 1700° F. The presence of Widmanstatten and the large grain size indicated that the pawl was carburized at a temperature in excess of 2200° F.

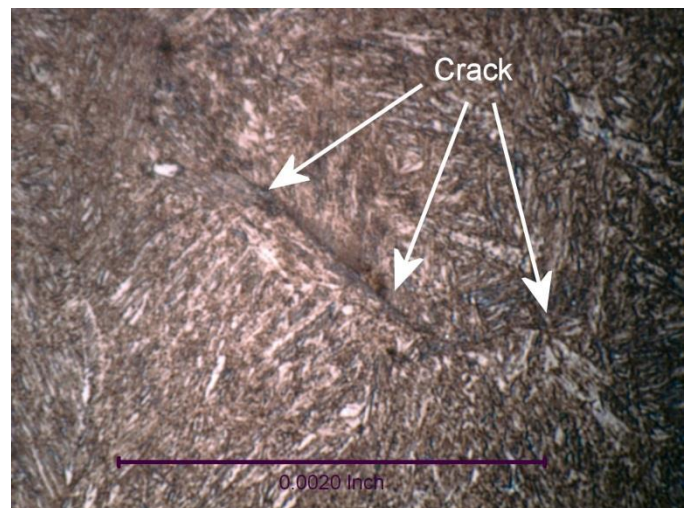
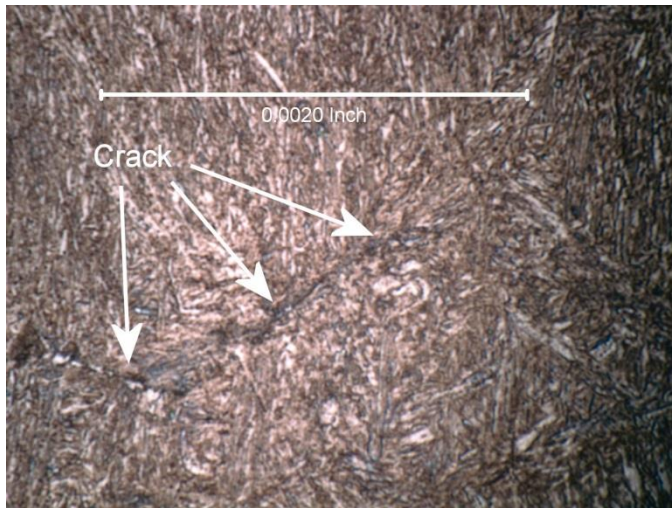
Figure 4 – 1500X Intergranular Cracking in Pawl's Carburized Case

Figures 4 and 5 show intergranular cracking in the locking pawl's carburized case. The likely cause of the cracking was the large grain size that resulted from the excessive carburizing temperatures. Small cracks,

resulting from the large grain size, will weaken the parts, and are too small to be detected by non-destructive test methods.

Figure 5 – 1500X Intergranular Cracking in Pawl's Carburized Case

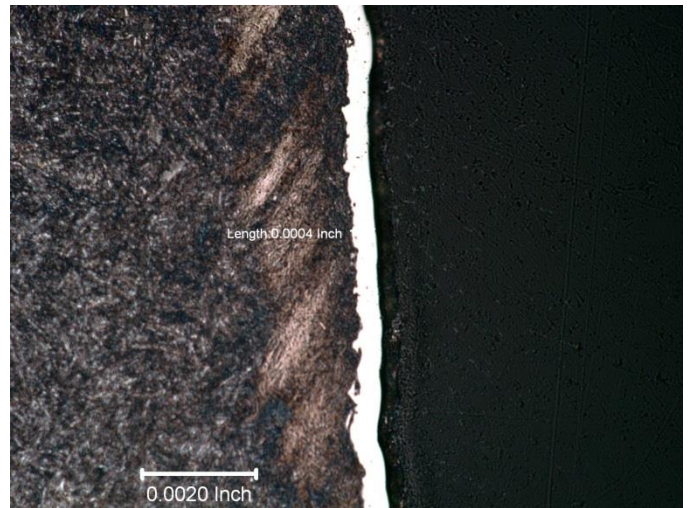
Figure 6 – 400X Nickel Plating on Pawl Surface

Figure 6 shows 0.0004 of an inch of nickel plating on the surface of the pawl. The purpose of the nickel plating was to prevent corrosion of the steel, which could result in hydrogen embrittlement, leading to intergranular fracture. If the nickel plating had been done electrolytically, the fine intergranular cracking found was likely the result of hydrogen embrittlement. Conversely, if the plating used was electroless nickel plating, then the fine intergranular cracks were the result of another factor, like delayed quench cracking.

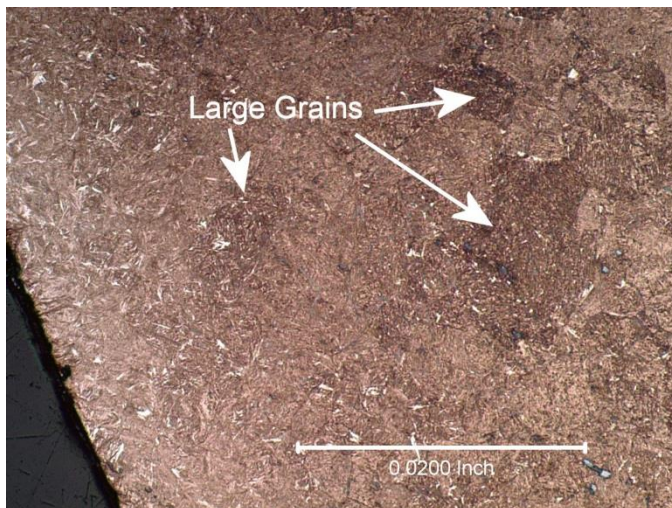
Figure 7 – 100X Carburized Case of Gear

Figure 7 shows large grains in the carburized case of the gear. The large grains were the result of excessive carburizing temperature.

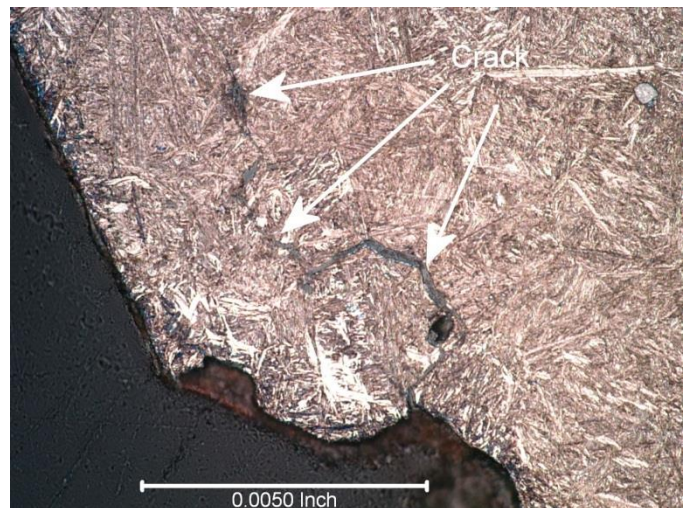
Figure 8 – 400X Intergranular Fracture of Gear

There was a chip in one of the gear teeth. The fracture mode associated with this chipping was intergranular fracture, Figure 8. A quality carburized case should not fail, but if it does, the fracture mode should be ductile rupture.

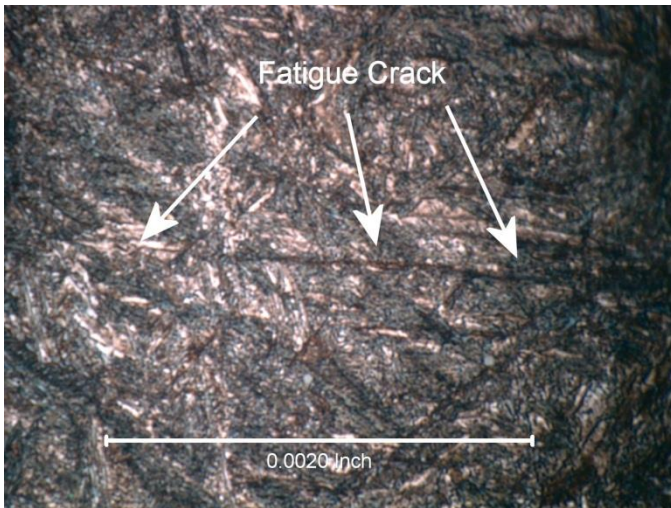
Figure 9 – 1500X Fatigue Crack in Gear

Figure 9 shows the initiation of a fatigue crack originating from the wear surface on the gear tooth face. The fatigue strength of the carburized case is about 100,000 psi. The presence of a fatigue crack indicates that the stress on the gear teeth was higher than 100,000 psi.

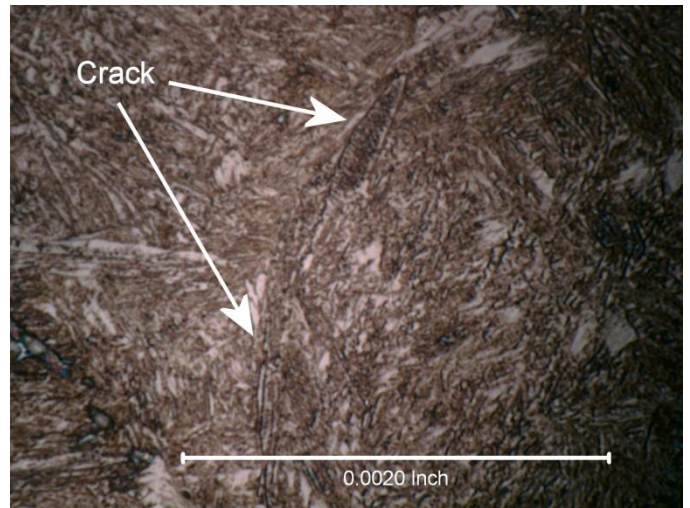
Figure 10 – 1500X Intergranular Cracking in Gear's Carburized Case

Figure 10 shows intergranular cracking in the gear's carburized case.

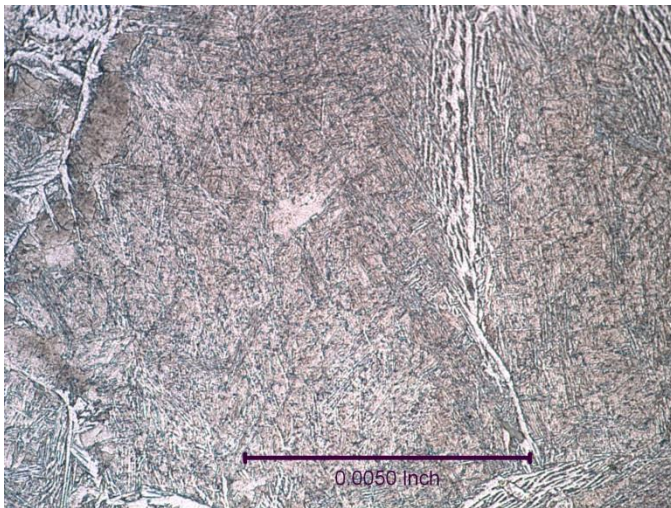
Figure 11 – 400X Large Grains in Gear Core

Figure 11 shows excessive grain size in gear core material, indicating excessive carburizing temperature.

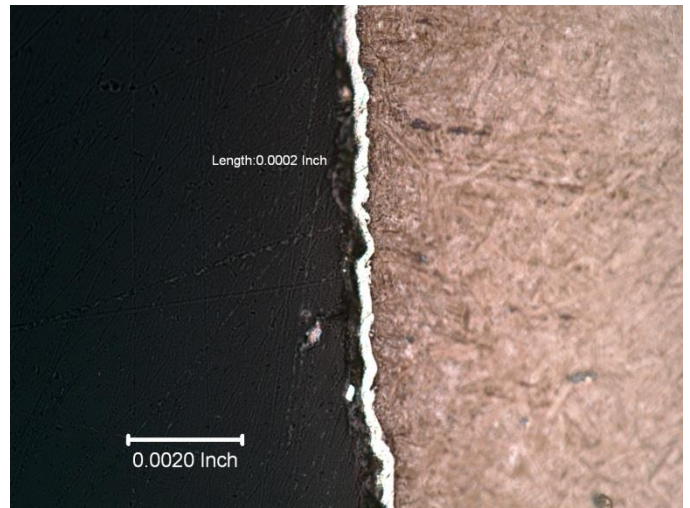
Figure 12 – 400X Nickel Plating on Gear

The thickness of the nickel plating on the gear was 0.0002 of an inch.
