# ***M. E. Williams and Associates, Inc.***

## Case Study: Compression Spring Failure

Merlin E. Williams, P.E.

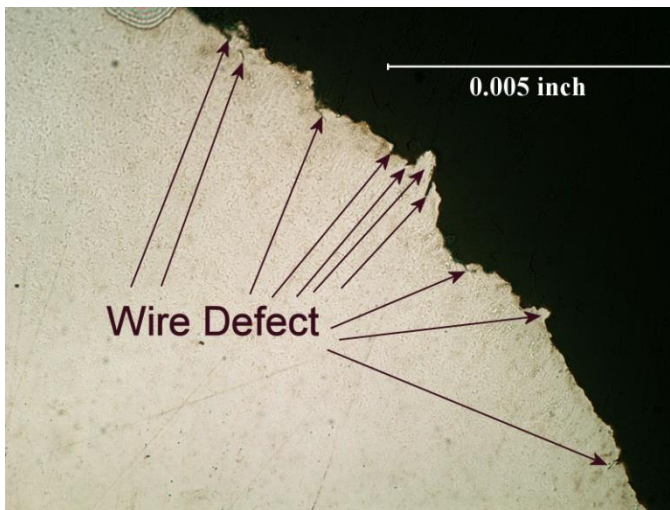
Figure 1 – 400X Wire Defects – Broken Spring

Figures 1 through 4 show wire defects on the surface of the broken spring. Any of the defects shown are capable of being a source of a fatigue crack. The broken spring failed by fatigue. Wire used for springs needs to be free of surface defects. Figure 4 shows three locations where white martensite is on the wire surface. White martensite on the surface of spring wire can be caused by friction during forming of the spring, or by redrawing of the spring wire.

The cause of failure of the broken spring was clearly defects on the surface of the spring wire. A sample of a new spring was examined to determine the source of the surface defects on the wire.

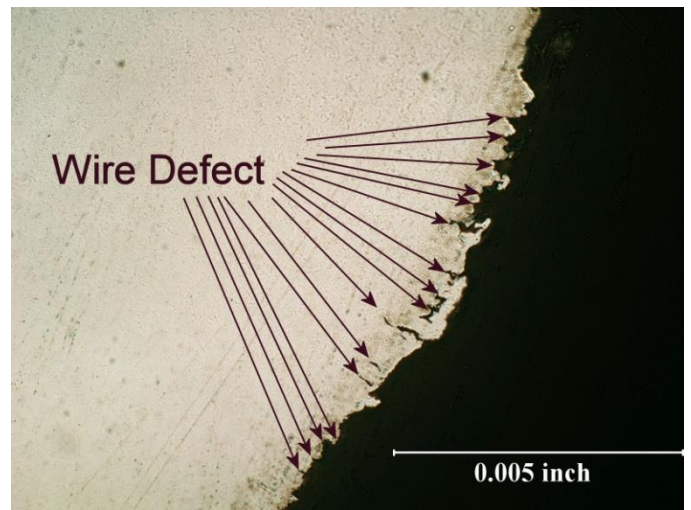
Figure 2 – 400X Wire Defects – Broken Spring

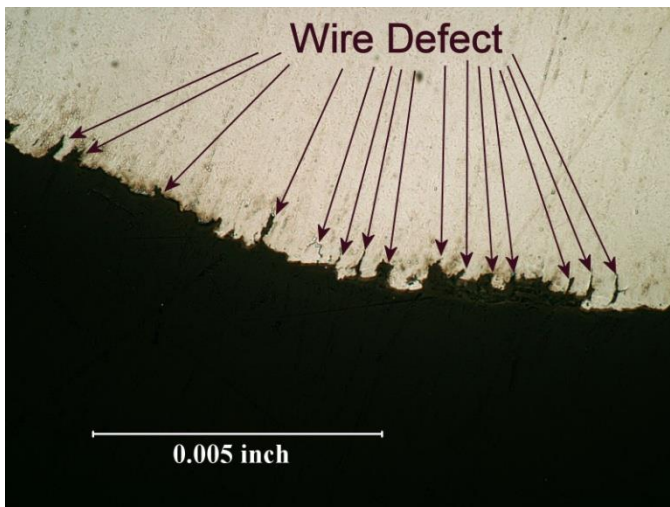
Figure 3 – 400X Wire Defects – Broken Spring

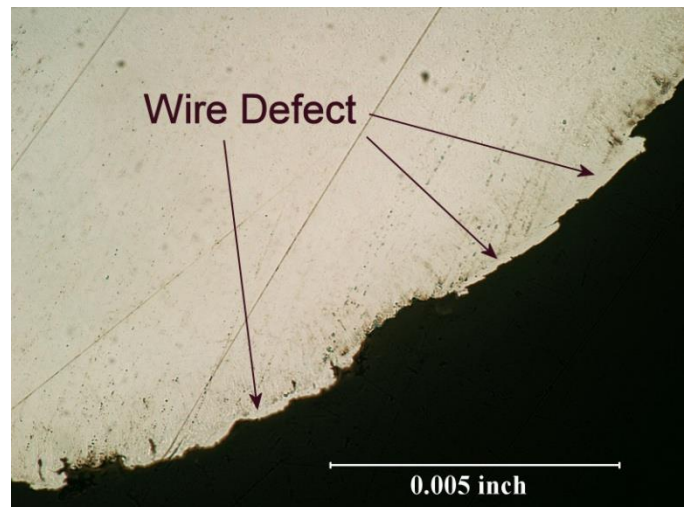
Figure 4 – 400X Wire Defects – Broken Spring

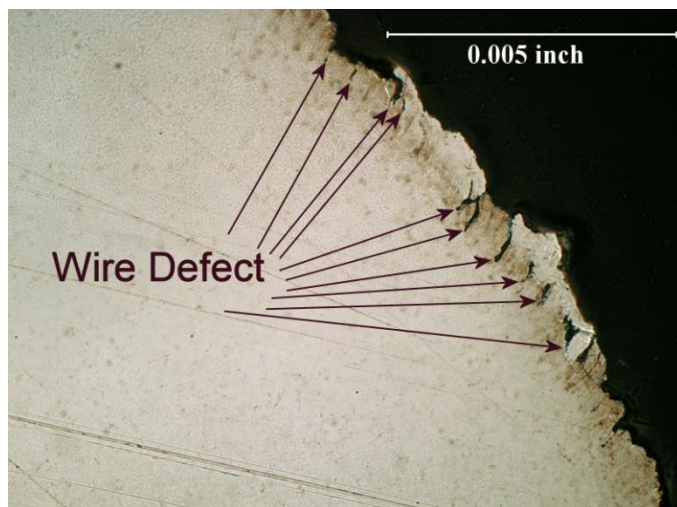
Figure 5 – 400X Wire Defects – New Spring

Figures 5 and 6 show numerous cracks and white martensite on the surface of the spring wire. These defects indicate that defective wire was used for making the spring. Figure 6 shows both surface cracks and white martensite.

The quantity and size of surface defects in this wire made the wire unsuitable for use as a spring. All springs made from this wire needed to be replaced. Premature failure in any spring made from this wire was highly likely.

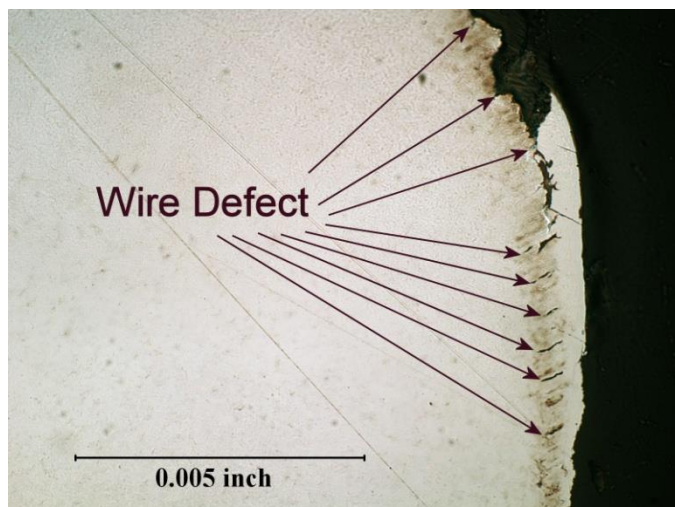
Figure 6 – 400X Wire Defects – New Spring

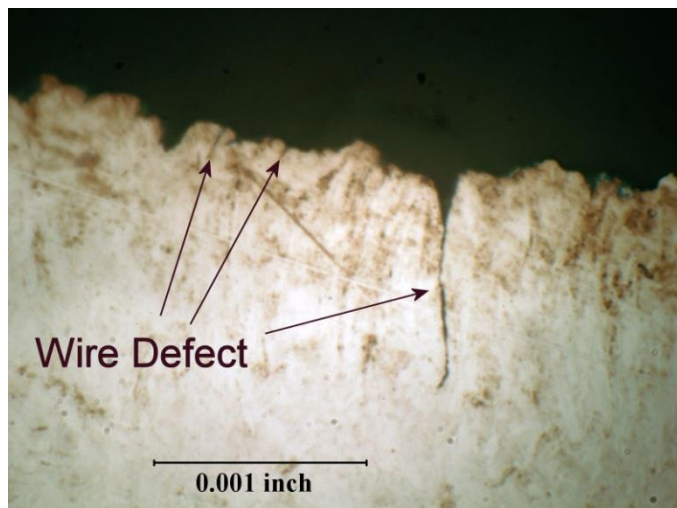
Figure 7 – 1500X Wire Defects – New Spring

Figure 7 shows three wire defects. The larger defect on the right was a compression crack. The lamellar microstructure running vertically at the surface indicates the wire was redrawn to the required 0.039 inch diameter size from a larger diameter wire, resulting in compression cracking at the surface.

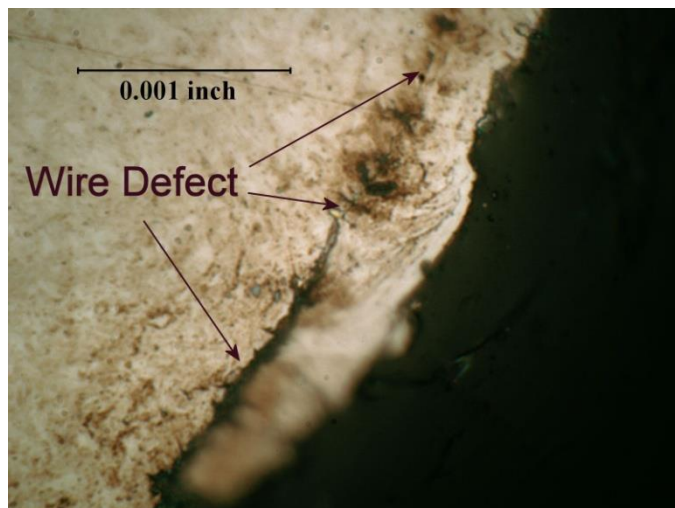
Figure 8 – 1500X Wire Defects – New Spring

Figure 8 shows highly sheared material on the wire surface. This shearing was likely caused during the redrawing operation. The shearing during redrawing was the cause of the white martensite.
