Case Study: Intergranular Failure

Failure analysis of a three-inch diameter drive shaft to determine the cause of failure, and to recommend reworking to prevent additional failures. The shaft was examined using chemical analysis, hardness testing, and metallographic examination.

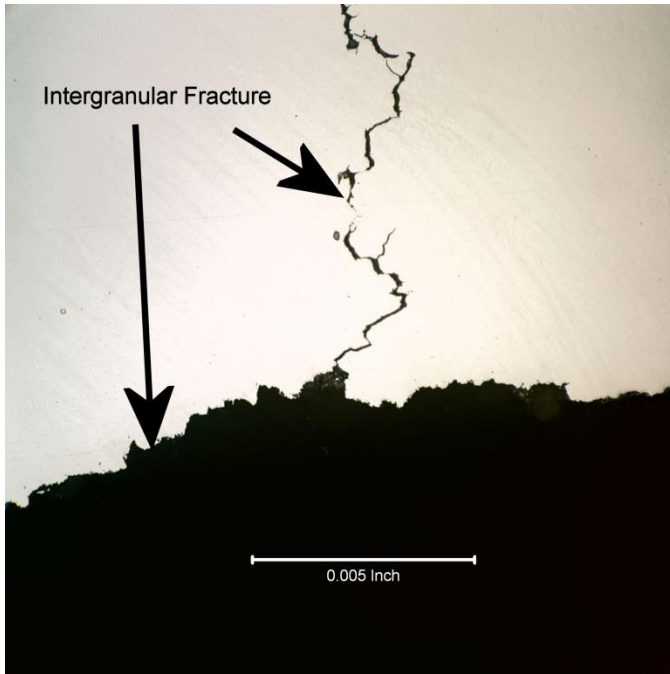
Figure 1 – 400X Intergranular Fracture, Sample 1

Figure 1 shows the tempered martensite microstructure and shear lip associated with Sample 1. The martensitic microstructure was very fine grained, indicating that the shaft was austenitized at the correct temperature. The shear lip, Figure 2, was approximately 0.002 inch. The size of the shear lip was used to estimate the Charpy Impact Strength at this location, which was estimated to be 4 foot-pounds. Charpy Impact Strengths of steel at room temperature of less than 20 foot-pounds is considered brittle.

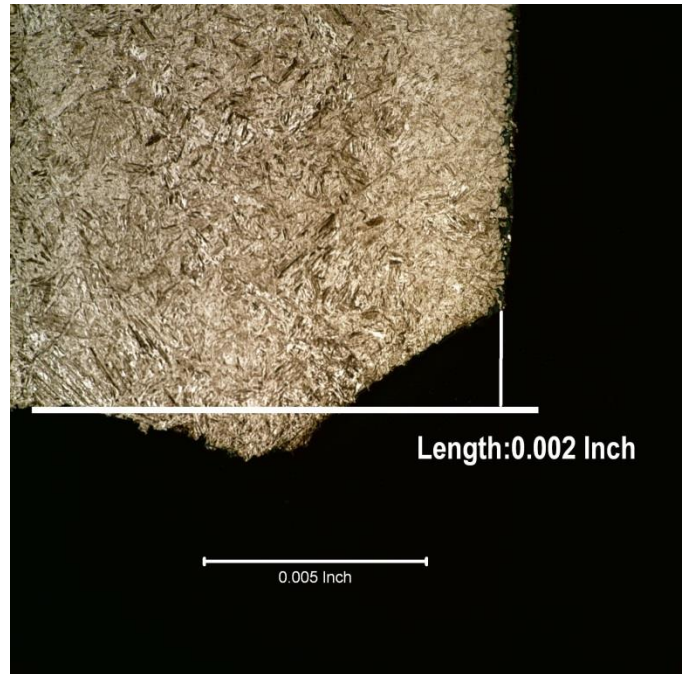
Figure 2 – 400X Shear Lip, Sample 1

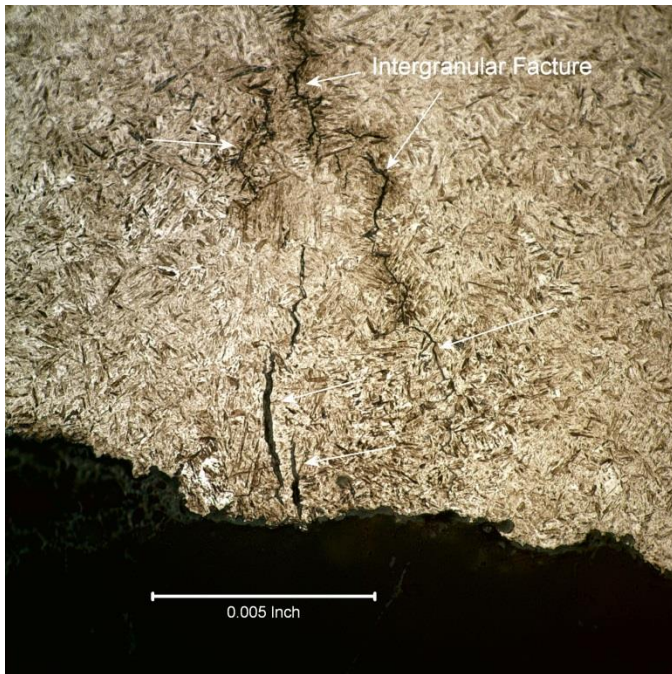
The Sample 2 fracture area is shown in Figure 3. The presence of intergranular fracture of the tempered martensite indicated very brittle steel. The presence of Bainite and pearlite, Figure 4, indicated that the quench rate was not high enough to produce a 100% martensitic microstructure, but, considering the overall size of the shaft, that was not unusual. The small area of Bainite and pearlite had little to no effect on the strength and toughness of the shaft.

Figure 3 – 400X Intergranular Fracture, Sample 2

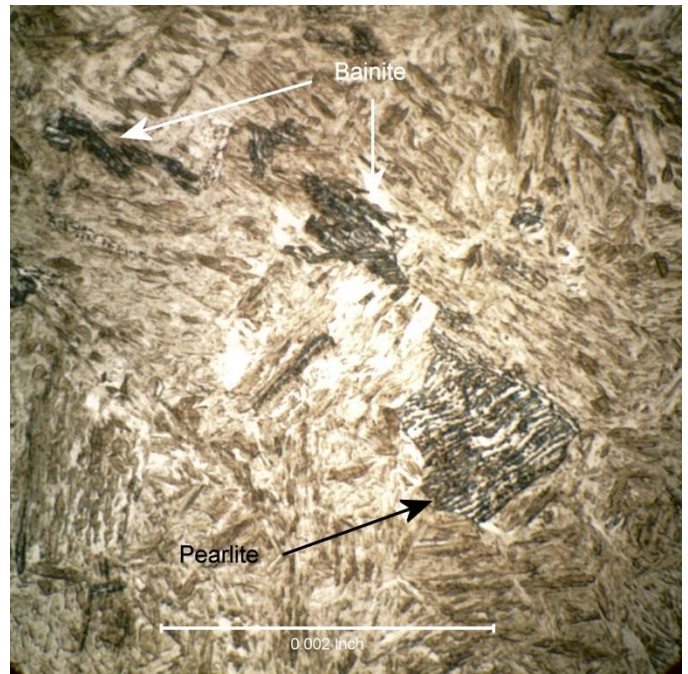
Figure 4 – 1500X Bainite and Pearlite, Sample 2

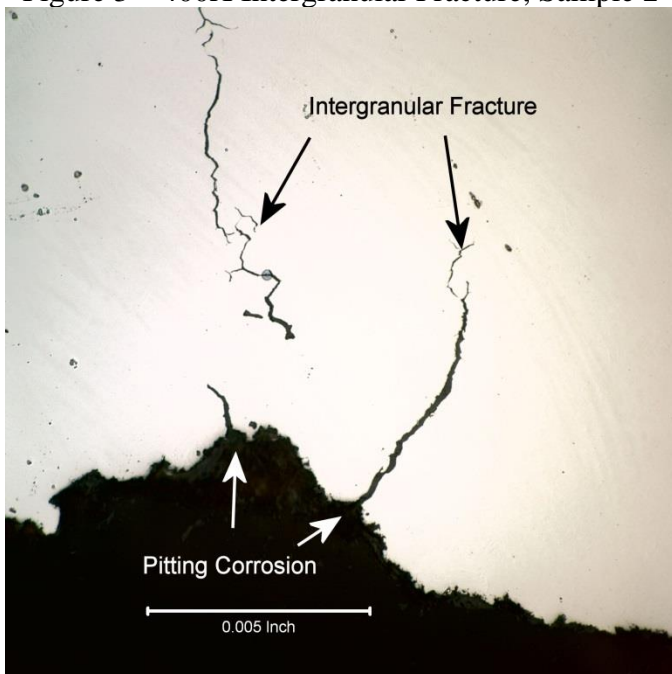
Figure 5 – 400X Pitting Corrosion and Intergranular Fracture, Sample 3

Sample 3 was taken near the fracture origin in the shaft. Figure 5 shows pitting corrosion and intergranular fracture. The pitting corrosion occurred after the shaft had been broken. The surface with the pitting corrosion was the original fracture surface. The intergranular fractures, indicated in Figures 5 and 6, were secondary cracks.

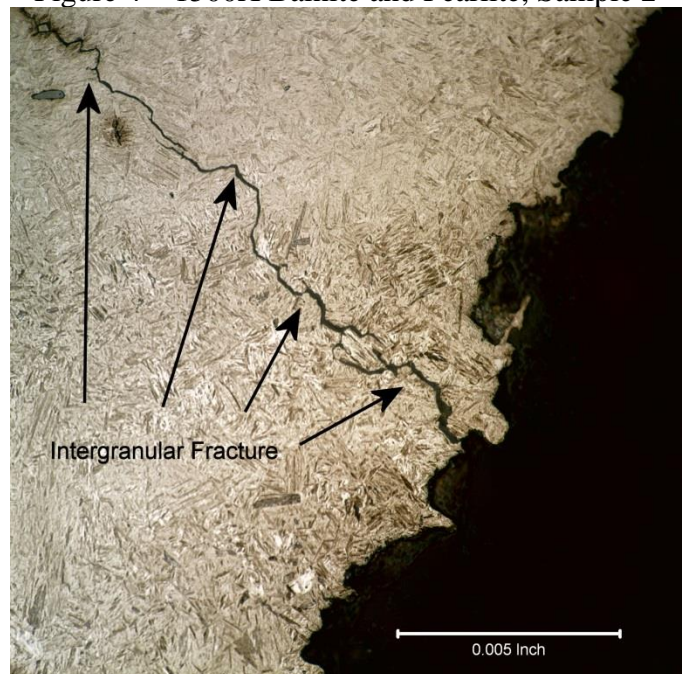
Figure 6 – 400X Intergranular Fracture, Sample 3
