## Case Study: Fatigue Failure

Merlin E. Williams, P.E.

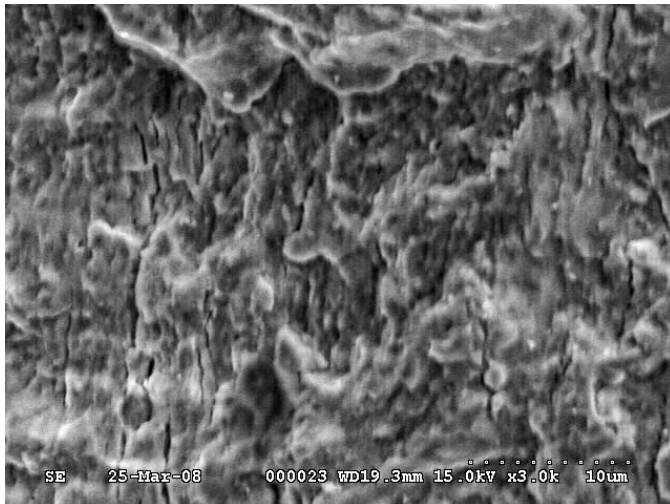
Figure 1 – 3500X Fracture Surface Bolt 1

The fracture mode of Bolt 1 was clearly fatigue, Figure 1. The fatigue striation spacing shown in Figure 1 is  $1.42 \times 10^{-5}$  inches. Fissile fracture is present, indicating that the localized cyclic stress exceeded the tensile strength of the bolt.

The value of  $a$  for Bolt 1 was 0.218 inches. The estimated cyclic stress on this bolt was 47,000 psi, which is below the endurance limit of around 60,000 psi. This indicated that the bolt had not been properly torqued.

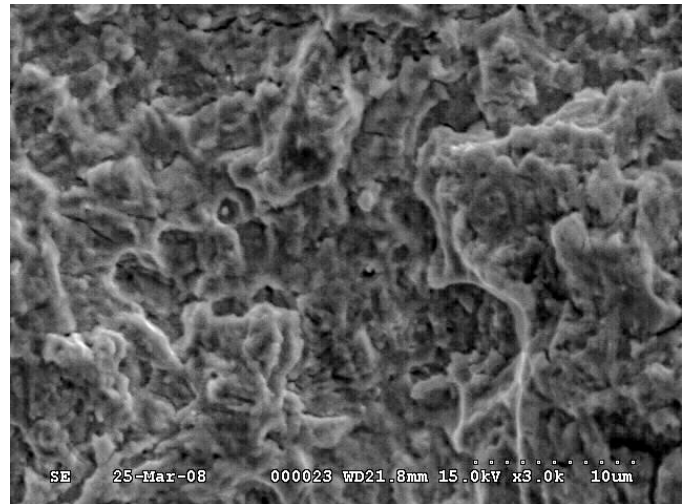
Figure 2 – 3000X Fracture Surface Bolt 2

The fracture mode of Bolt 2 was also fatigue, Figure 2. The fatigue striation spacing shown in Figure 2 is  $1.77 \times 10^{-5}$  inches. There are only a few fissure cracks present, indicating that the cyclic stress was below the tensile strength of the bolt.

The value of  $a$  for Bolt 2 was 0.152 inches. The estimated cyclic stress on this bolt was 62,900 psi. The endurance limit would have been around 75,000 to 80,000 psi, indicating this bolt had also not been properly torqued. Based on the comparative estimated cyclic stress of the bolts, Bolt 2 likely failed after Bolt 1 had failed.

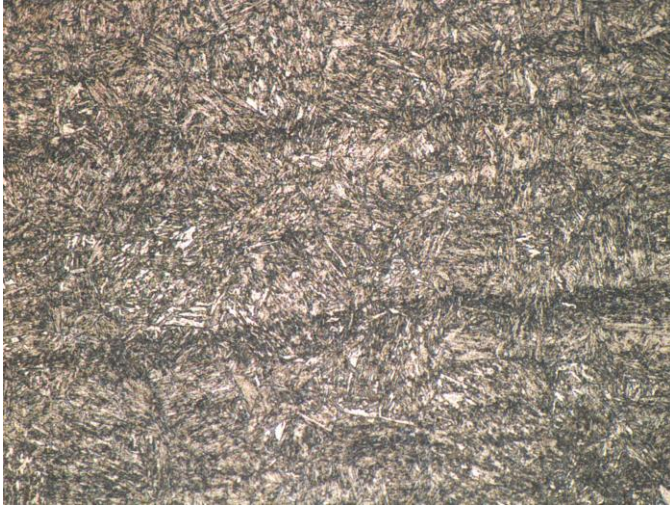
Figure 3 – 400X Tempered Martensite, Bolt 1

Bolt 1 had a microstructure of tempered martensite, Figure 3, which is typical of SAE Grade 8 fasteners. The bolt had rolled threads, Figure 4, and was a good quality Grade 8 fastener.

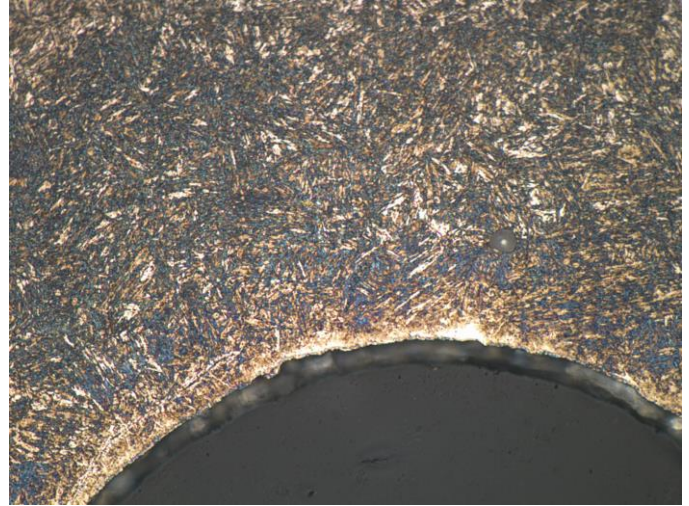
Figure 4 – 400X Tempered Martensite Thread Root, Bolt 1

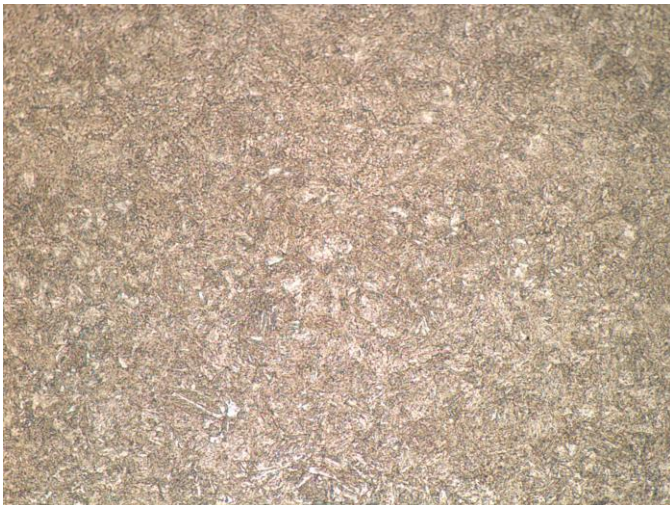
Figure 5 – 400X Tempered Martensite Microstructure, Bolt 2

The microstructure of Bolt 2 was fine grained tempered martensite, Figure 5. The microstructure was typical of a bolt of this hardness. The outer surface of the bolt showed pitting corrosion, Figure 6. The type of corrosion shown is typical of excessive-acid pickling prior to electroplating. Pits on the surface and in the thread roots can act as stress risers for fatigue failures.

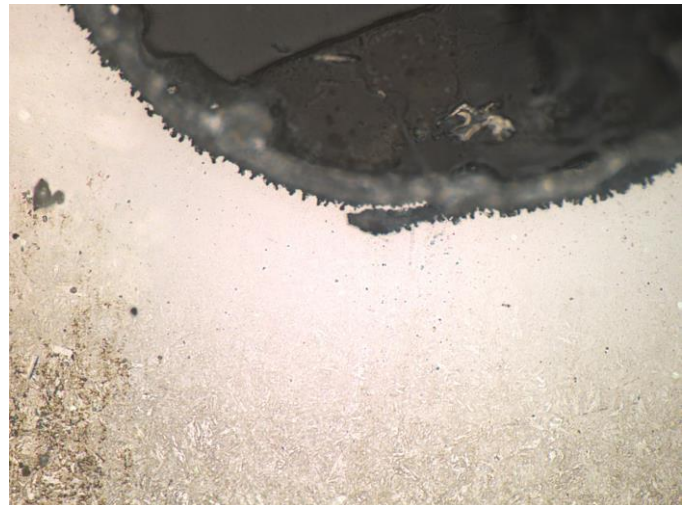
Figure 6 – 400X Pitting Corrosion Thread Root, Bolt 2

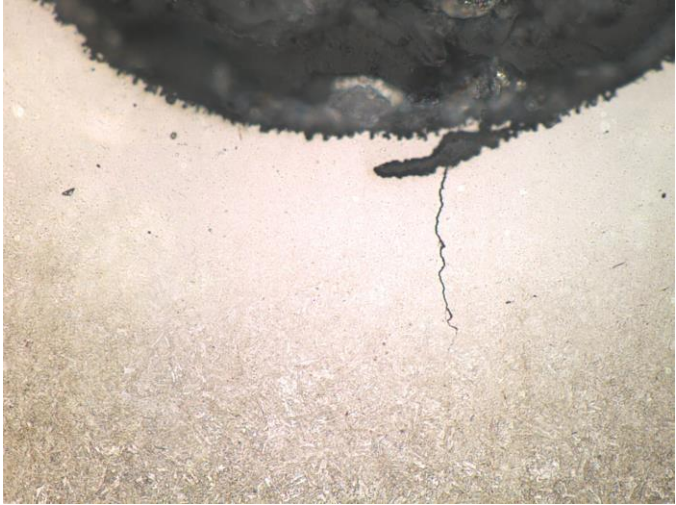
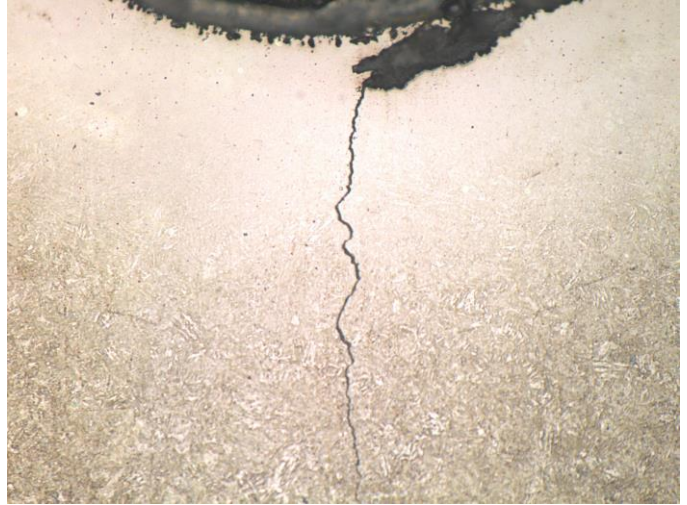
Figure 7 – 400X Intergranular Cracking, Thread Root, Bolt 2

Figure 8 – 400X Intergranular Cracking, Thread Root, Bolt 2

A number of the thread roots of Bolt 2 showed intergranular cracking. Figures 7 and 8 are examples of this. The intergranular cracking was likely the result of hydrogen embrittlement. These cracks can act as stress risers for fatigue.

If Bolt 2 had been properly torqued it would still have failed by hydrogen embrittlement.
