M. E. Williams and Associates, Inc.

Cast Iron Failure – Case Study

One of the more difficult situations faced by many manufacturers is trying to purchase cast irons that meet their specifications from a new supplier. This is particularly true when purchasing from a low cost supplier. This case study involves a cast iron hub that failed shortly after being placed in use. The hub was from a second order of castings, supposedly from the same foundry as the original order of castings which performed as expected. The castings were specified and certified to be 80-55-06 ductile cast iron. Prior to machining, the casting weight was 75 pounds. The failed casting was examined by visual examination, hardness testing, and metallographic examination.

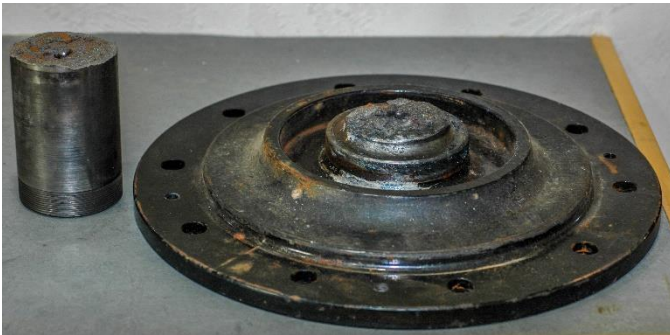
Figure 1 – Broken Casting as Received from Client

Figure 1 shows the broken casting as received from the client. The fracture occurred on the interface between the flange and the shaft. Figure 2 shows the fracture surface on the flange side. The fracture appears to be brittle, and the material is similar in appearance to gray cast iron, not 80-55-06 ductile cast iron.

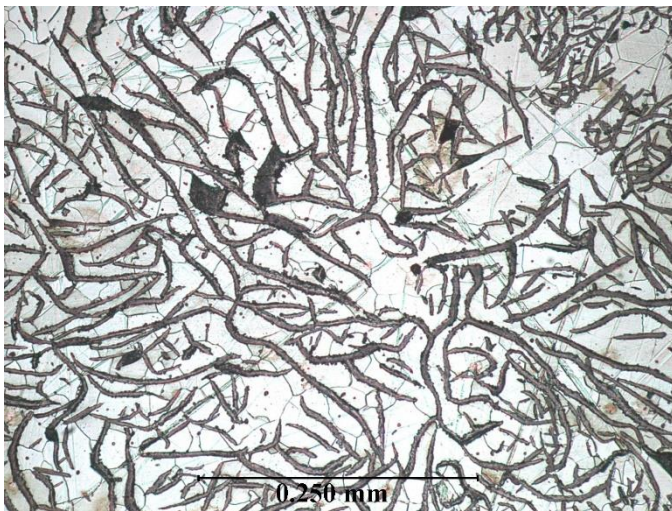
Figure 7 – 200X Ferritic Gray Cast Iron – Flange Area of Fracture

Ferritic gray cast iron microstructure is shown in Figure 7, which is typical of Class G1800 cast iron. The hardness of 105 BHN indicates that the gray cast iron areas of the casting were Class G1800, which is typically used for applications where vibrational damping is required, and minimal strength characteristics are not required.
