## Case Study: Chromate Conversion Coating

Merlin E. Williams, P.E.

Evaluation of trivalent chromate conversion coating on zinc plating to determine possible cause of discoloration of the coating upon storage of the parts. At the time of this case study, the discoloration of trivalent chromate conversion coatings was an industry wide problem that was assumed to be corrosion. It was apparent that the discoloration only happened when parts were chromated by tumbling in barrel plating drums. This study determined the nature of the problem, that the soundness of the material was not affected, but only the surface appearance. Possible causes of the problem were also determined.

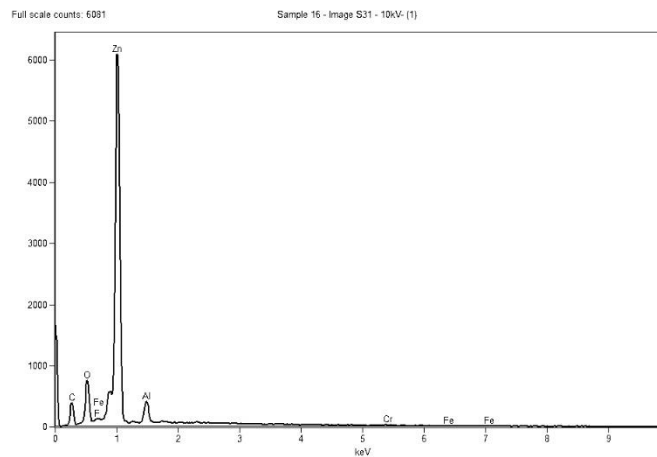
Figure 3 – Spectrum of Zinc Die Casting

A zinc die cast part, treated with trivalent conversion coating six months prior to the analysis of the surface, was examined. Figure 2 shows the area of analysis on the Zinc Die Casting. The semi-quantitative analysis results are given in Table 1, and the spectrum is shown in Figure 3.

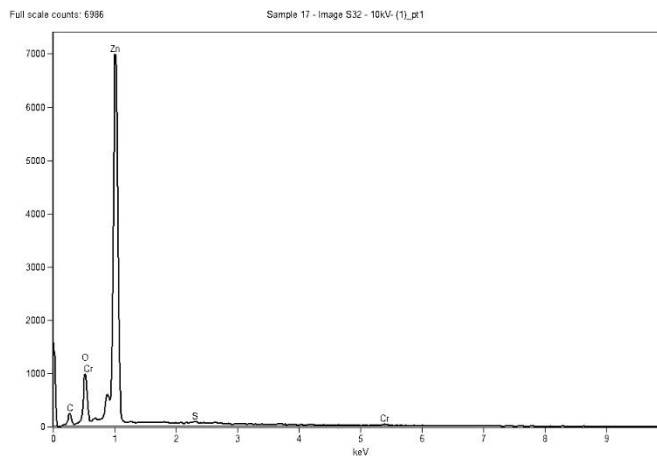
Figure 4 – Spectrum of Zinc Plated Steel, Area 1, Location 1

There was no fluorine or silicon present at Location 1, but chromium was found. Location 2 was free of the conversion coating. The dark material, Figure 3, Locations 3 and 4, showed the presence of fluorine

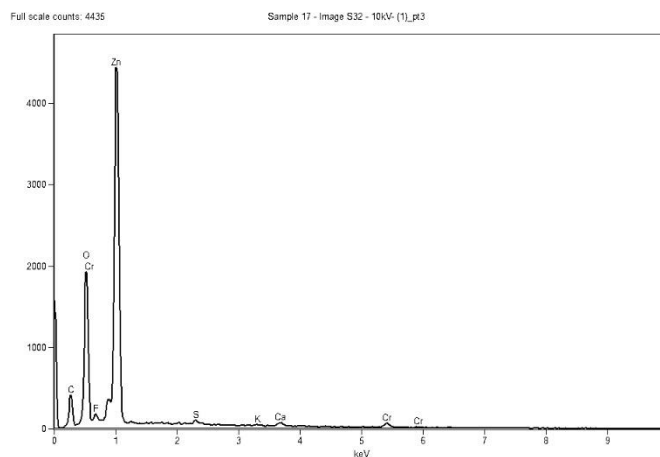
Figure 6 – Spectrum of Zinc Plated Steel, Area 1, Location 3

and chromium. Location 4 also had silicon. In Locations 3 and 4, the coating was thicker, allowing for better analysis.

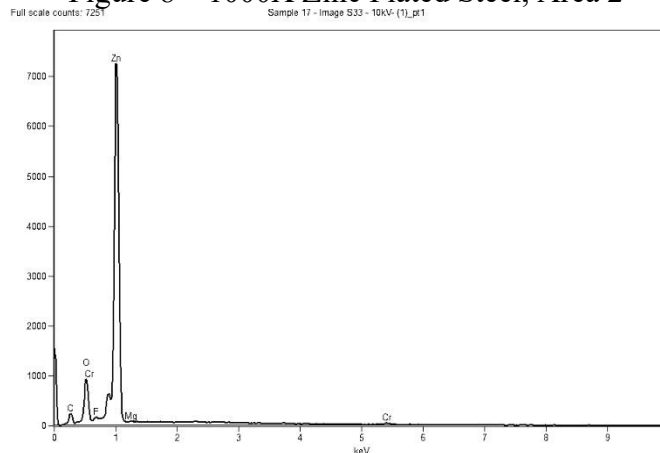
Figure 10 – Spectrum of Zinc Plated Steel, Area 2, Location 1

Locations 1 and 2 had the conversion coating, but the supplemental coating was not detected. Locations 3, 4, and 5 were free of any detectible coating.

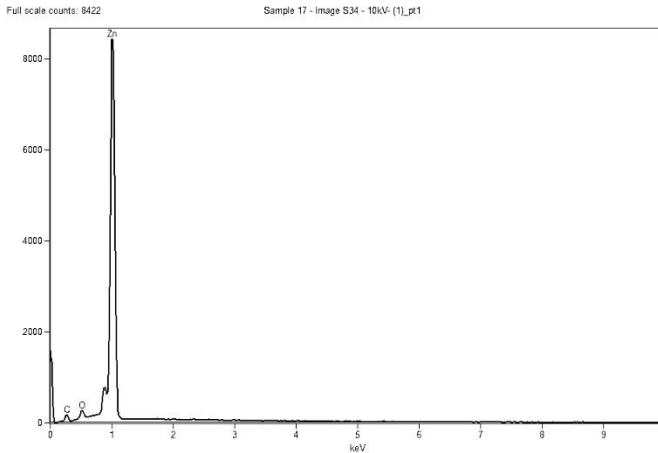
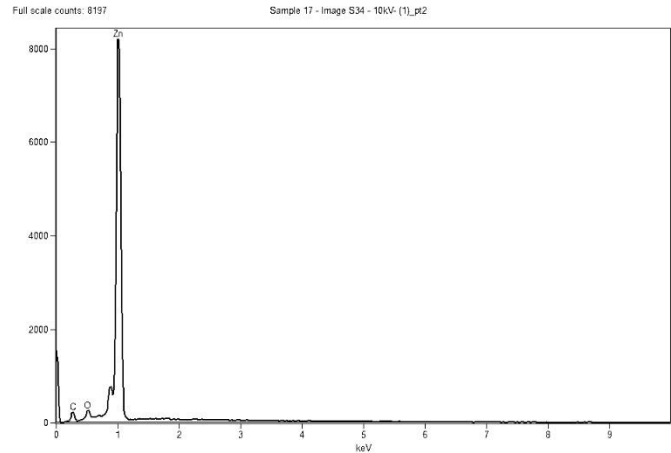
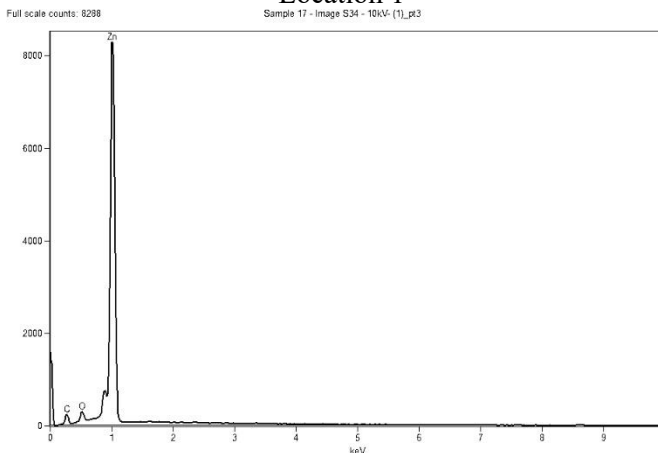
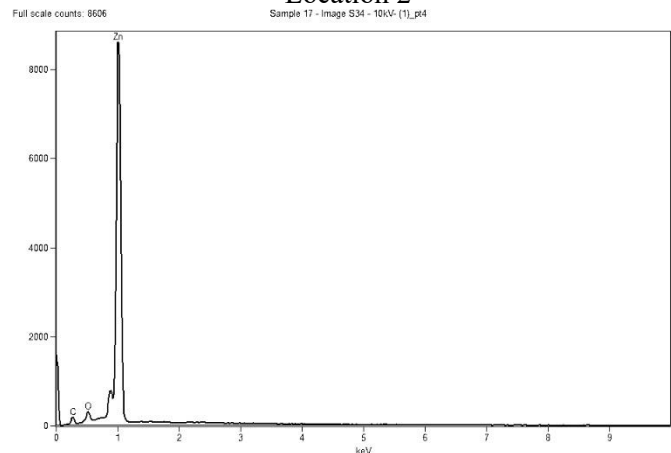
The analysis of the particles showed that they were submicron-sized zinc particles.
